HOIS/OGTC guidance for trunnion pipe support management and inspection

HOIS-G-033, Issue 1

October 2020

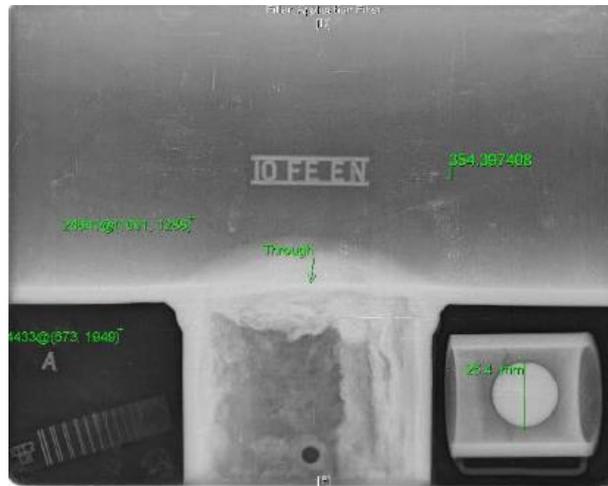
Figure 6-1: CR image (courtesy CAN), evidence of through wall external corrosion of process pipe, large volume of corrosion product inside trunnion.

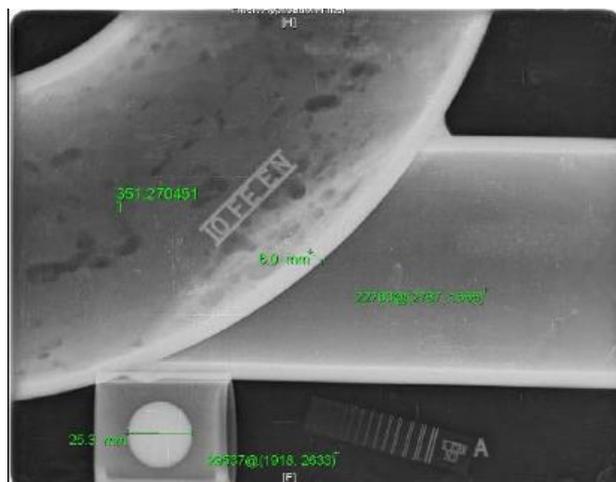
Figure 6-2 CR image (courtesy CAN), evidence of pitting type wall loss of the process pipe. Internal corrosion not limited to the section of process pipe covered by the trunnion.

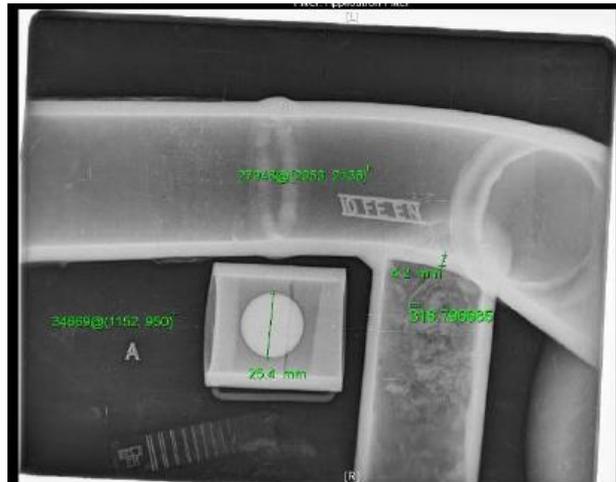
Figure 6-3: CR image (courtesy CAN) external corrosion noted within trunnion, MRWT measured. Some evidence of pitting in the process pipe wall within the trunnion would put further caveats on MRWT measurement. Significant volume of corrosion product visible inside trunnion.

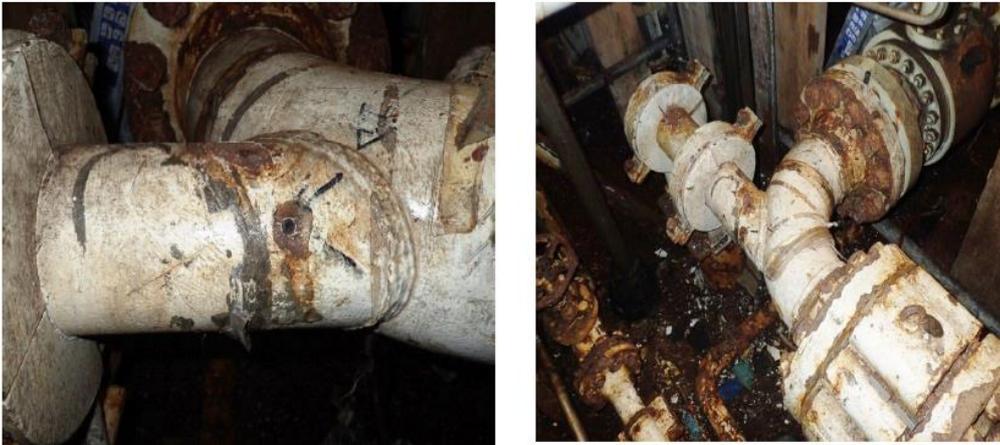
A gas sensor on site detected gas during normal operation. The system was shut down and depressurised to allow investigation into the hydrocarbon release. This identified that the gas leak was emanating from a carbon steel trunnion, shown in Figure 7-1. The spool was removed from service and onshore inspection subsequently confirmed the leak to be due to external pinhole corrosion on the pipework within the trunnion.

Figure 7-1: Leaking spool *in situ*.

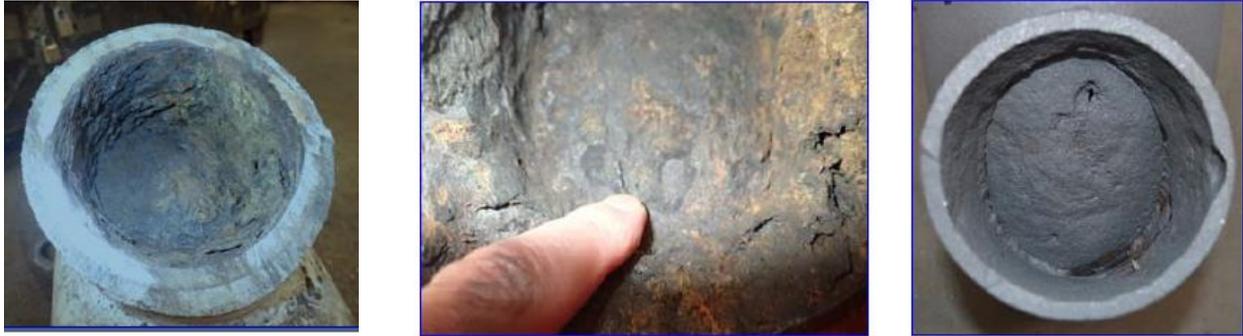
The trunnion was sectioned and this revealed generalised corrosion of the internal trunnion wall and pitting was found on the external wall of the hydrocarbon pipework which led to a through wall perforation, shown in the images in Figure 7-2. The weep hole was in an exposed location (3 o'clock, horizontal trunnion) and the trunnion showed signs of water ingress.

Figure 7-2: Trunnion sectioned to reveal internal corrosion of trunnion and pitting corrosion on process pipe. Image on the right shows trunnion/process pipe internals following blasting.

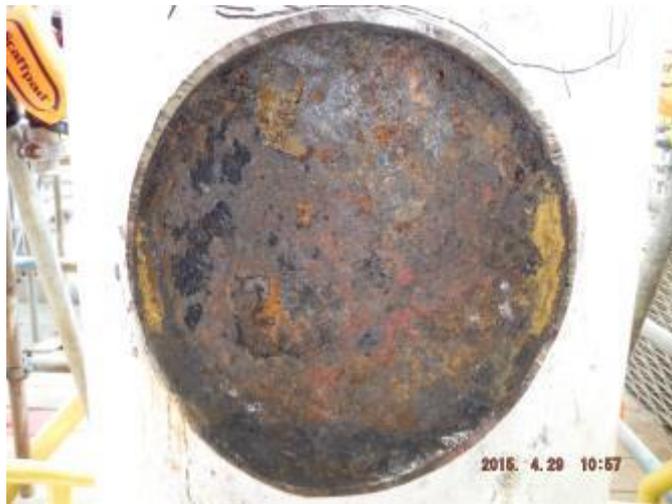
Figure 7-3: Trunnion footprint area (most of trunnion pipe removed). Pre-blast cleaning.

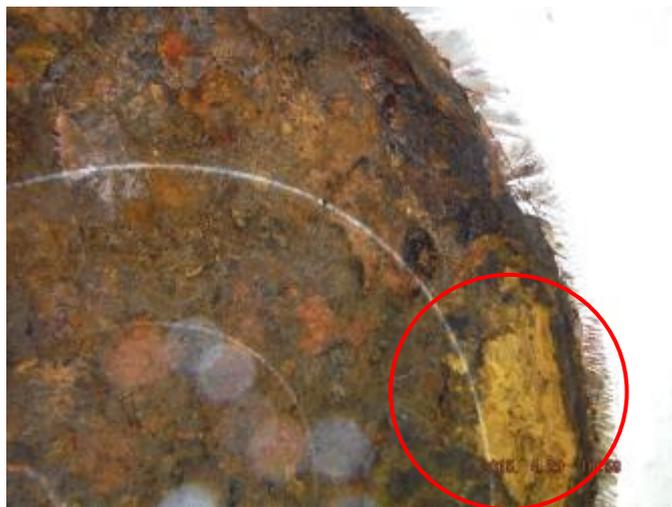
Figure 7-4: Trunnion footprint pre-blast cleaning. Pitting found under corrosion material.

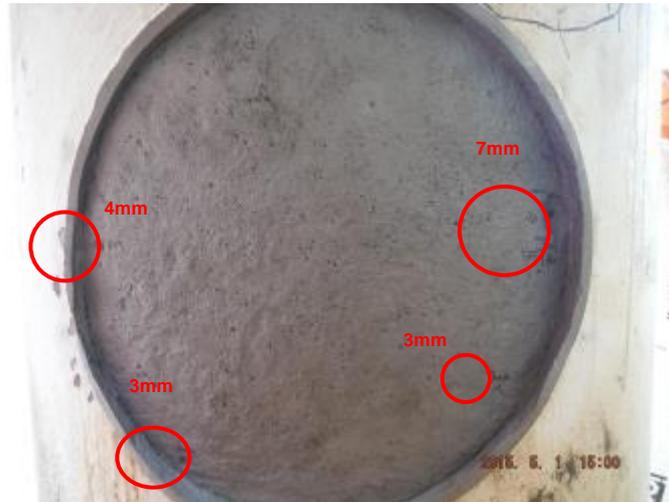
Numerous supplementary isolated pitting over the whole of the footprint area was noted, with depths measuring $\leq 2.5\text{mm}$.

Figure 7-5: Trunnion footprint after blast cleaning (pit depth measurements in red).

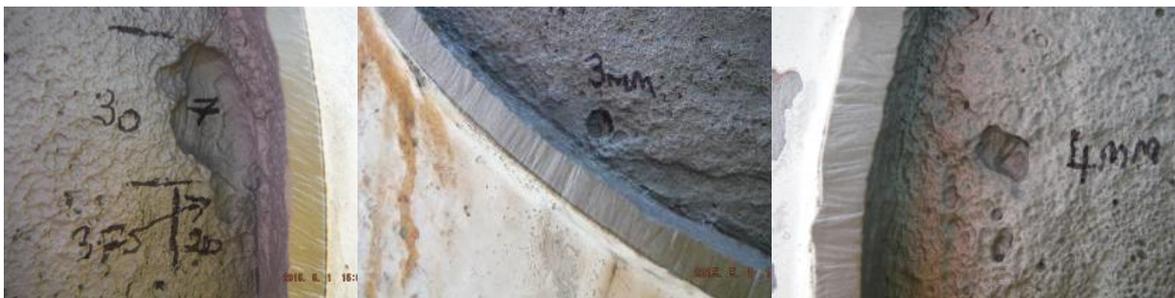
Figure 7-6: Isolated pits: Left: 7mm, Centre: 3mm deep 5x5mm, Right: 4mm deep 8x6mm

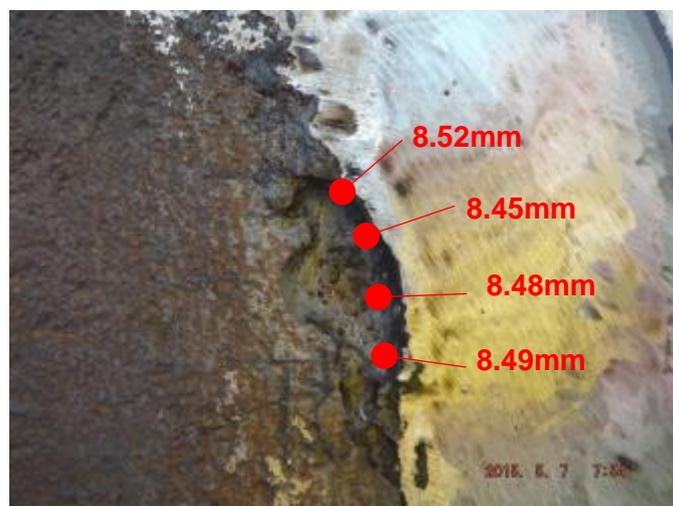
The remaining trunnion wall was then removed and ground back to sound material shown in Figure 7-7. Additional UT wall thickness measurements could then be taken from sound material directly adjacent to the deepest pitted areas using a 5mm button probe. Four measurements were taken along the side of the pit: 8.52mm, 8.45mm, 8.48mm and 8.49mm.

Figure 7-7: Four UT wall thickness spot readings adjacent to pitted area

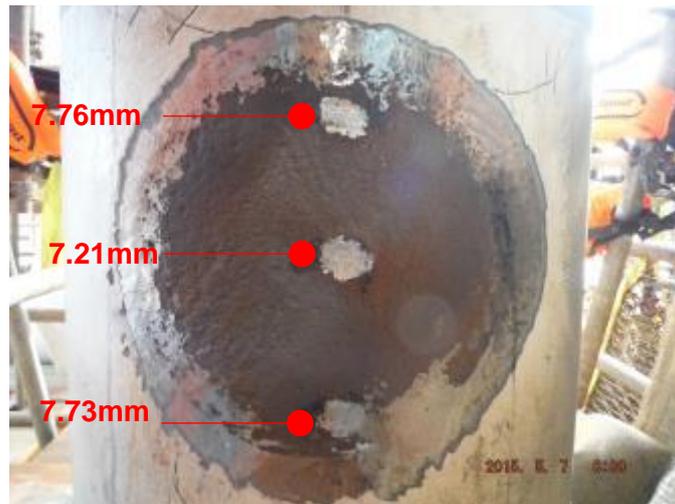
Figure 7-8: Three UT wall thickness spot readings from footprint area

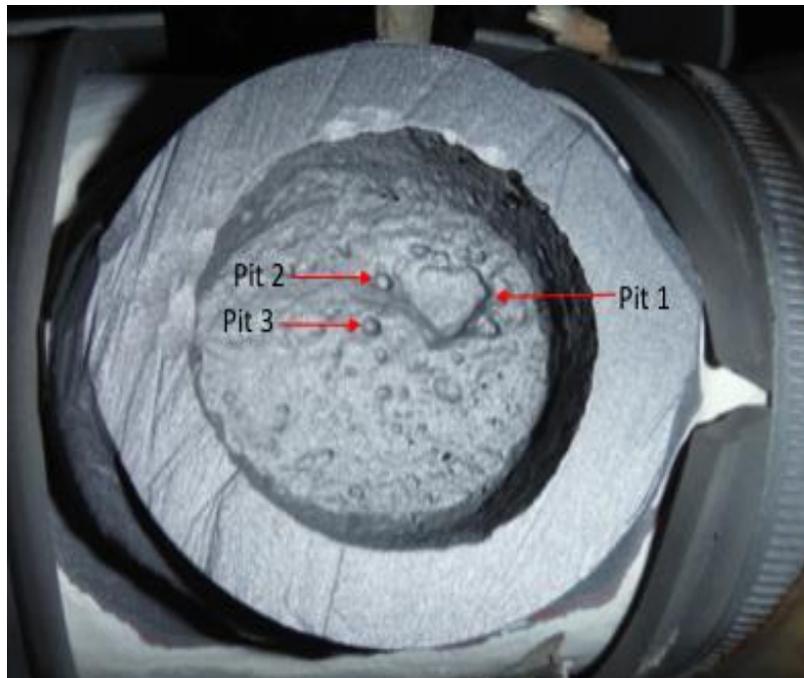
The trunnion endcaps were removed, and external delaminating corrosion was located on the external and internal surfaces of the trunnion pipe supports. The depth of the scale on the inside of both trunnions was estimated to be between 5 and 6mm. The scale was removed, and UT spot readings were performed where possible. Blasting revealed pitting corrosion over the whole trunnion footprints with more severe pits, as shown in Figure 7-10 and Figure 7-11.

Figure 7-10: Trunnion A post blasting: Pitting of between 0.5mm and 1.0mm over whole footprint with 3 more severe pits.

The spool was changed out because of the 4.0mm deep pit not meeting the operator's company performance standard.

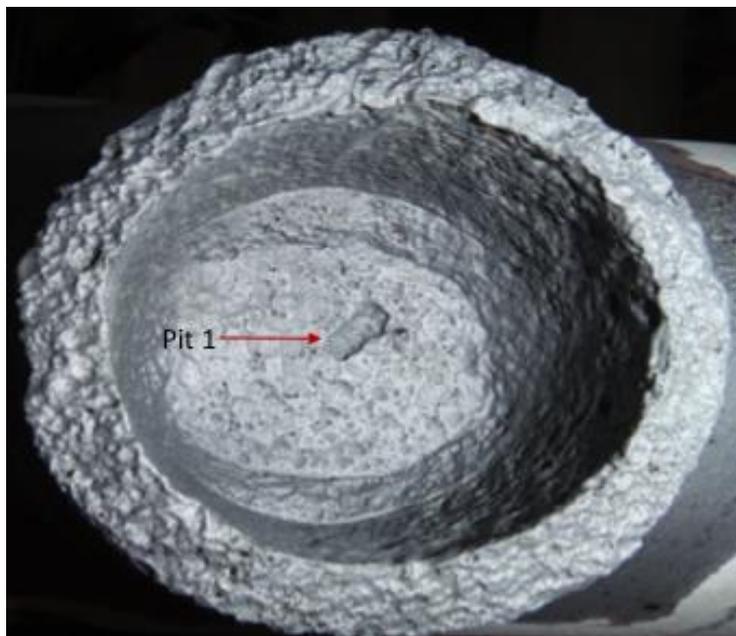
Figure 7-11: Trunnion B post blasting: Pitting of between 0.5mm and 1.0mm over whole footprint with 1 more severe pit.

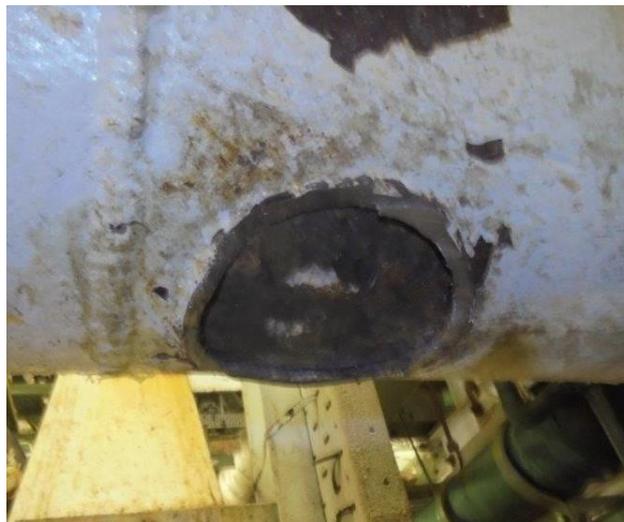
The trunnion was then removed (cold cut) to further assess the condition of the process pipe. Light surface corrosion was identified with no excessive pits as shown in Figure 7-15. The area was cleaned, and wall thickness measurements taken using a button probe and found to be within nominal. A new clamp type support was fitted Figure 7-16.

Figure 7-15: Area within trunnion exposed.

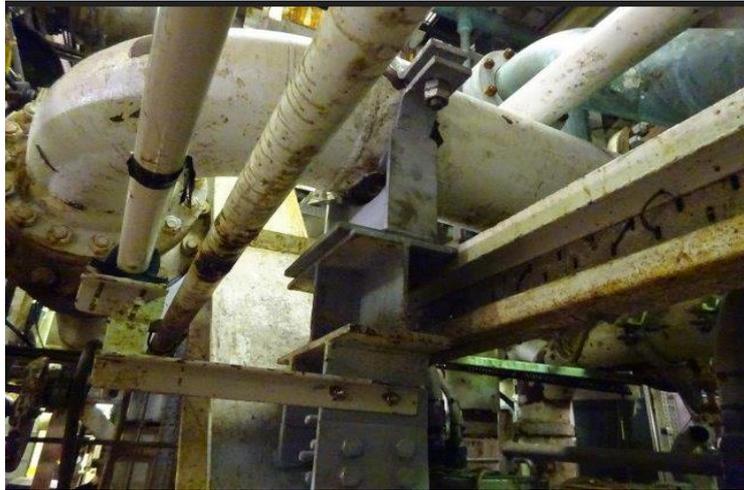
Figure 7-16: Clamped shoe arrangement.

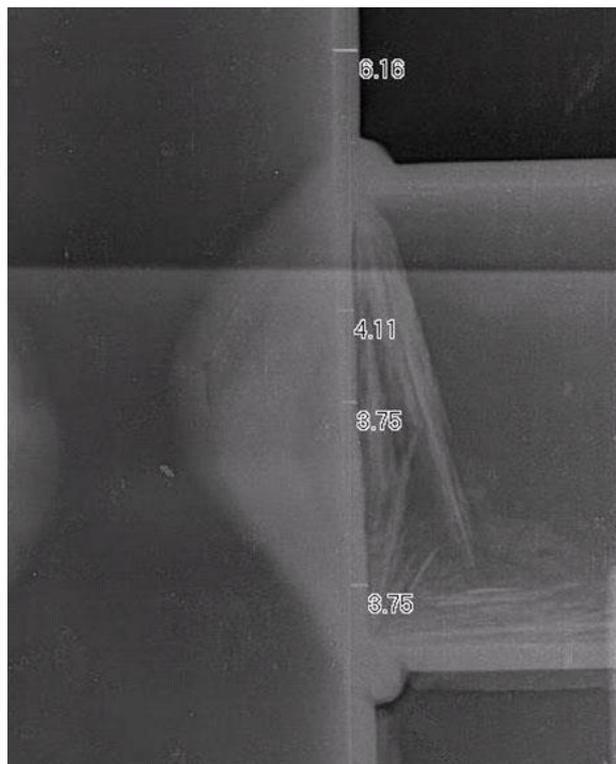
The company conducted further investigations on site and have found other instances of the same corrosion. This has led to immediate replacement in some cases. In total, almost 5% of the site population of trunnions had to have some remedial work. An example radiograph is shown in Figure 7-17.

Figure 7-17: Radiography of corroded pipework at trunnion showing wall loss and corrosion product in trunnion.

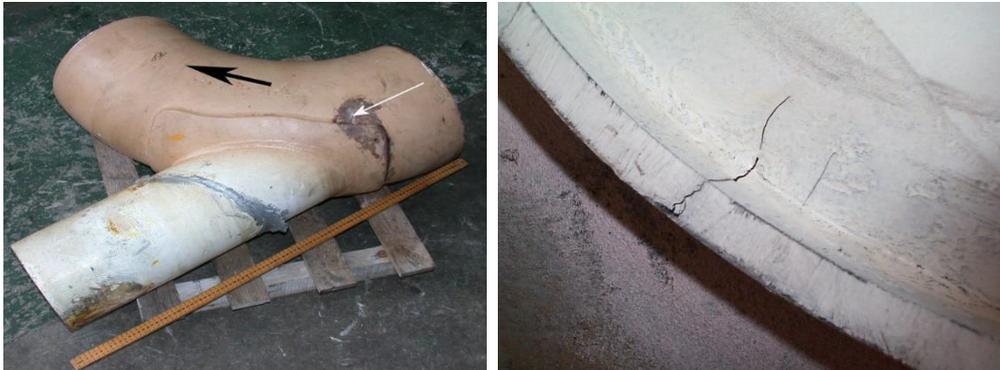
These failures led to platform shutdown, although no injury to personnel. The estimated production losses were 1.4million barrels of oil equivalent.

Figure 7-18: Left: Trunnion and process pipe with flow direction and location of crack indicated. Right: crack.

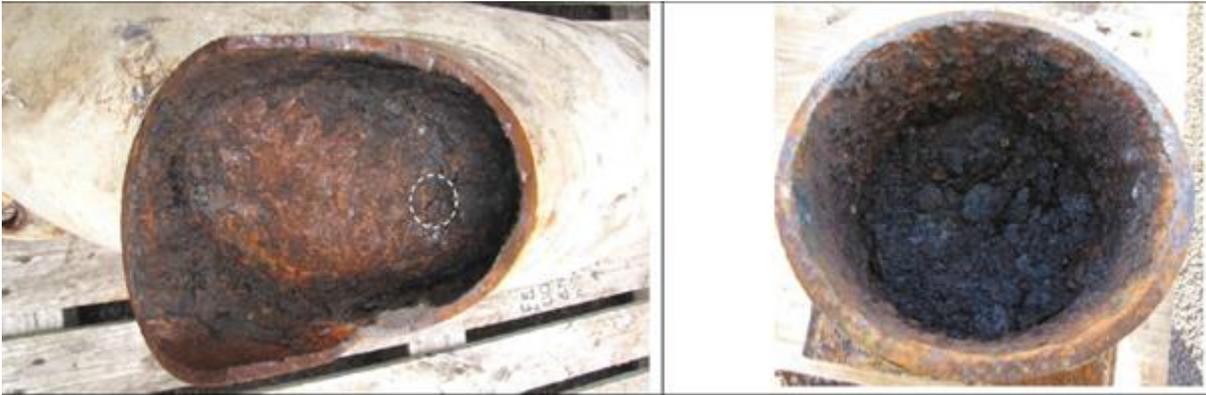
that had fallen and collected at the bottom of the vertical trunnion, as shown following removal of the process pipe and trunnion in Figure 7-19.

Figure 7-19: Left: Corrosion scale leading to a perforation (circled) with relatively superficial appearance. Right: Heavy corrosion scale collected at bottom of vertical trunnion

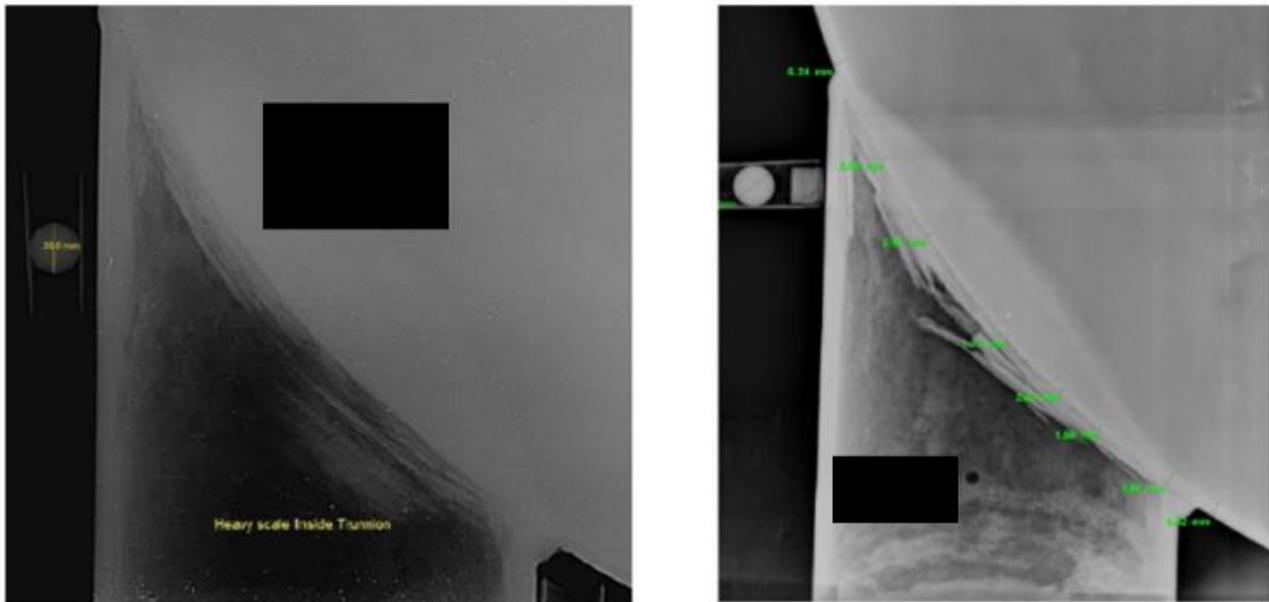
After the borescopic inspection, radiographs were taken again. This time using digital radiography rather than film as per original inspections. The significantly improved radiographs, shown in Figure 7-20, clearly showed significant wall thinning and greater scale build up, causing the three related trunnions to have Fitness for Service assessments carried out for the interim period to change out.

Figure 7-20: Left: Initial radiography. Right: Second radiograph three years later using larger source and digital capture, providing significantly more detail.

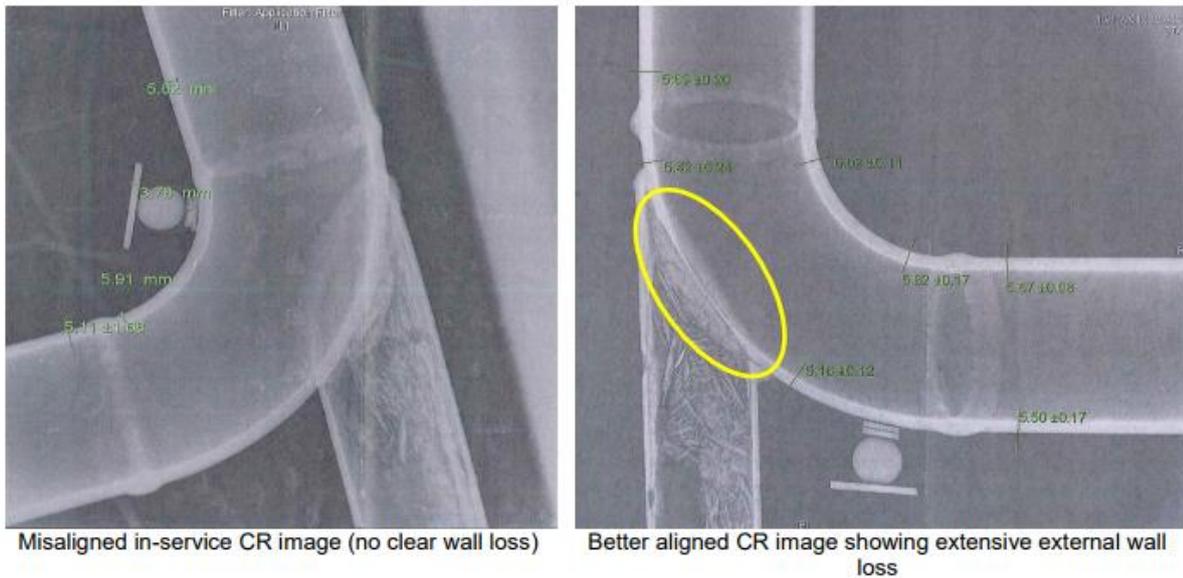
reported from the CR image (Figure A 1-8: , left) but there was known to be a leak due to corrosion. The pipe and trunnion were cut-out and removed from service. Subsequent CR images were obtained in an exposure bay at different angles to better align the corroded area with the tangent position. The lack of site restrictions on source and plate positioning also allowed the source to detector distance to be increased to reduce the geometric unsharpness. The resulting images obtained for different pipe rotation angles relative to the bend extrados located at the tangent position are shown in Figure A 1-9: . At 0° there is close to zero remaining wall thickness (consistent with the leak) whereas at 30° there is no evidence of major wall loss.

Figure A 1-8: Computed radiography images of trunnion support: Left: original in-service image. Right: image with source and detector better aligned following removal from service.

There are clues in the left-hand image of Figure A 1-8: to the experienced operator that the image is misaligned and therefore unreliable for wall thickness measurement i.e. the edges of the pipe are not well delineated and the elliptical nature of the trunnion to pipe weld image. Also, there is a significant volume of corrosion product inside the trunnion which should be indicative of a problem.

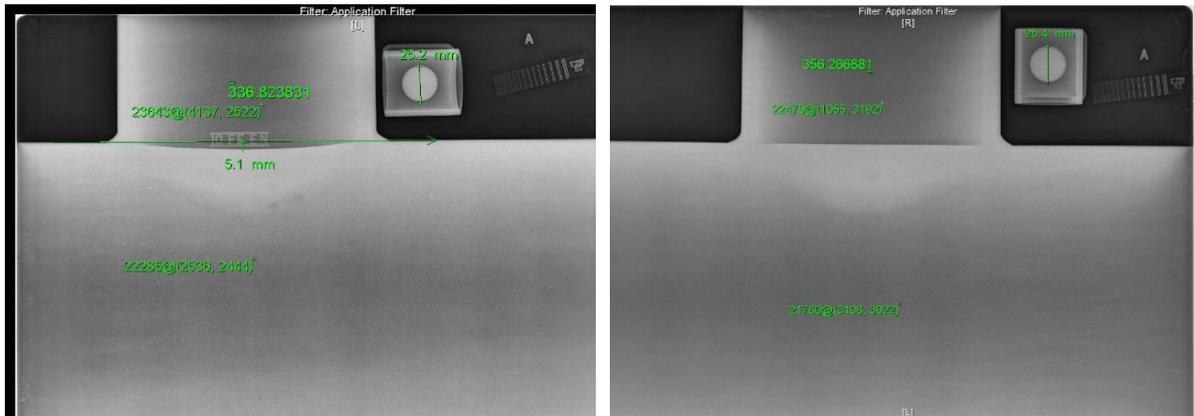
Figure A 1-10: Example CR results: Left – estimated wall loss out with procedure and area of pitting noted. Right: area of pitting noted.

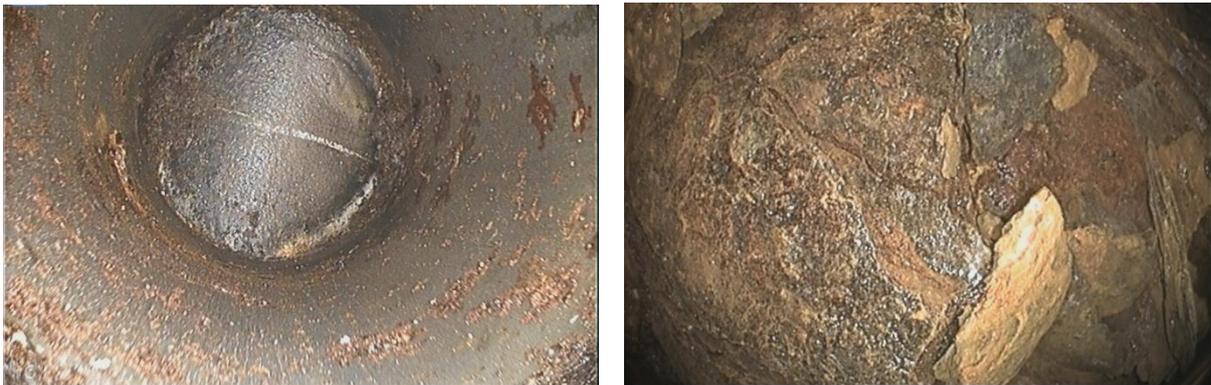
Figure A 1-12: Left: video scope image of an uncorroded trunnion, shows trunnion wall and process pipe, Right: video scope image of a severely corroded trunnion (scope inserted fully into trunnion to view process pipe wall only).

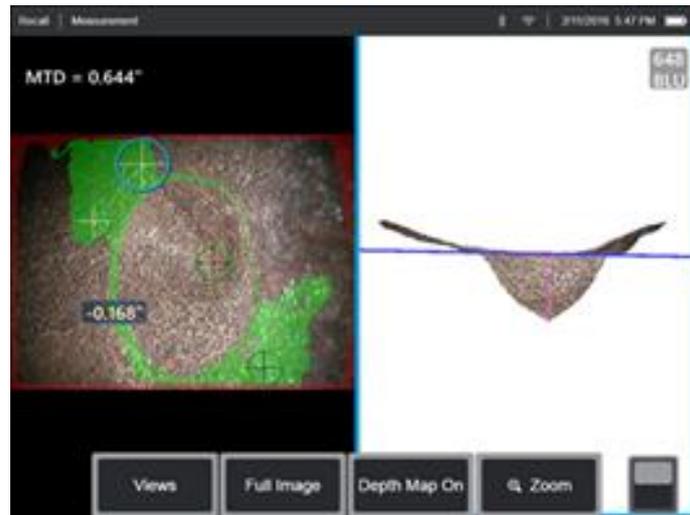
Figure A 1-13: 3D Stereo measurement tools on debris free corrosion pit. Image courtesy of Waygate Technologies.
