# INVESTIGATION OF AN ANOMALOUS FAILURE OF BEARING ON A FAN WITHIN THE COLUMBUS MODULE OF THE ISS

## ABSTRACT

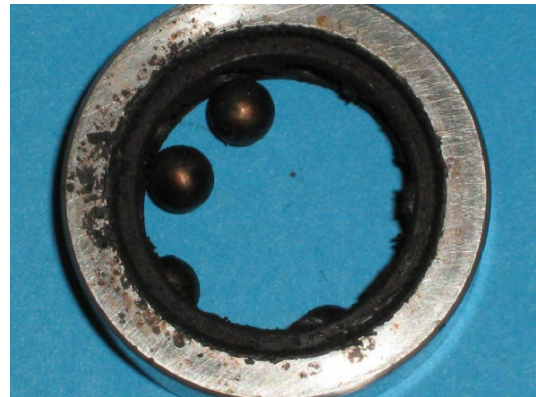
Figure 2: Left hand bearing (without inner ring)

After separation of the motor from the aerodynamics items and dismounting of the motor subassembly, the grease within and around the bearing showed a brownish aspect, with a very high viscosity. Figure 2 shows the general aspect of the bearing with the “dried” grease.

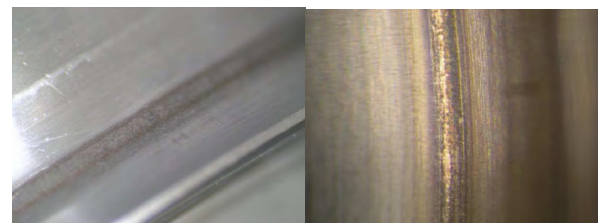
Figure 3: Inner ball race (left) and outer ball race (right)

The ball raceways, when observed with a binocular optical magnifier, appeared to have a brownish colouration in the inner and outer rings (Figure 3). This condition had been generated possibly by lack of lubricant capability or high load over a short time period.

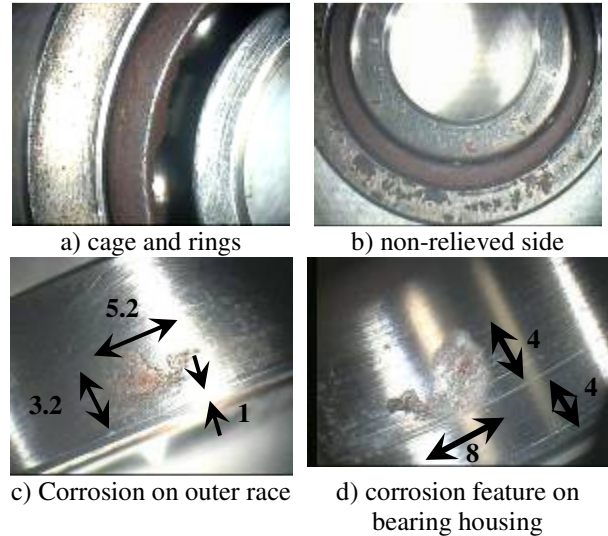
Figure 5: Images of the right hand bearing and housing. Dimensions in mm

The right bearing could be rotated readily by hand but did not spin freely. The cage, which was designed to be outer-race riding, appeared a fairly close fit (small gap) with the outer race lands (Figure 5a). Where visible, the grease in the assembled bearing appeared brownish in colour – indicating the possible presence of phenolic cage debris and/or oxidised steel debris. The end face of the outer ring on the non-relieved side exhibited some patches of dark discolouration (Figure 5b). There was one reddish-brown corrosion mark (Figure 5c) present on the OD of the outer ring. A corresponding corrosion mark (mirror image) was found on the bearing housing (Figure 5d).

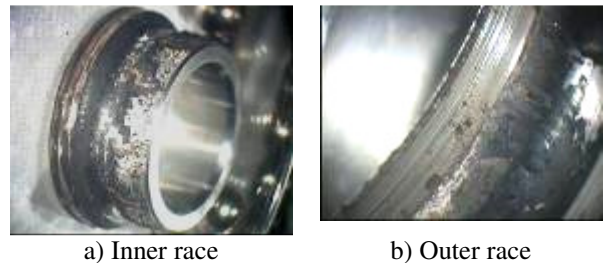
Figure 6: Images of bearing parts after dis-assembly

The bearing was dis-assembled and the separated parts were examined by optical microscopy. There was blackened (greyish black) grease over much of the inner race surface (Figure 6a). The bore of the inner race appeared free of grease and relatively clean.

Black-coloured grease was also present in the outer ring race (Figure 6b) and there were also reddish-brown patches present.

The lands of the outer race showed distinct circumferential wear marks in the steel which appeared bright and shiny (Figure 6b). The corresponding surfaces of the cage were heavily worn (Figure 7) in some areas and a distinct step could be seen between the worn and unworn (central) part. Clearly such cage wear was indicative of strong cage-to-land interactions.

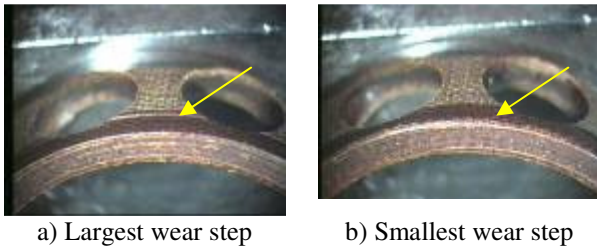
Figure 7: Images of cleaned cage

The wear on the OD (outer diameter) of the cage varies with circumferential position. The position of greatest cage wear (about 0.15 mm) is shown in Figure 7a and that of least wear (about 0.02 mm) in Figure 7b.

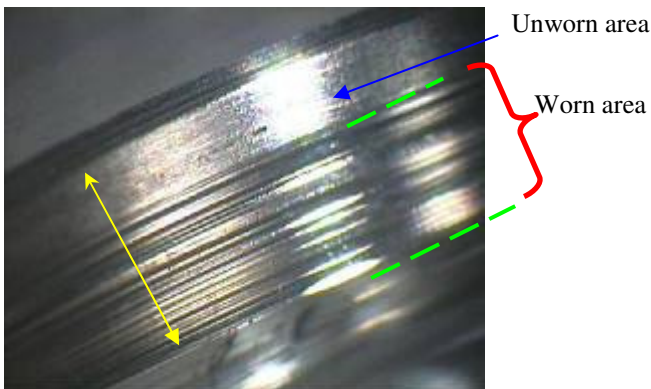
Figure 8: Wear grooves on land of outer ring. In yellow the entire width of the land

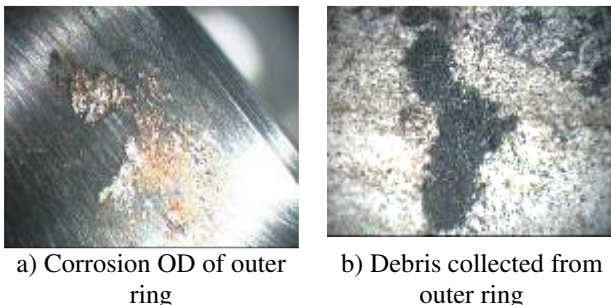
Solvent cleaning removed most of the black-coloured debris but there remained brownish patches within the raceway. The circumferential wear marks on the land appeared clearly visible as grooves not extending for the entire width of the land (Figure 8). Both lands exhibited wear of this nature. The ball track was not clearly discernible. There remained the corrosion mark on the OD (Figure 9a). The debris filtered from the solvent is shown in Figure 9b.

Figure 9: corrosion on OD of outer ring (left) and debris recovered from solvent used to clean outer ring (right)

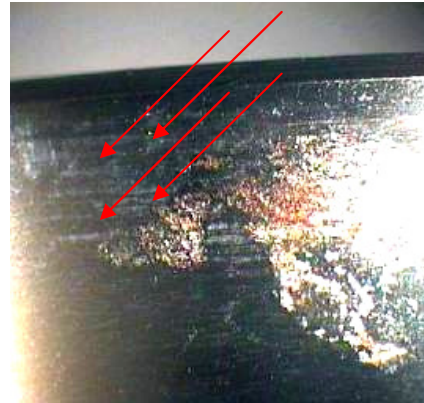
The appearance of circumferential marks on the bearing housing and on the outer ring corresponding to

the corroded mark (Figure 10) suggested that rotation of the outer ring within the housing had, at some stage, taken place.

Figure 10: circumferential lines passing through corroded area

- Update procedures for handling of the bearing during assembly in order to avoid contamination of the outer surface that could lead to a corrosion blockage of the outer diameter against the housing
- Lubrication of the outer diameter of the bearing to facilitate its sliding if in contact with the housing, so to maintain its nominal position and preload

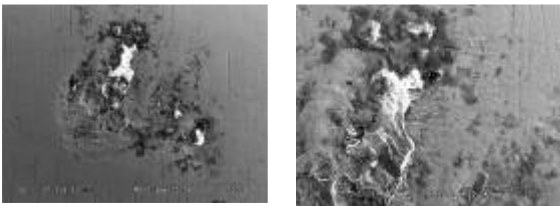
Figure 11: SEM images of corroded surface on OD of outer ring

SEM images of the corroded area are shown in Figure 11. The EDAX spectrum corresponding to this area displayed the expected peaks of iron, chromium, molybdenum, carbon and silicon which are inherent to the bearing steel and also relatively strong signals from nickel and copper which are minor constituents of the steel's composition (Table 1) but which were not apparent in the spectrum from the uncorroded steel. This could be related to the higher Ni content of the housing steel, and the interactions among the two parts

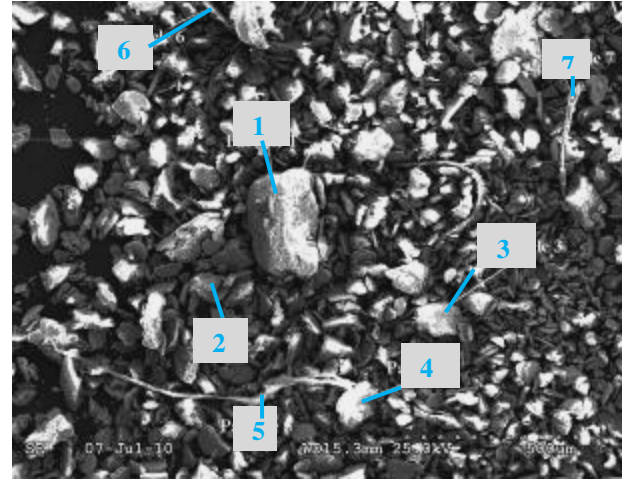
Figure 12: SEM micrograph of debris recovered from outer ring

Some of the wear debris filtered from the cleaning of the bearing's outer ring was examined by SEM. Figure 12 shows an SEM image of typical debris and the elements identified using EDAX analysis are shown in Table 4.

Based on the EDAX signatures obtained from the raw cage and ring material we have attempted to identify the composition of the particles (final column, Table 4). The worn area of the OD of the cage was also examined by SEM in order to determine whether there was any embedded steel wear debris present. The

results indicated conclusively that steel debris was present and embedded in the cage

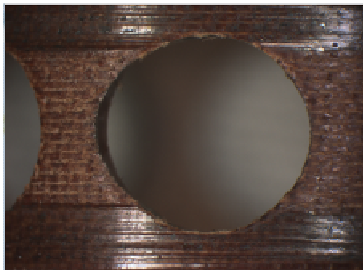
Although marks of interactions between balls and cage are present in several pockets, in correspondence of the maximum wear zone the ball pocket shows the strongest interaction marks with the ball, and an oval shape (Figure 13). Mainly one pocket shows this effect, while the roundness of the other ones is better maintained, indicating less severe ball-pocket interaction.

Figure 13: Pocket oval shape. Magnification x12

The cage was pushed against the outer ring mainly by the effect of one ball, as suggested by the oval shape of one of the balls pockets.

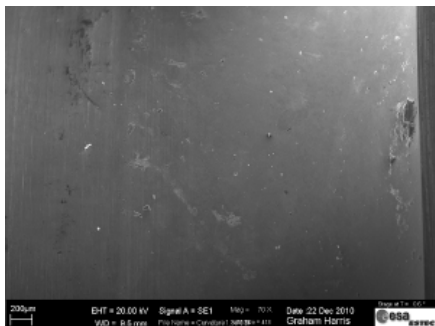
The brown zone, indicating the track of the balls is quite limited in width and the surface morphology of the track is not clearly distinguishable from the raceway when observed with the SEM (Figure 15). These two evidences indicate a likely low preload of the bearing. The different colour could be due to the deposit of some cage material on the surface.

Figure 15: SEM image of the inner ring. The entire raceway is visible

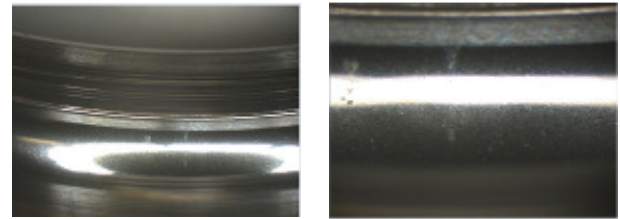
The outer ring was in overall quite good condition and did not appear to have been affected by severe damage

or wear, apart from the already mentioned lands' wear. The raceway of the balls appears in good condition. No evidence appears in the raceway of a ball track whatsoever (Figure 16).

Figure 16: Outer ring worn lands and raceway

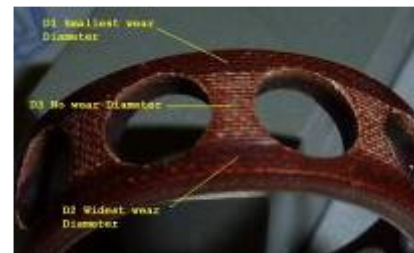
Figure 17: Cage different wear zones

It appears evident from the measurement that the diameters of the worn areas (D1 and D2) are affected by non negligible deviation indicated by the out of roundness value. The outer diameter and the inner diameter have a better circular shape with very small displacements from roundness. This also confirms the small effect of the interaction between the cage and the inner ring.

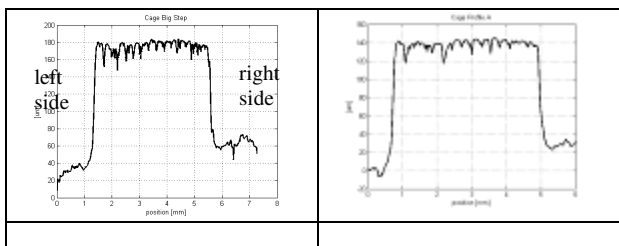
The profile was measured in three sections as indicated in Figure 18. It can be observed (Figure 19) that the wear is not equal on the two sides of the cage and appears bigger on the left hand side (140-150  $\mu\text{m}$ ) when compared to the right hand side (110-120  $\mu\text{m}$ ). The smallest wear is about 10-15  $\mu\text{m}$ .

Figure 19: cage profile. Position B (upper left), position A (upper right)

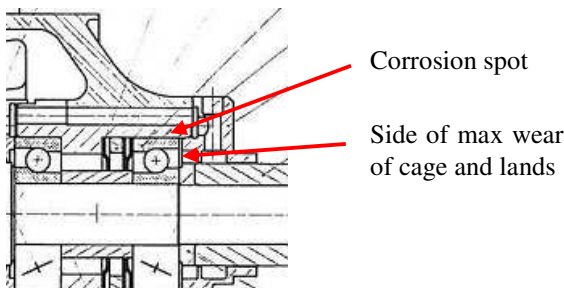
Figure 20: location of the biggest wear of the cage

The greater wear of the cage (left hand side in the profile plots) corresponds to the outer side of the right bearing in the assembly picture (Figure 20).

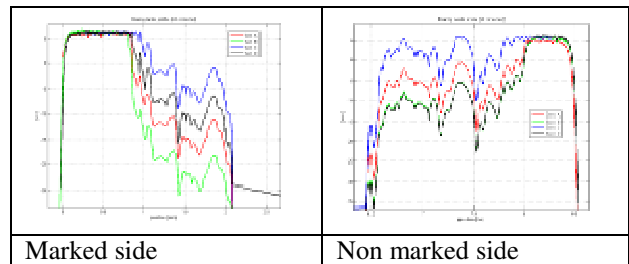
Figure 22: Profiles of the lands of the outer ring. A (red), B (green), C (blue), D (black) for both marked and non marked side

It can be observed (Figure 22) that the wear of the lands is not uniform over the circumference, and it ranges between roughly 10  $\mu\text{m}$  (section C) to the max of 30  $\mu\text{m}$  (section B). Moreover the maximum amplitude between peak and valley of the profile is of the order of 10  $\mu\text{m}$ . The left hand side of the profiles (corresponding to the outer side of the bearing as indicated in Figure 20) shows a higher wear than the other side of the bearing.

It is worth to note the very good matching of the shape in all the profiles clearly indicating the same source of wear along the entire circumference, likely to be some particles entrapped between cage and outer ring clearance.

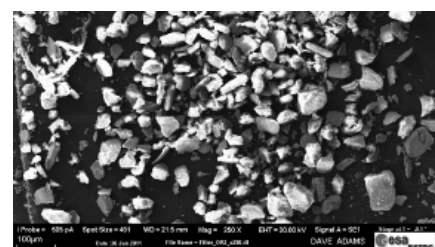
Figure 23: SEM analysis of debris. Outer ring

From Fig. 17 it appears that the size of the debris collected is quite significantly large, reaching 80-100  $\mu\text{m}$  in size. These dimensions appear to be inconsistent with the wear observed on the outer ring lands, in which the maximum amplitude of the peak-valley of the profile is 20  $\mu\text{m}$  (see Figure 22).

From the results of the components analysis of the debris samples (steel particles), only elements compatible with the composition of the steel of the bearing have emerged. It has to be noted that the difference in the composition of the bearing steel and the housing steel is quite subtle, mainly consisting in some percent in Ni content, therefore not easily detectable.

A clear statement cannot be made on the origin of these steel debris, while incompatibility in size with the wear of the lands is quite evident.
