## A POST-FLIGHT TRIBOLOGICAL ASSESSMENT OF THE HUBBLE SPACE TELESCOPE SOLAR ARRAY MECHANISMS

M J Anderson, K Parker & M Eiden\*

*European Space Tribology Laboratory,  
AEA Technology, Risley, Warrington, Cheshire, WA3 6AT, UK*

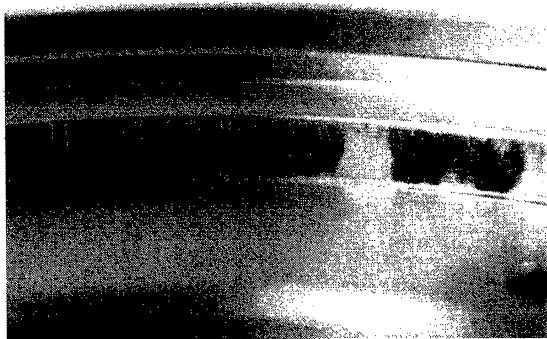
Roughened black marks (Figure 2) were present on the locating interface between the OLD flange and the fixed bearing flange, concentrated at four positions approximately 90 degrees apart, consistent with wear caused by contact and low amplitude motion at this interface.

Figure 2. Roughened black mark on the OLD flange/bearing flange interface of the SADM.

Roughened black marks at some unprotected flange locating interfaces were consistent with wear caused by contact and low amplitude motion, and lubrication (preferably by solid thin film, eg sputtered  $\text{MoS}_2$ ) is recommended at all close-tolerance locating surfaces which may be subject to vibration motion.

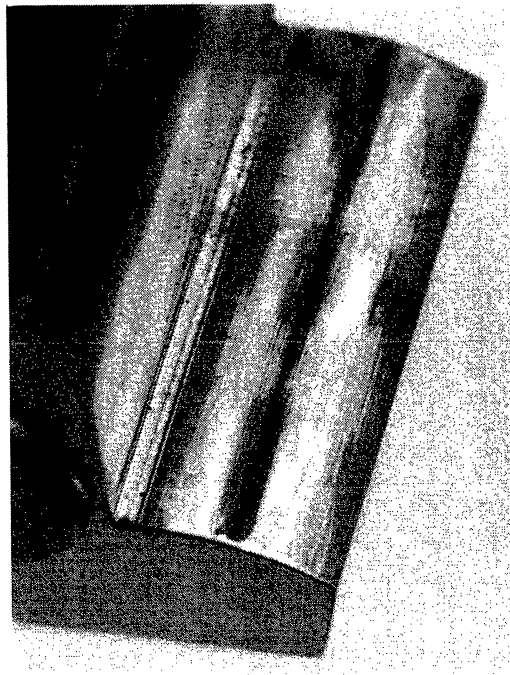
The offloading and locking devices comprised nominally identical pairs of Memory Alloy Element (MAE), Manually Activated and Manual Locking Devices. Marks, corresponding to those on the OLD flange clamping interfaces, were observed on the titanium alloy tabs and rocking levers. Although not all of these devices were used in the actual mission, these marks indicate that extensive pre-flight tests of the various locking devices occurred. In general, the burnished  $\text{MoS}_2$  solid lubricant applied to the clamping surfaces and latch/lever interfaces of the offloading and locking devices was depleted, although remnants of the film remained (Figure 3).

Figure 3. Clamping mark on the rocking lever of a typical SADM offloading device. The lubricant is depleted at the clamping interface.

Solid lubricant depletion was observed on the titanium alloy clamping interfaces of the offloading and locking devices, and the use of a more adherent sputtered  $\text{MoS}_2$  film is recommended.

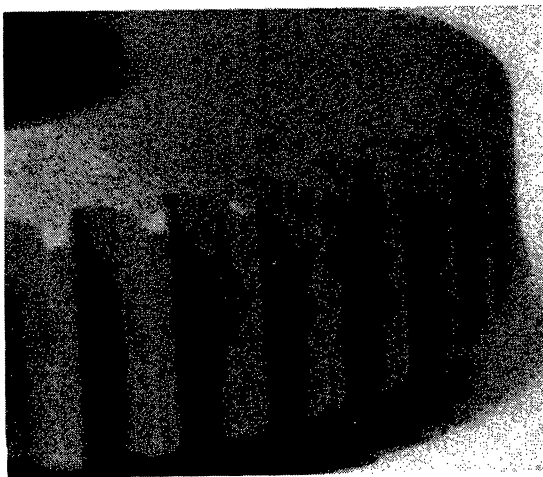
The motorised gears, of tooth module 1mm and width 8mm, comprised a central sun gear (PCD 60mm), three planetary gears (PCD 42mm) and a ring gear (PCD 144mm), manufactured from aluminium alloy and treated by the Ematal process to produce a hard anodised surface layer of 8 to 10 microns thickness. These gears generally exhibited tooth wear consistent with relatively light duty. However, some gear teeth showed roughened black surface marks (Figure 4).

Figure 4. Planetary gear from the PDM showing blackened teeth.

These marks were located in groups of a small number (2 to 3) of teeth at positions corresponding to the stationary meshing during vibration testing and/or launch, or in the operational position. The marks revealed compacted, dark, friable material on an adherent base layer, probably oxidised aluminium partially covering the underlying, shiny, surface, and non-contacting laser surface profilometry confirmed exposure of the aluminium.

Some qualification tests, which did not incorporate vibration testing, were conducted at ESTL (Ref. 4) and showed that the Ematal surface treatment successfully protected the underlying aluminium under normal operational motion and stresses. If the protective anodised layer is breached, then the possibility of static adhesion cannot be discounted. A suitable lubricant coating (eg sputtered MoS<sub>2</sub>) or an anodising treatment incorporating PTFE would provide some additional protection, but would need qualification in appropriate vibration tests.

The Ematal surface treatment applied to the aluminium alloy gears which experienced only rotational motion was intact, but was not successful in preventing substrate wear on teeth subjected to vibrational motion and stresses. The lifetime of such gears could be extended by lubrication (eg, sputtered  $\text{MoS}_2$ ) but would need qualification in vibration tests.

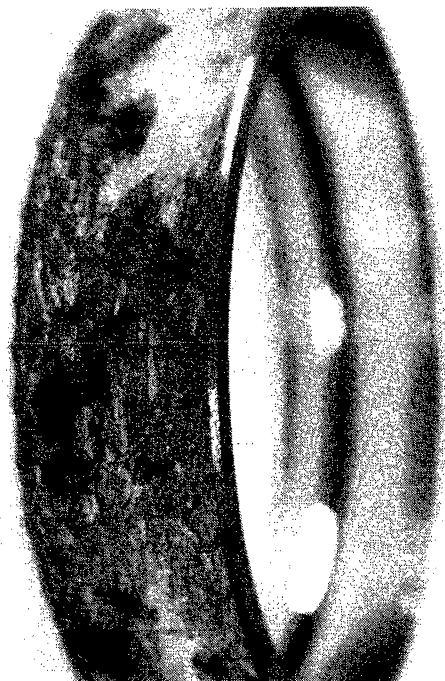
Inspection revealed corrosion on the exterior surfaces of several bearings, most extensive (Figure 5) on the external bearings, ie the main trunnion and lever arm shaft. A few small spots of corrosion were also present on the raceways and on the ball tracks of some of the bearings. Unprotected, clean 52100 steel surfaces are at risk from corrosion unless stored and used in a controlled environment (low humidity or inert gas purge) but this may not be achievable throughout the bearing lifetime. Some method of surface protection is therefore appropriate, or the use of 440C bearings considered (but even this material can be made to corrode (Ref 5)).

Figure 5. Lever arm shaft bearing from the PDM showing extensive corrosion on the outside diameter.

Corrosion was present on the outside diameters and bores of most of the bearings, and some spots were visible on the ball grooves of some bearings. Protection of all such 52100 steel surfaces is recommended. Internally, the bearings showed features consistent with lubricant transfer from the cage, and relatively mild duty. In bearings with lead-bronze cages, a pre-deposited solid lubricant film is recommended and/or

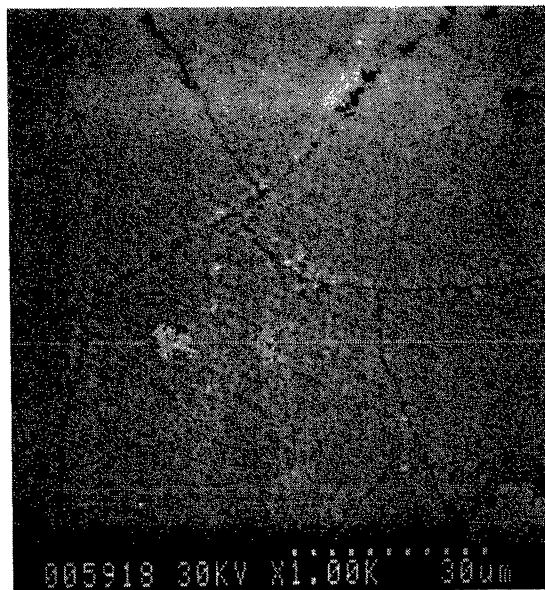
The appearances of the balls were not identical, due to the variable nature of the transfer process through normal ball loading distributions and ball dynamics. A surface feature, with the appearance of a network of very fine lines, was evident on some balls from the main trunnion and the manual drive bearings. Examination, using a Scanning Electron Microscope, showed that these marks appeared to be fine surface cracks in the TiC coating (Figure 6). No delamination, or wear, of the TiC was found.

Figure 6. SEM image of fine surface lines on a TiC coated ball from the manual drive bearing.

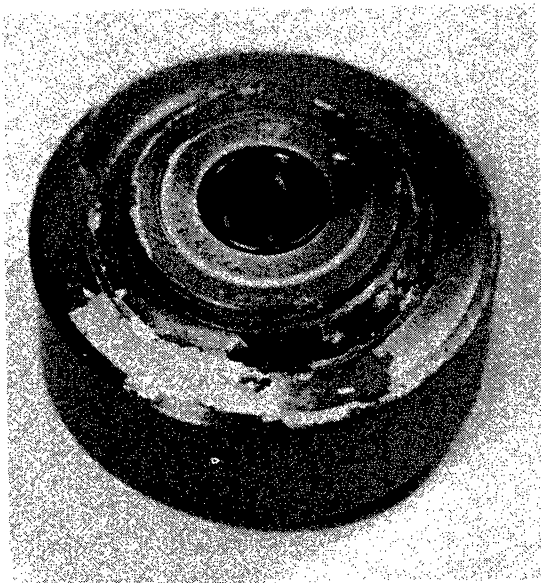
The end brackets supported the cushion roller in two spherical bearings (type RSTVV10-M50 with two flanged SFR4 bearings). A friable pale brown deposit, shown in Figure 7, was noted on the outboard spherical bearing and on the corresponding bracket end cover, and this deposit is believed to originate from outgassing products from the fibre/resin cushion roller.

Figure 7. Spherical bearing from SDM outboard cushion roller support bracket. A light-coloured deposit is apparent on the surface.

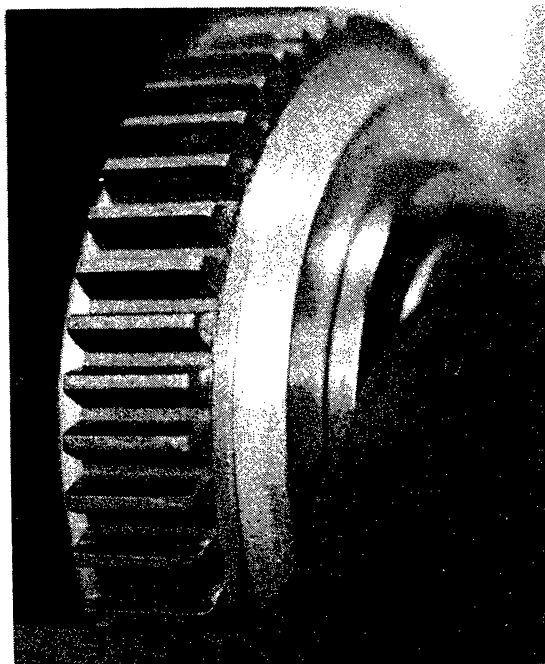
Figure 8. Large idler gear from the SDM inboard actuator. Severe lubricant depletion is evident on the gear teeth.

Wear of the surface coating (Lubeco bonded  $\text{MoS}_2$  film) was observed on all of the gear teeth, on all gears, but there was adequate lifetime margin. Figure 8 shows the coating to be depleted but there was no evidence that the anodised layer had been worn through except on the input pinion which showed slight tooth profile distortion.

Some of the idler gears in the inboard actuator showed severe solid lubricant depletion on the teeth, suggesting the use of a more adherent film such as sputtered MoS<sub>2</sub>.

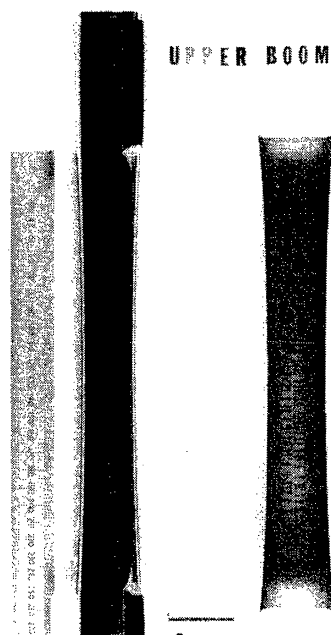
Surface marks were observed on virtually the complete lengths of the boom elements, and can be attributed to rubbing between the inner and outer elements, in part due to a rippling effect slightly deforming the straight sides (which had sharp, raised edges) of the inner boom element. Figure 9 shows corresponding parts of the upper boom elements held open within a clamp, the polished outside face of the inner element at the left with the unpolished inside face of the outer element on the right.

Figure 9. Typical marks on both the inner and outer boom elements.

The positions, number and width of these radial marks are variable along the lengths of the elements and provide evidence which suggests that the booms were subjected to twisting motion (due to thermal movement and/or vibration) while deployed, with maximum twist about two thirds (from the deployed end) along the length. A detailed photographic survey has been made over the full boom element length (Reference 1).

Marks observed on the inner and outer boom elements, resulting from mutual contact and small movements of the elements (which had sharp, raised edges), provide an insight into possible modes of boom failure. A small amount of steel debris in the cassette housing is believed to have originated from sliding contact at the boom element interfaces and this may have been reduced if the inner face of the outer element had been polished.

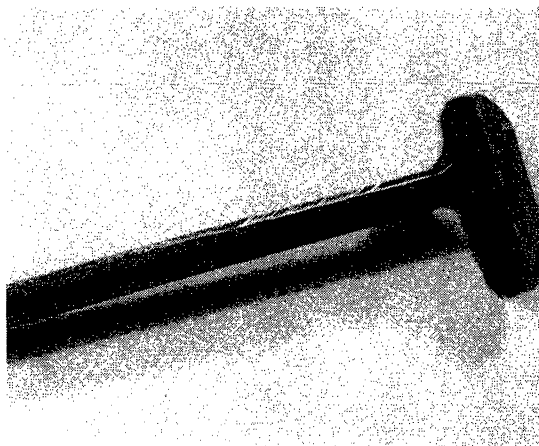
The sliding contact area between the flanged bearing and the boom extension piece was lubricated by bonded  $\text{MoS}_2$  (Molykote), and has worn to expose the underlying aluminium alloy substrate, which is itself worn (Figure 10) at the fixed fork end where the boom

extension was found to be twisted through about 10 degrees. These findings suggest the use of harder materials and more adherent, durable sputtered lubricant films. The roller was also worn, with some deformation of the sliding face and flange. The exposed areas of the solid lubricant coating were duller and lighter in colour than areas masked by the steel tape or bolt heads.

Figure 10. Wear of coating on boom extension piece.

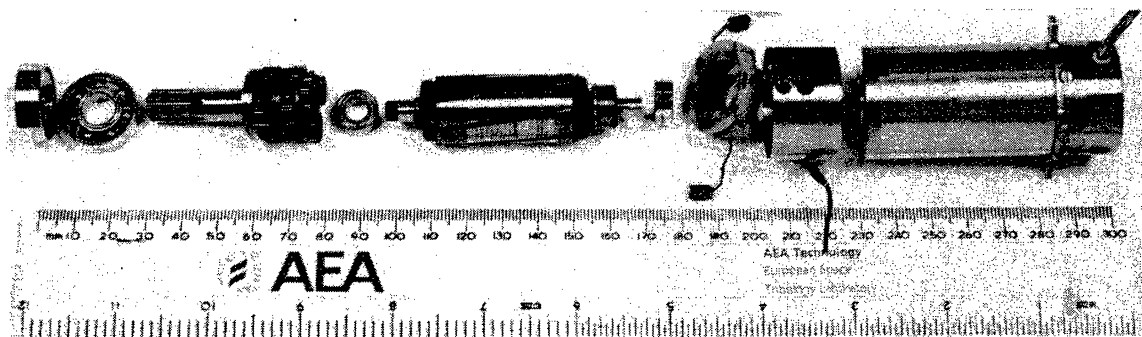
The motor brushes and commutator were in good condition, the remaining brush lengths and the low amount of wear (to a maximum of 7 microns) on the commutator confirming the motor was well within its life expectancy. Only a fine sprinkling of black brush wear debris was found within the brush housing. A possible source of particulate contamination which could migrate to the commutator was identified within the motor housing where part of the magnet material had a very rough texture in which crystalline deposits were embedded, some of which could be dislodged to provoke a coarse powder. The motor bearings were in good condition, but relative axial motion had caused severely blackened marks on both the rear bearing and its locating bore in the motor housing, suggesting a protective lubricant film or sleeve would have been appropriate.

Figure 11. Components of tandem motor/gearhead, with one dismantled motor.
