HOIS Joint Industry Project: Good practice for NDT in the oil and gas industry

Highlights for 2017/18

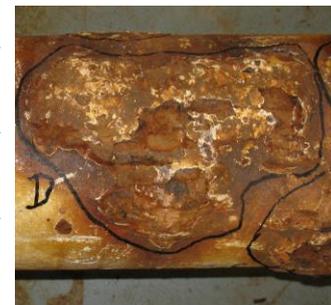
Benchmark internal UT scan of an externally corroded area using the in-house scanner.

This HOIS project has greatly improving benchmarking capabilities through the in-house design and build of an internal UT scanner for corrosion mapping deployed from the inside of a pipe. The scanner has been designed to allow scanning of pipes with outer diameters between 6" and 12. Data is collected using a TD Pocket Scan and the probe, scanning, data collection and processing are in full accordance with the HOIS recommended practice for precision UT thickness measurements. This allows accurate measurements of remaining thickness to be made. The scanner has been used to benchmark ex-service specimens with external corrosion scabs for which no information on remaining wall thickness has previously been available.

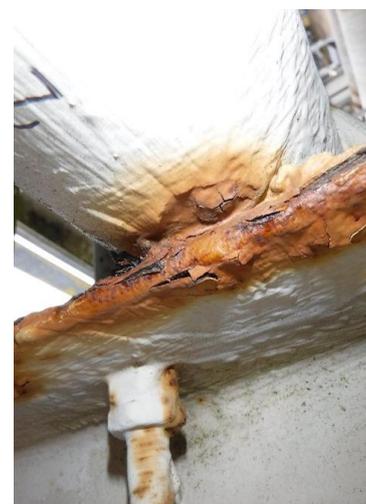
Photograph of 2" U-bolt specimen with visible signs of corrosion at the contact point with flat beam support.

This project has allowed extension of the HOIS specimen database with 22, 1m long, 10" nominal bore samples either schedule 40 or 80. These had areas of corrosion CNC machined into the pipes based on Creaform 3D laser scan data from ex-service thin-walled specimens which had previously been donated to HOIS by Shell. These ex-service samples had corrosion that occurred when pipes were supported by flat beams (i.e. touch point corrosion).

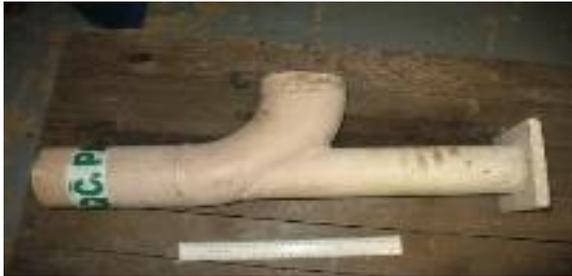
Ex-service trunnion pipe support

Pipe support trunnions are a common means to support-pipework on process plant and offshore and, in common with other pipe support types, trunnions do not permit visual inspection of the areas most susceptible to corrosion. However, the attachment weld around the trunnion and the curvature of the pipe at many trunnion supports are likely to make their inspection even more challenging than corrosion at flat beam or saddle type supports.

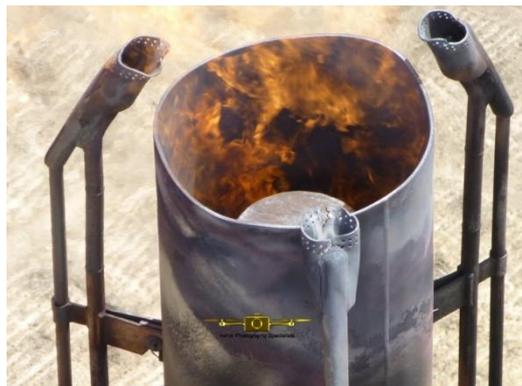
UAV RVI image of a flare tip

ESR and members conducted UAV based trials to assess the key variables that affect the conditions under which specific resolution values can be achieved. The key parameter identified was the image pixel size, in terms of millimetres on the target and a consistent relationship between image pixel size and spatial resolution was found for most cameras trialled. This allows prediction of the target distance required to achieve a particular image spatial resolution, given the parameters of the imaging system in use.

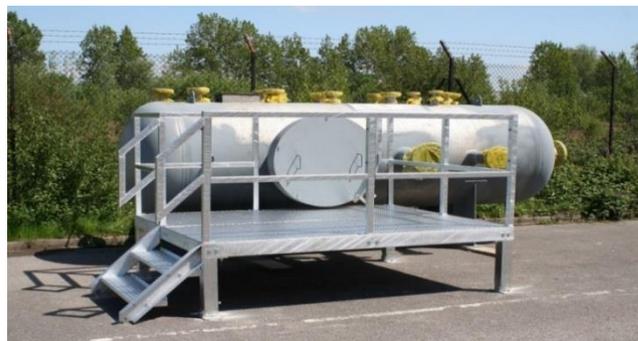
Ex-service CRA clad vessel installed at ESR Warrington

This year the project has focussed on trials of techniques for the NII of the internal cladding condition as well as the carbon steel vessel shell. The blind trial components included the ex-service CRA clad vessel, a manufactured weld overlay plate and an ex-service heat exchanger plate with hot rolled cladding. Three blind trials have been completed and the results documented in a trial report.

For hot rolled cladding angled beam shear wave probe measurements were able to detect SCC in the heat exchanger plate, but for the vessel the SCC had different characteristics and to date has only been conclusively detected using low frequency probes (1MHz). The Olympus DMA angled compression probes detected corner and tip signals of some of the SCC on the ex-service heat exchanger plates and gave promising results on the ex-service vessel.

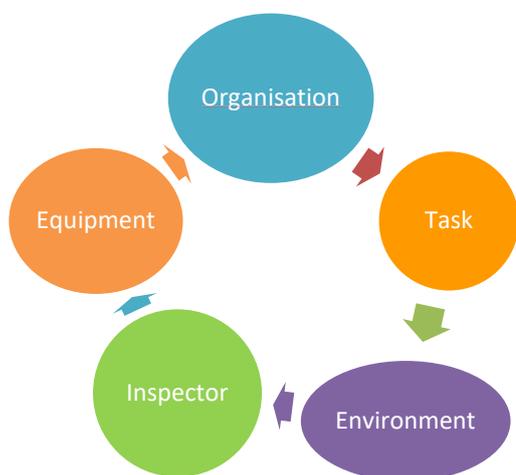
Categories of human factor

Human factors affect all stages of the inspection process and are influenced by environmental factors such as ergonomics, temperature and shift time as well as the ethos of the companies. There is currently little guidance of the human factors affecting the various stages of an offshore inspection work scope and how to minimise their effects.

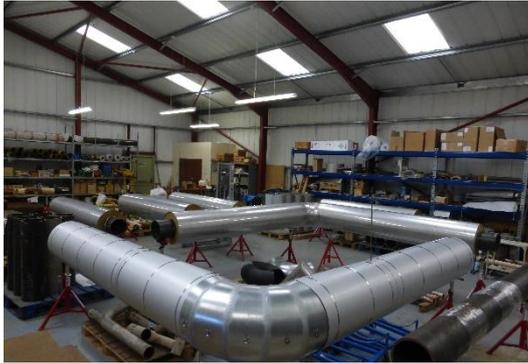
Inside the NICE specimen storage facility

The facility houses many ex-service components with examples of weld corrosion, flange face corrosion, external corrosion scabs, corrosion under pipe supports (CUPS) and inside trunnions, supplied by several of the category 1 HOIS members.

The HOIS trial and specimen storage facility (referred to as the 'National Inventory of Corroded Equipment' or NICE) continues to play an important role by providing trial facilities for several HOIS projects.

Several rigorously controlled blind trials of inspection techniques have been performed on these specimens by HOIS category 2 members, hosted by ESR Technology, primarily for the HOIS projects on inspection of external corrosion, corrosion under insulation (CUI) and pipe supports (CUPS).
