HOIS/OGTC Guidelines for in-situ inspection of corrosion under insulation (CUI)

HOIS-G-023 Issue 2

January 2021

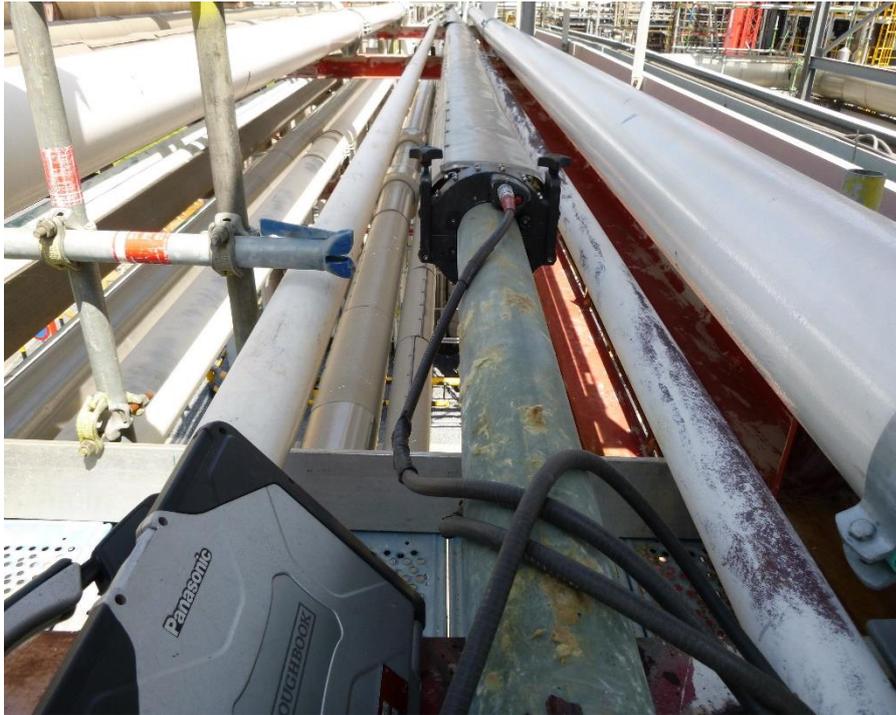
This case study involved a 4" NB pipeline with a Zinc coated pipe surface and mineral wool insulation. The requirement of the inspection included inspection of the longitudinal welded pipe supports for CUI. The insulation was removed at the inspection location and a 4" Solid sensor ring was installed, as shown in Figure 8-1. This was connected to a GUL WaveMaker® G4-mini instrument and readings obtained.

Figure 8-1: Test location for inspection of 4" pipeline.

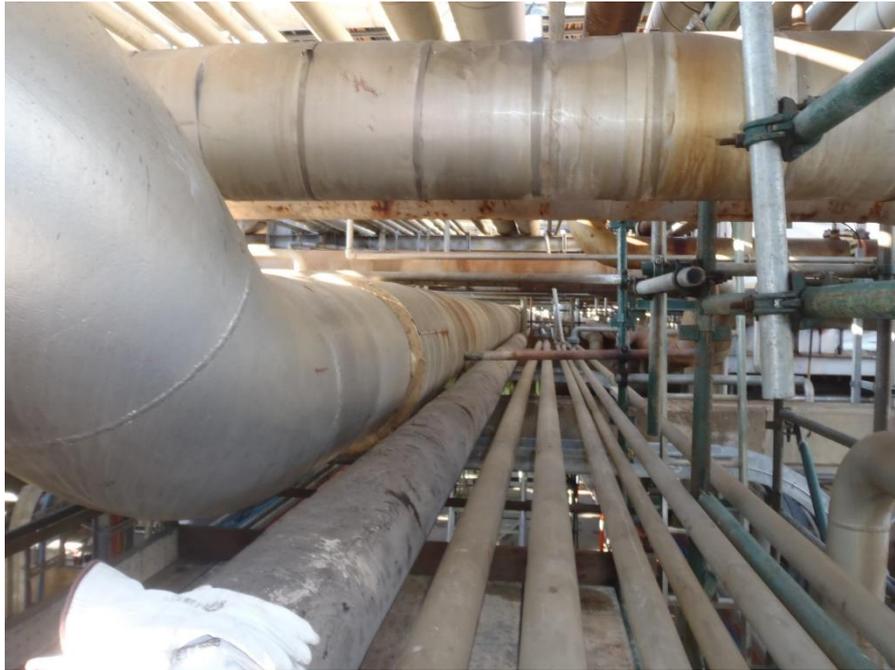
The equipment used comprised a WaveMaker® G4 with a 24" EFC inflatable sensor ring. The test location is shown in Figure 8-6.

Figure 8-6: Test location for inspection of 24" high pressure gas line.

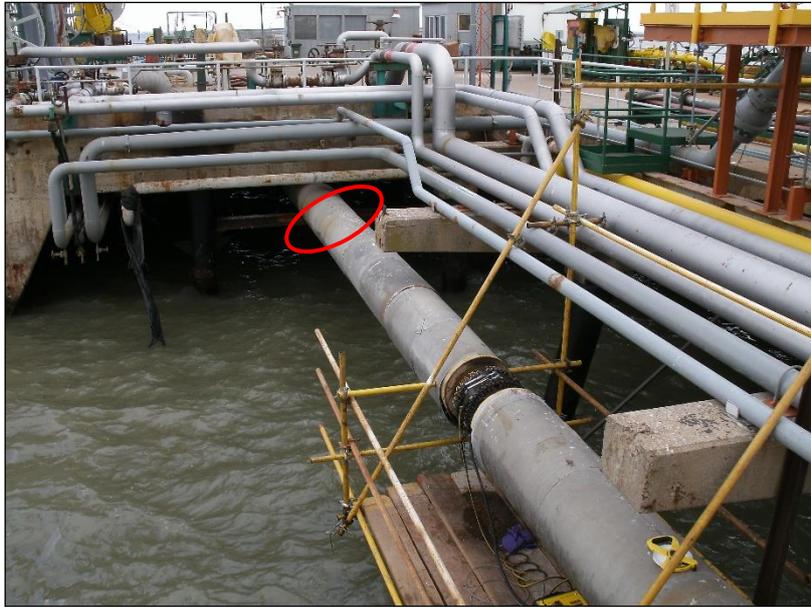
Figure 8-9: Location of anomaly area highlighted in Figure 8-8.

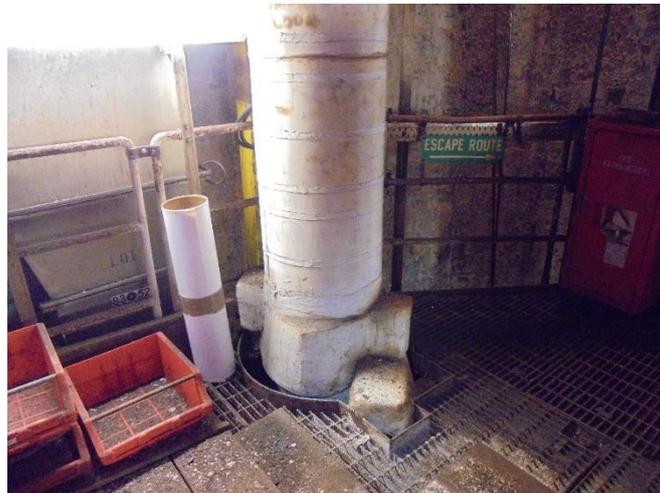
During 2018 an inspection using pulsed eddy current (PEC) was requested by a North Sea offshore operator to identify and locate any areas of corrosion under insulation (CUI) or corrosion under fireproofing (CUF) on a live gas export riser (see Figure 8-11).

Figure 8-11: Live gas export riser in an offshore location.

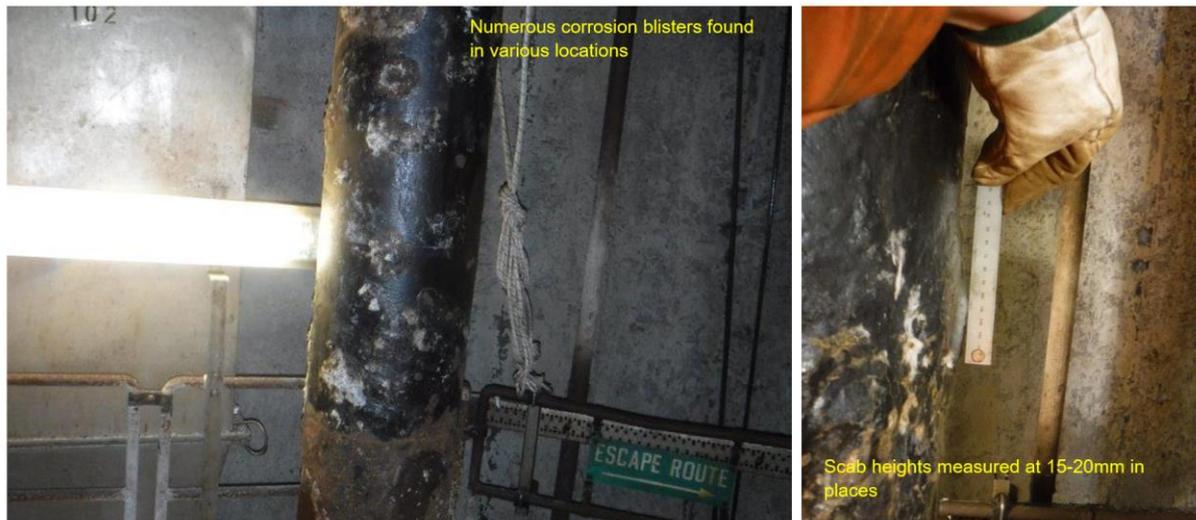
Figure 8-13 shows the riser after the insulation removal. Numerous corrosion blisters (scabs) were found, with scab heights of up to ~15-20mm in places.

Figure 8-13: Riser after insulation and passive fire protection removal. Numerous corrosion blisters (scabs) were found (left) with scab heights measured up to ~ 15-20mm in places.

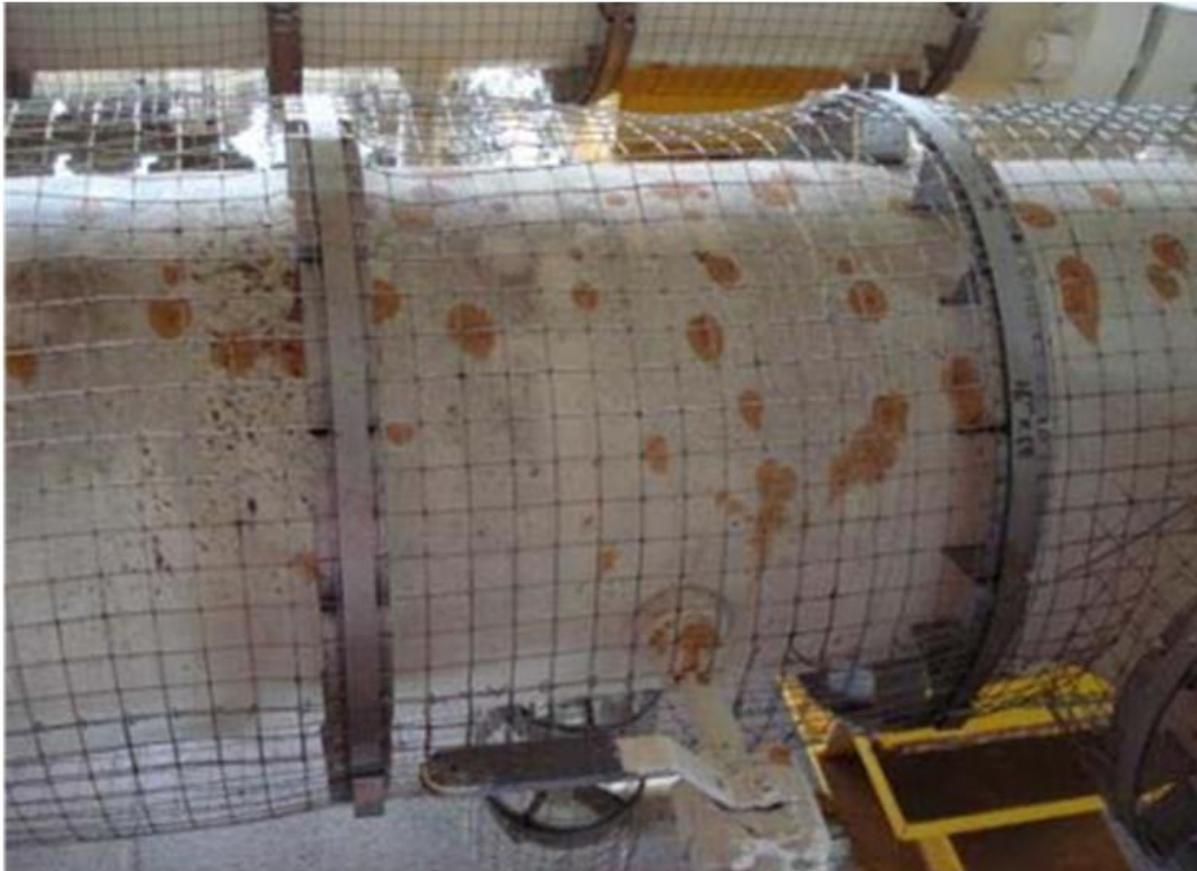
Figure A1-1: An example of a personnel protection cage (courtesy Total).

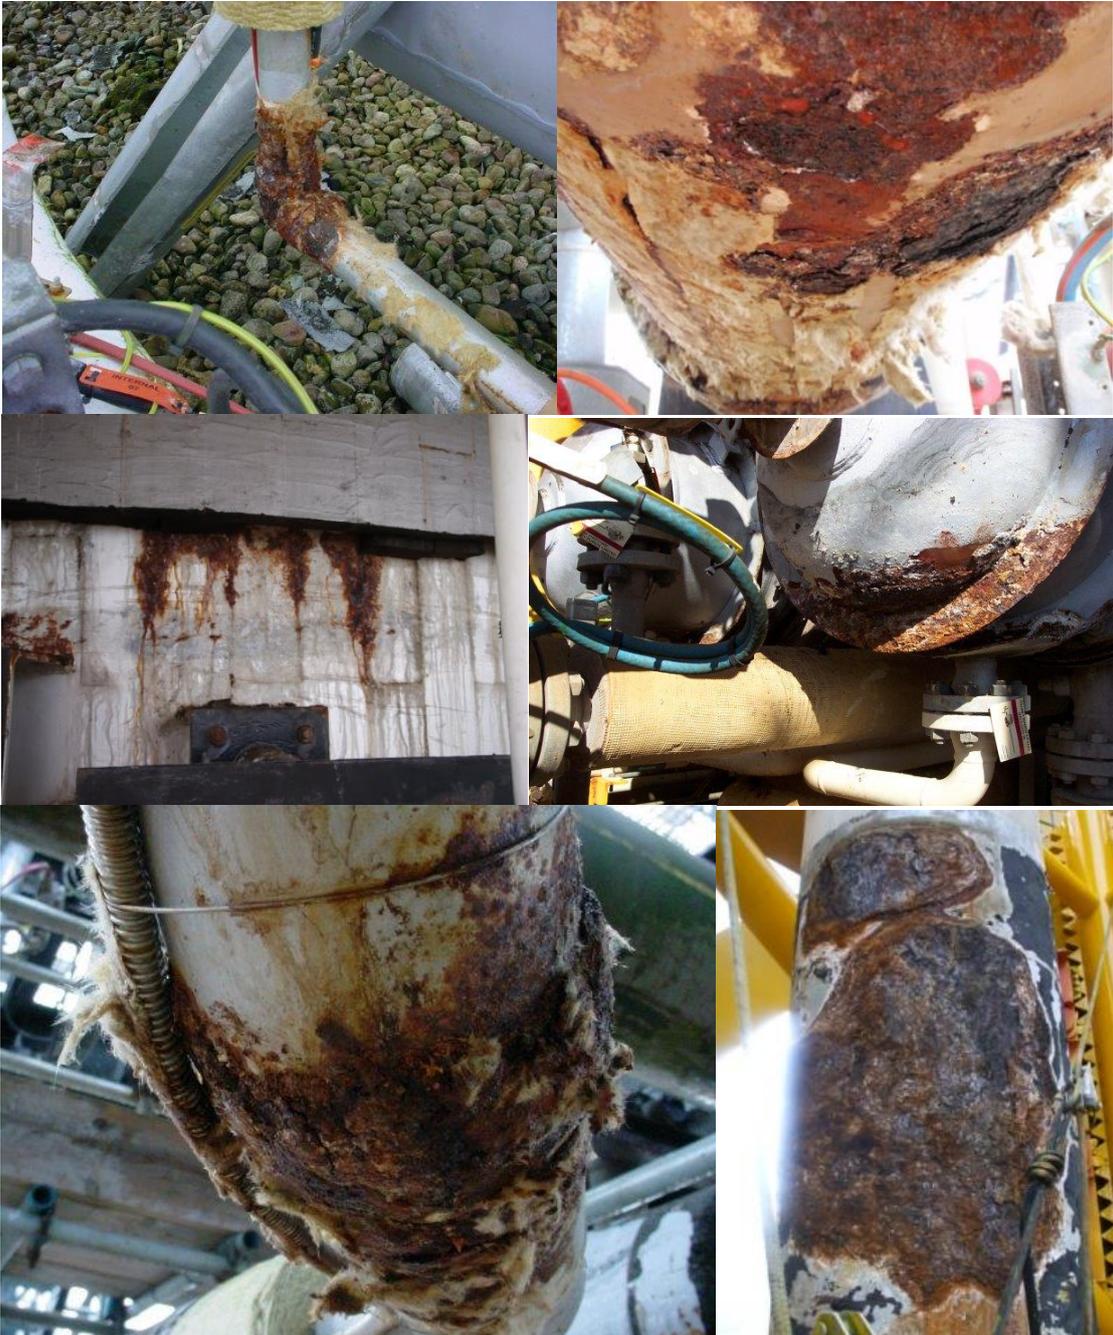
Figure A1-2: Some examples of CUI

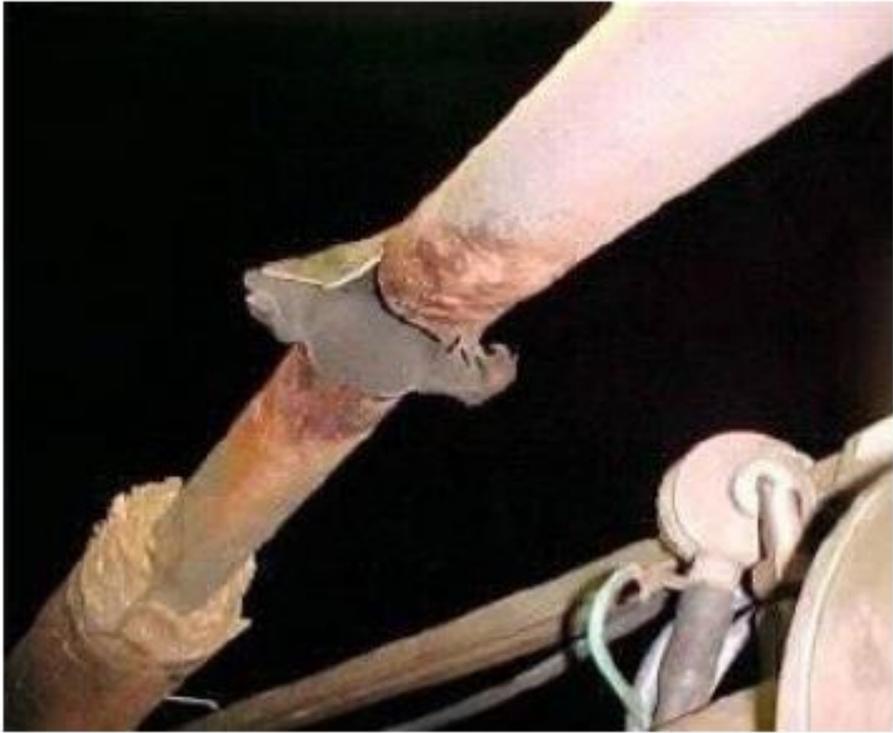
Figure A1-3: Failure of a 4" pipe caused by CUI

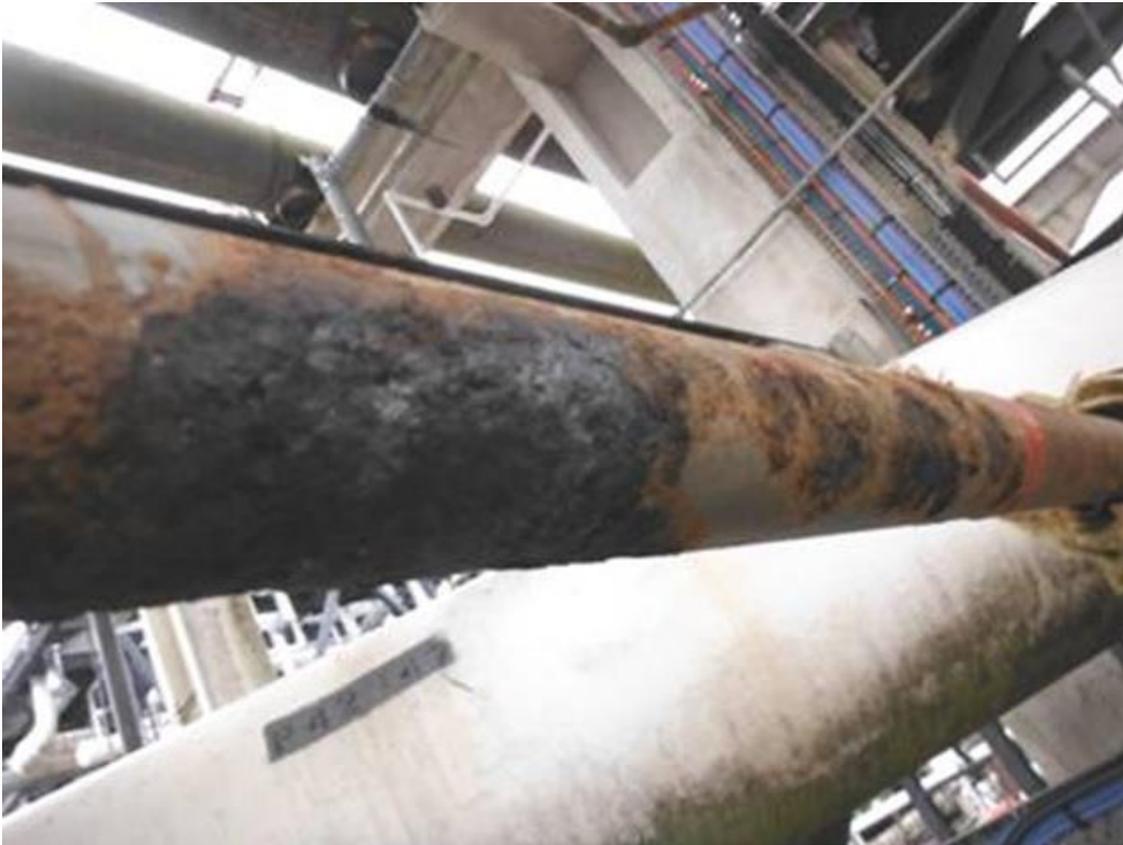
Figure A1-4: A further example of CUI, following insulation removal (courtesy Total)

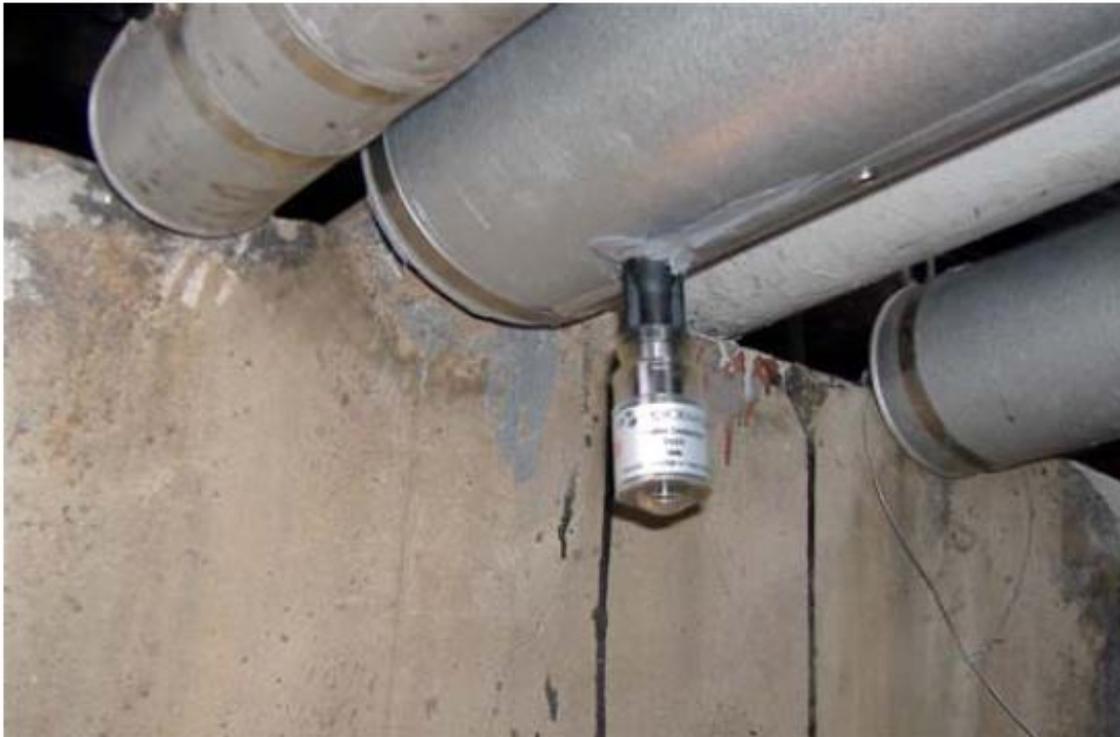
Figure A2-1: H2Obvious device installed on a UK refinery

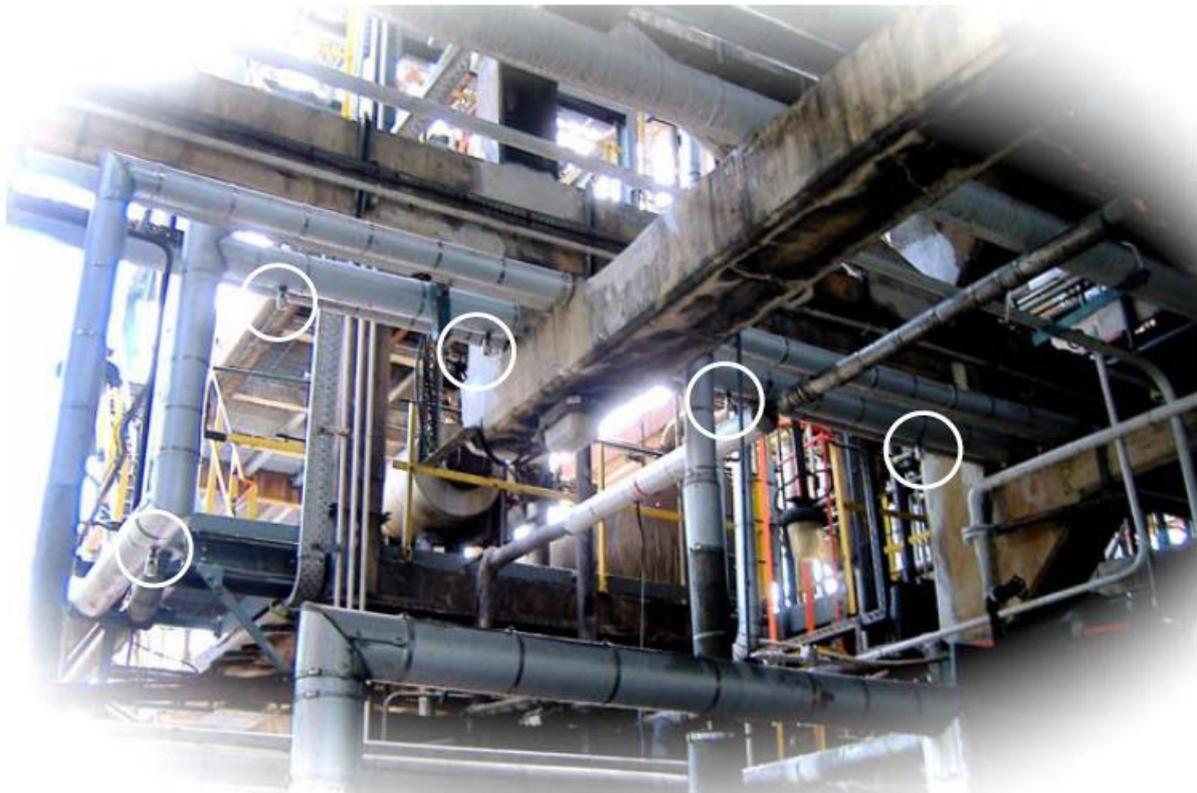
Figure A2-2: H2Obvious devices installed on a UK refinery

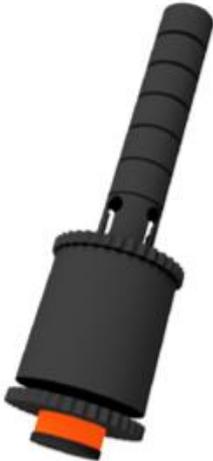
Figure A2-3: The Benarx WUI Plug is a tool for draining and detecting the presence of water under the insulation

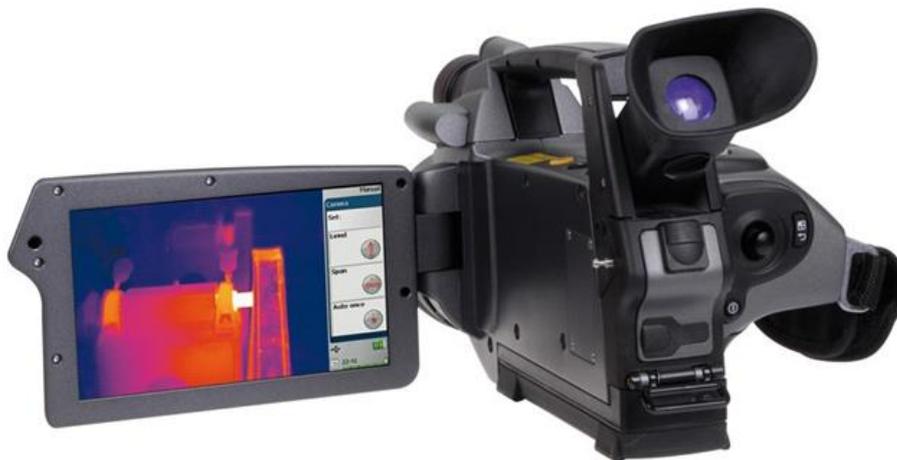
Figure A2-4: A high-end infrared camera for industrial applications

There have been recent improvements in infrared camera technology, which have increased the quality of the resultant images. Figure A2-4 shows a high-end infrared camera for industrial applications. The weight and cost of infrared cameras have also been significantly reduced. Temperature differences as small as 0.05°C can be detected with modern, hand-held cameras. Results can be readily recorded as colour coded (false-colour) images in digital form, see Figure A2-5 for an example.

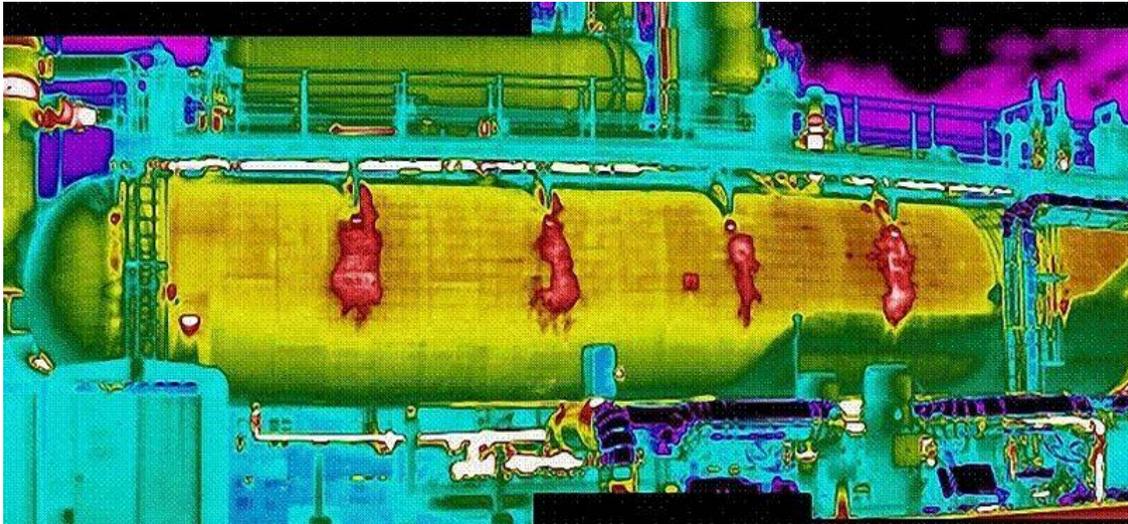
Figure A2-5: De-Salter vessel showing water intrusion under the insulation, apparently at penetrations for the walkway along the top of the vessel (courtesy Infrared Vision).

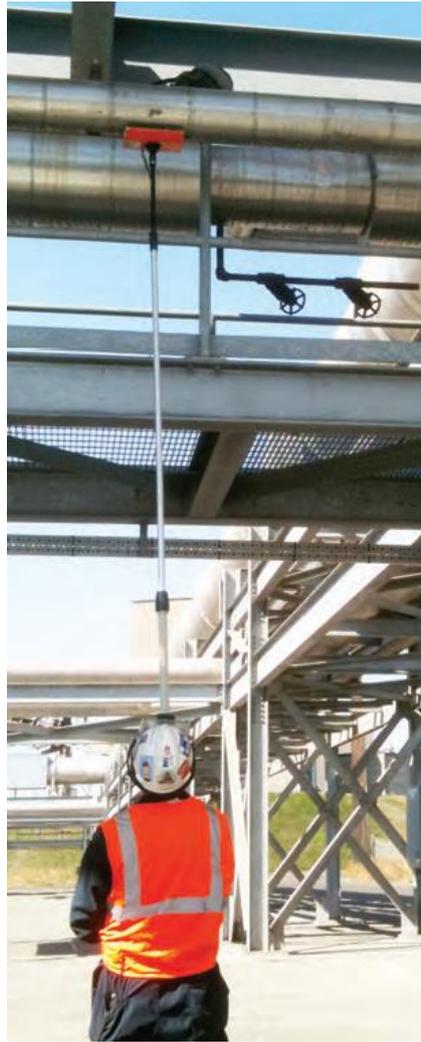
Figure A2-10: Hydrotector system being used for CUI inspection.

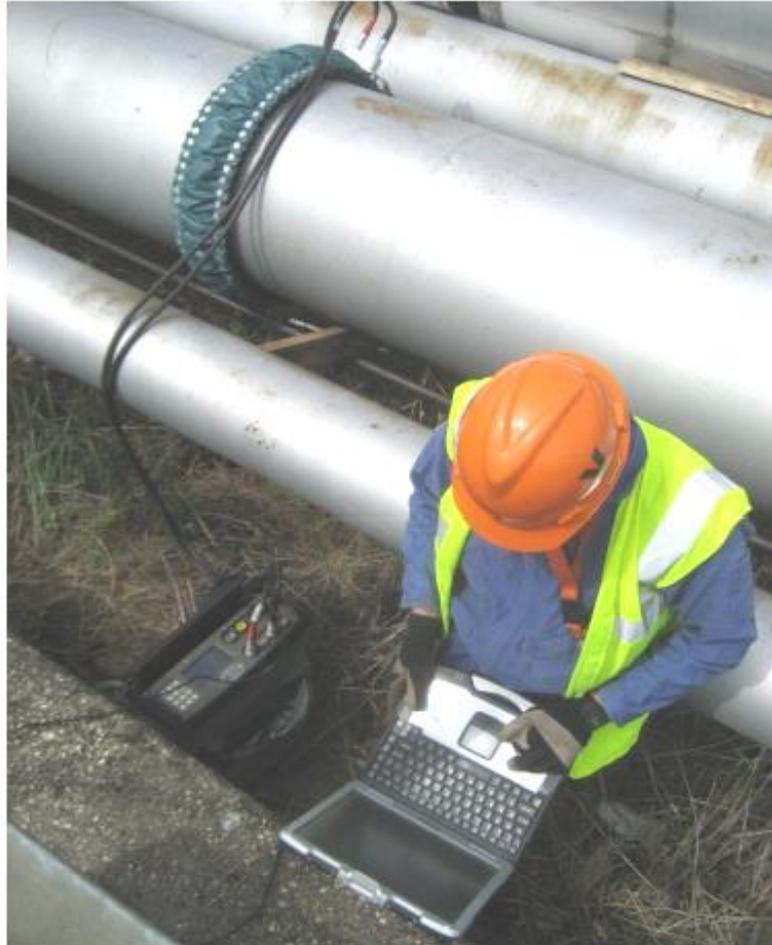
Figure A2-12: Equipment for GWT with inflatable sensor ring attached to an un-insulated section of pipe (courtesy Guided Ultrasonics Limited).

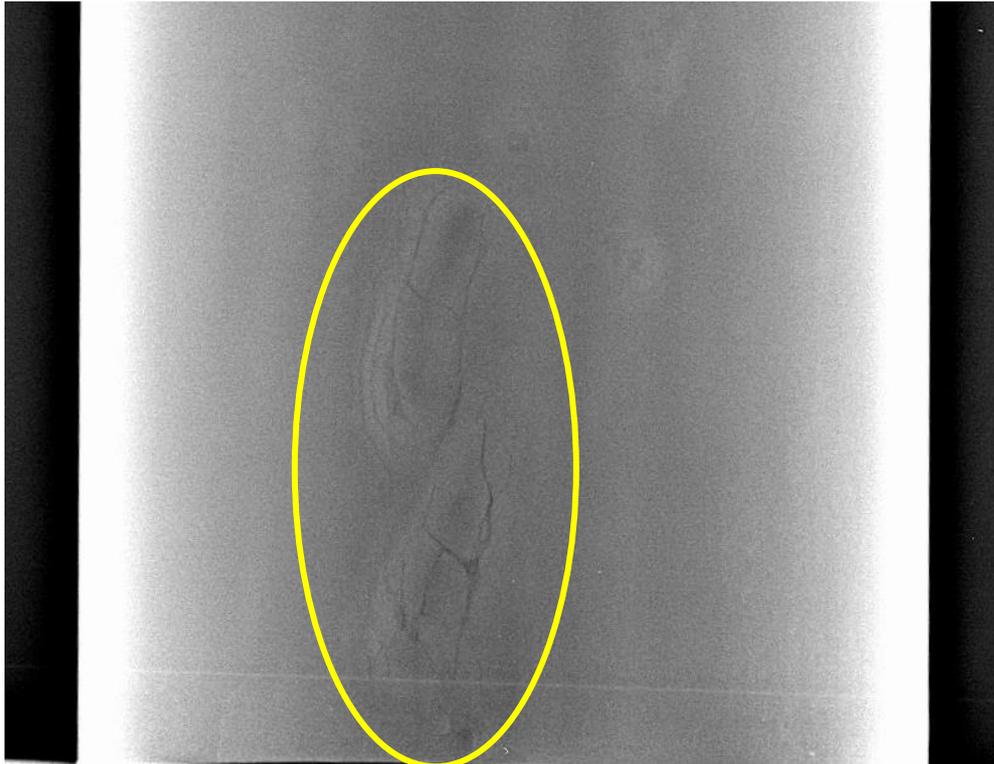
Figure A2-22: DWDI image showing presence of external corrosion and associated corrosion product – note the overall low contrast despite the wall loss due to the corrosion being about 75% of the wall thickness, caused by the “infilling” effect of the corrosion product.

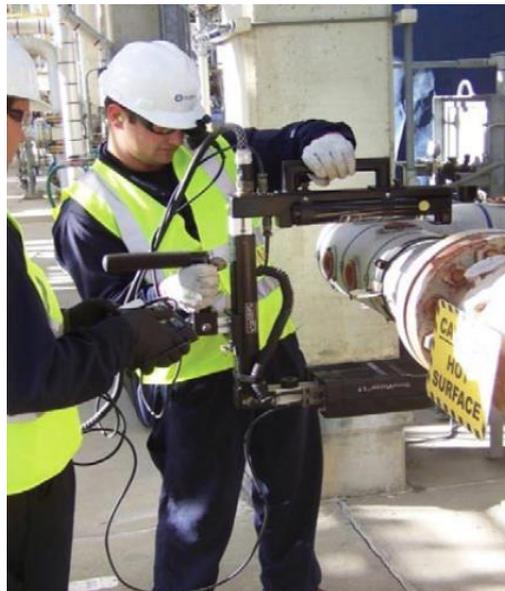
Figure A2-27: The Sentinel OpenVision real time radiography equipment being used for CUI inspection (courtesy TUV Petrochem).

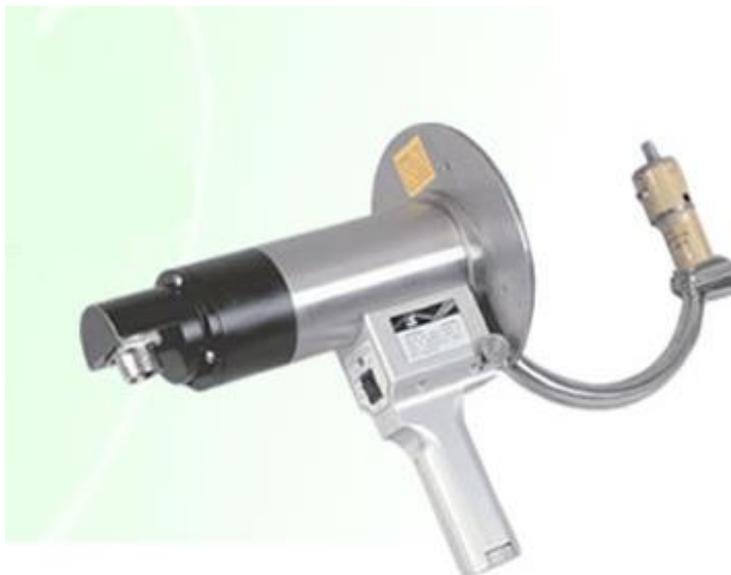
Figure A2-29: Lixi profiler.

The Lixi profiler was evaluated as part of the CRIS POD trials and achieved a high overall POD for 6" NB pipes, with nominal wall thicknesses of 7.1 and 14.3mm (Burch and Hood, 2011). However, although the flaws in the test specimens in this trial were external and surrounded by insulation, there was no corrosion product in-situ.

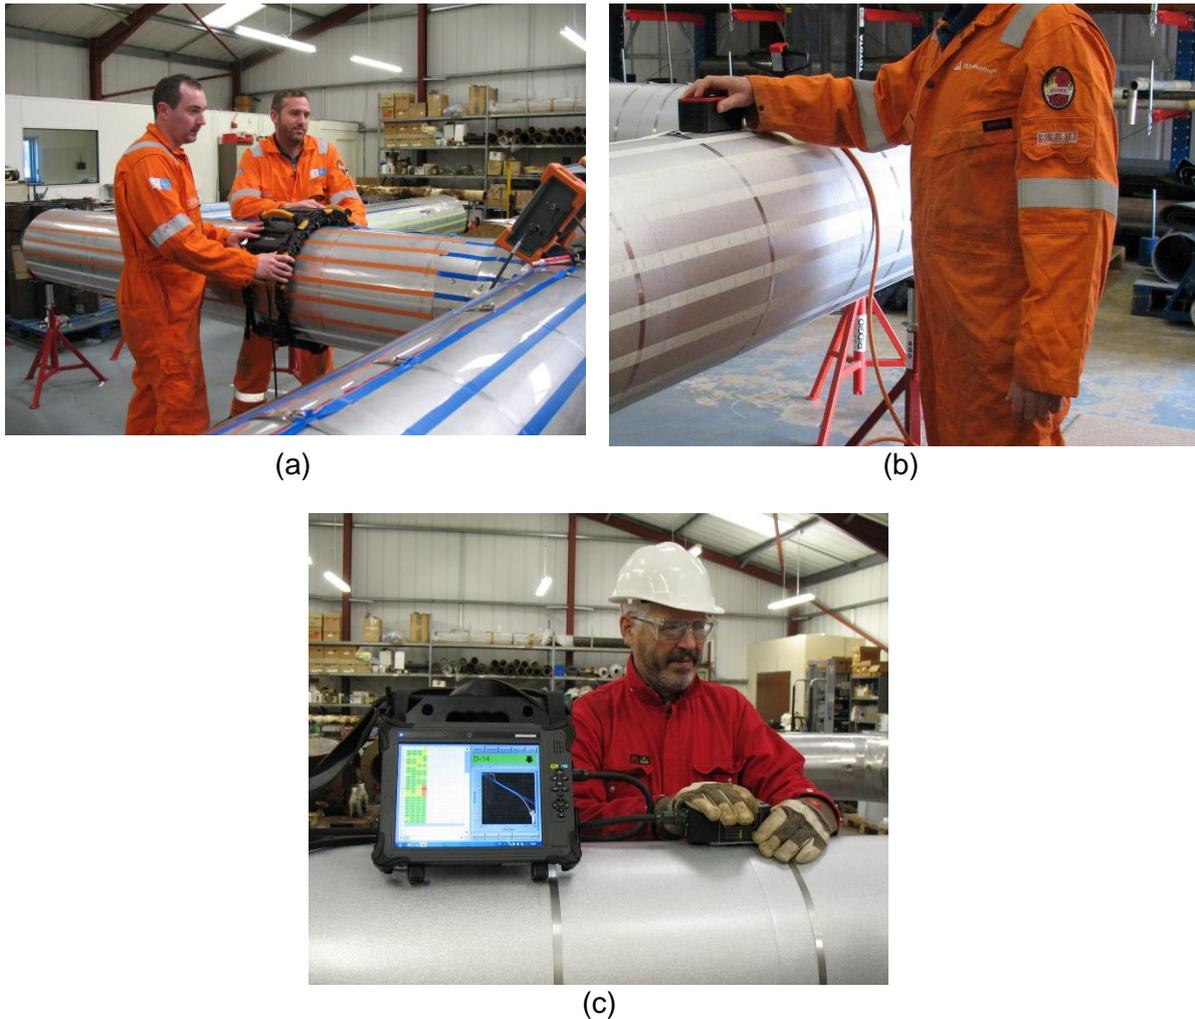
Figure A2-33: Examples of PEC equipment being operated in the 2018/19 HOIS/OGTC CUI trials: (a) Eddyfi Lyft PECA™ array, (b) TUV Rheinland Sonovation Sonopec and (c) Maxwell NDT PECT.

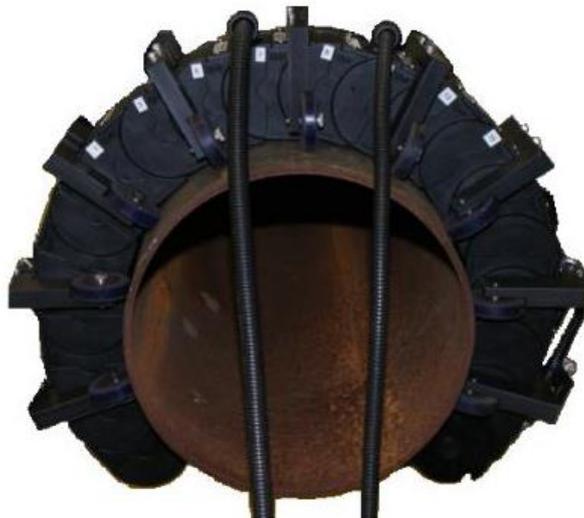
Figure A2-35: The Russell NDE bracelet probe, as applied to a pipe.

This system includes 16 sensors mounted in an 8" (200mm) long bracelet (see Figure A2-35). This array can be used to scan pipe OD's down to 6", including the insulation, so that a 4" pipe with 50mm insulation can be scanned. Pipes up to 2m diameter have been examined. Typical scan speeds are up to 1.5 – 2 m per minute.

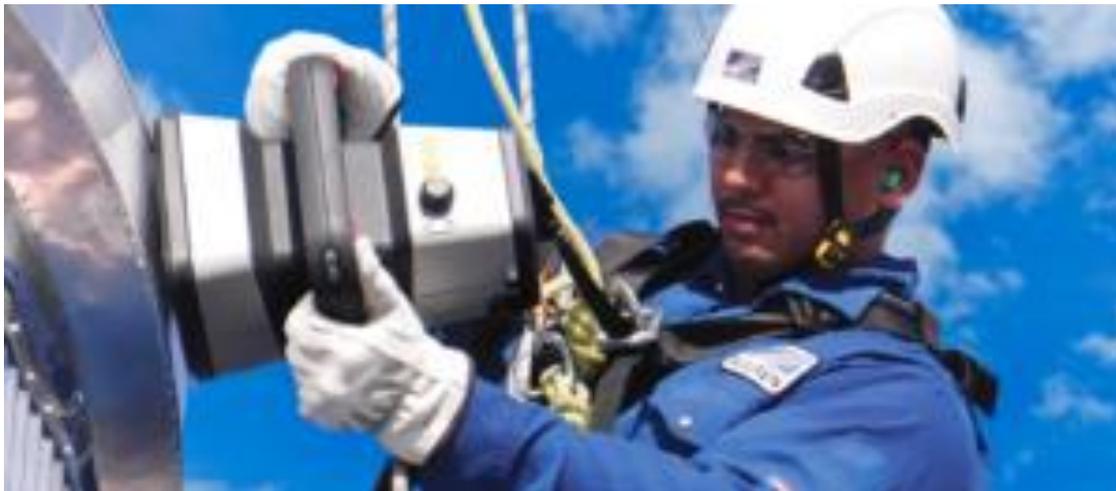
Figure A3-1 Acuren's MDI equipment for moisture identification (courtesy Acuren)

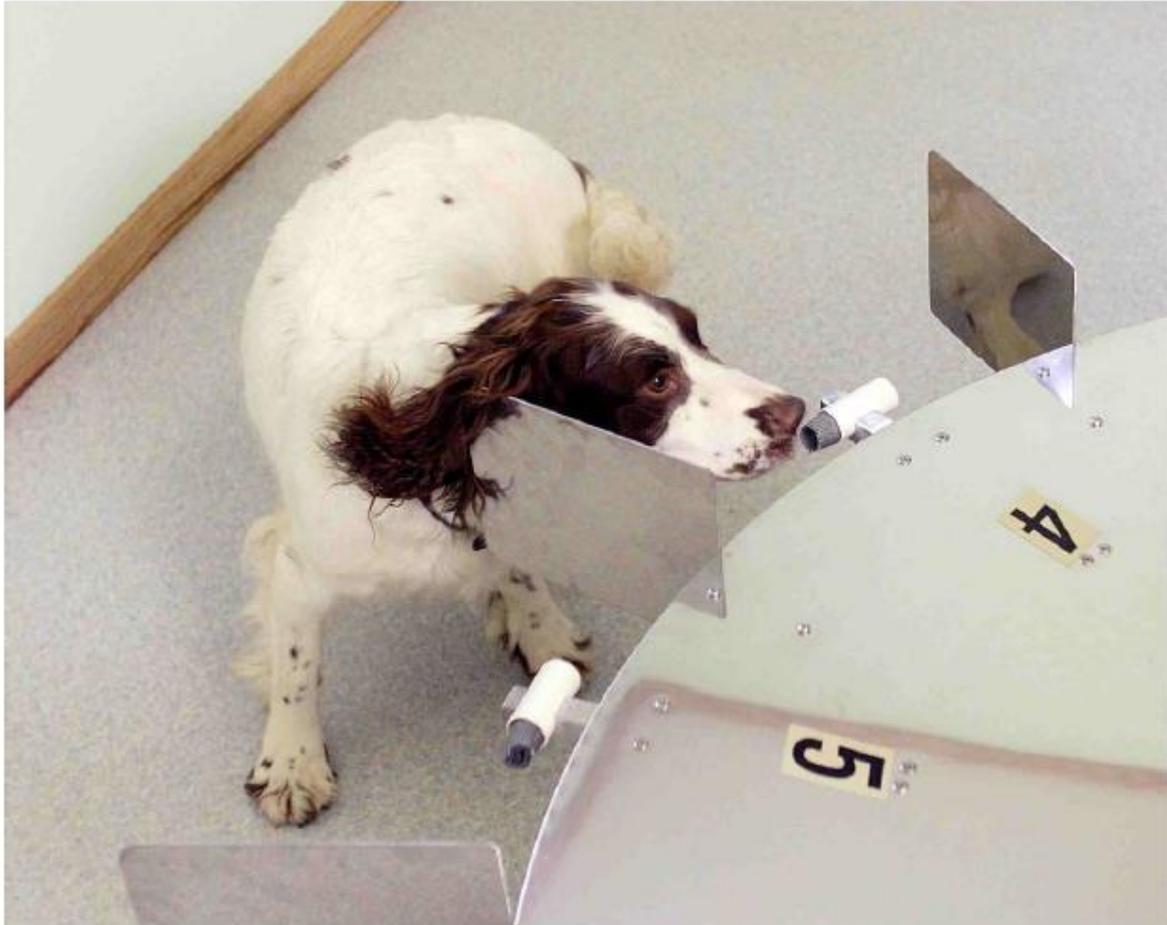
Figure A3-8 Dog sniffing a numbered gas sample.

Figure A3-8 shows one of the dogs sniffing a gas sample placed on a numbered station on a rotating carousel. If the dog detects the target odour this is indicated by some clear change in the animal’s behaviour.

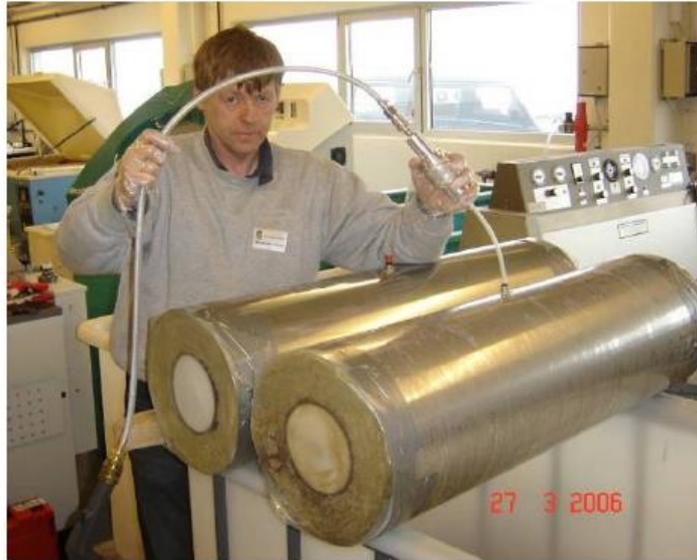
Figure A3-9 Setup for laboratory training phase.

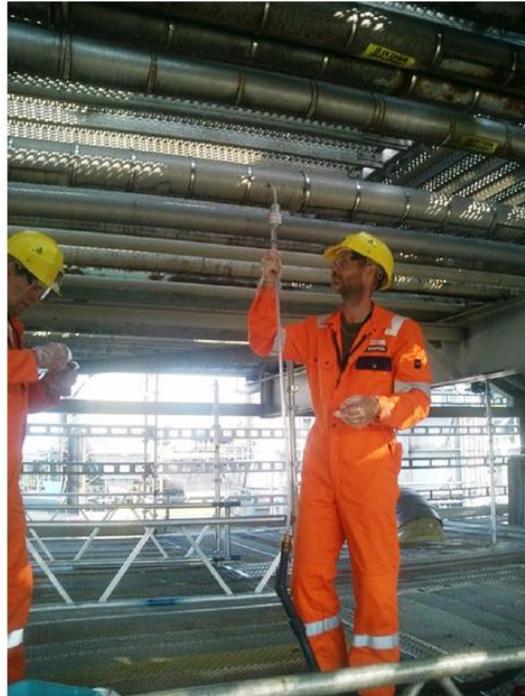
Figure A3-10 Gas sampling during phase 2 on an operating plant.

The training phase was followed by a trial on an operating Statoil (now Equinor) plant (Figure A3-10), which involved sampling from insulated pipes, followed by removal of the insulation and visual inspection to determine the extent of any CUI present.

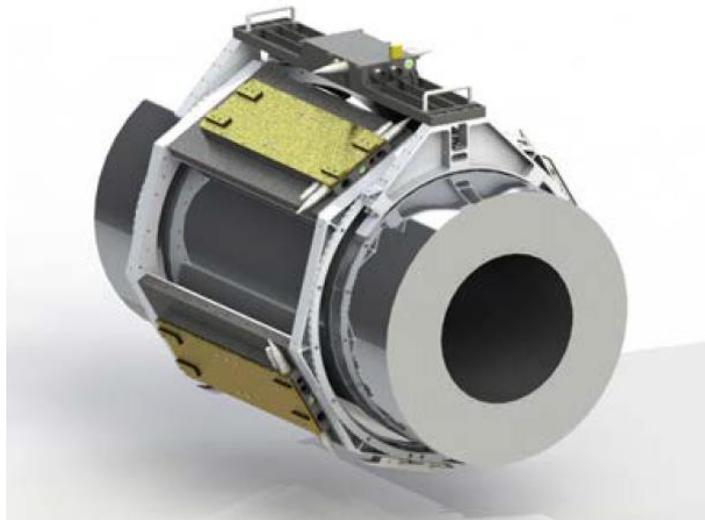
Figure A3-13 Schematic of Exxam systems MFECT circumferential scanner.

The Multi-frequency Eddy Current (MFECT) method developed by Exxam Systems is currently (2019) based on a laboratory prototype rotary scanner with four bespoke planar electromagnetic sensor arrays, as illustrated in Figure A3-13. This method was described at the 2017 API Inspection Summit, which led to its evaluation as part of the HOIS/OGTC trials that started in 2018.

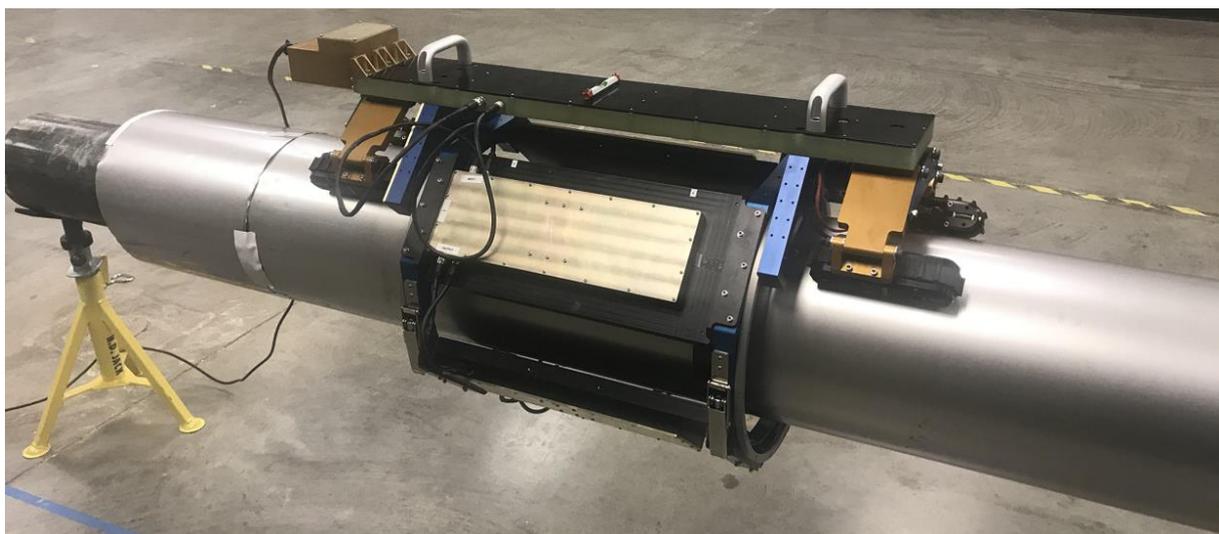
Figure A3-15 Updated (2020) Exxam Systems automated scanner (courtesy Exxam Systems).

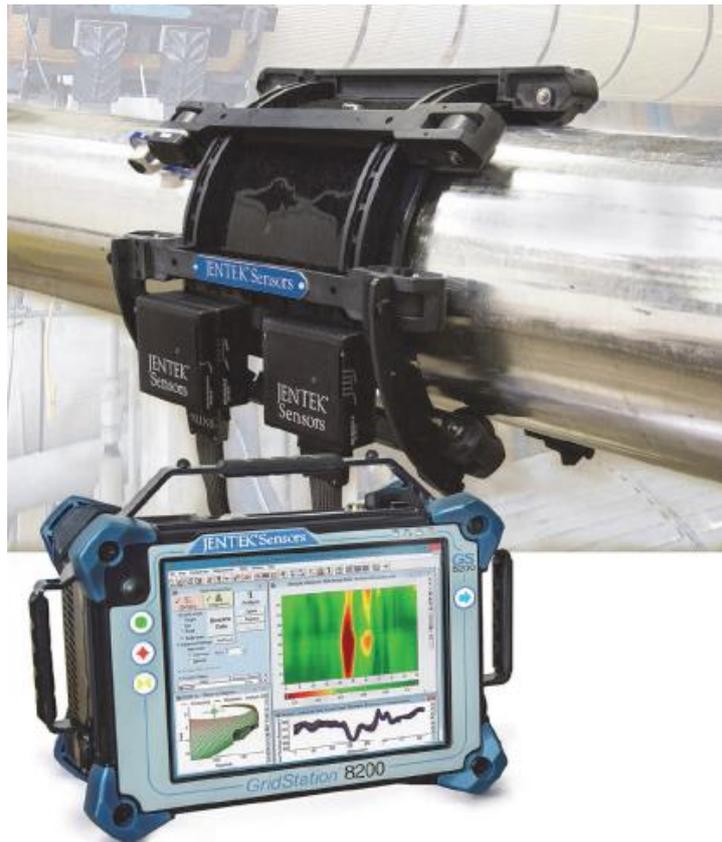
Figure A3-16 Jentek MWM technology for CUI scanning from their website (<http://www.jenteksensors.com/>).

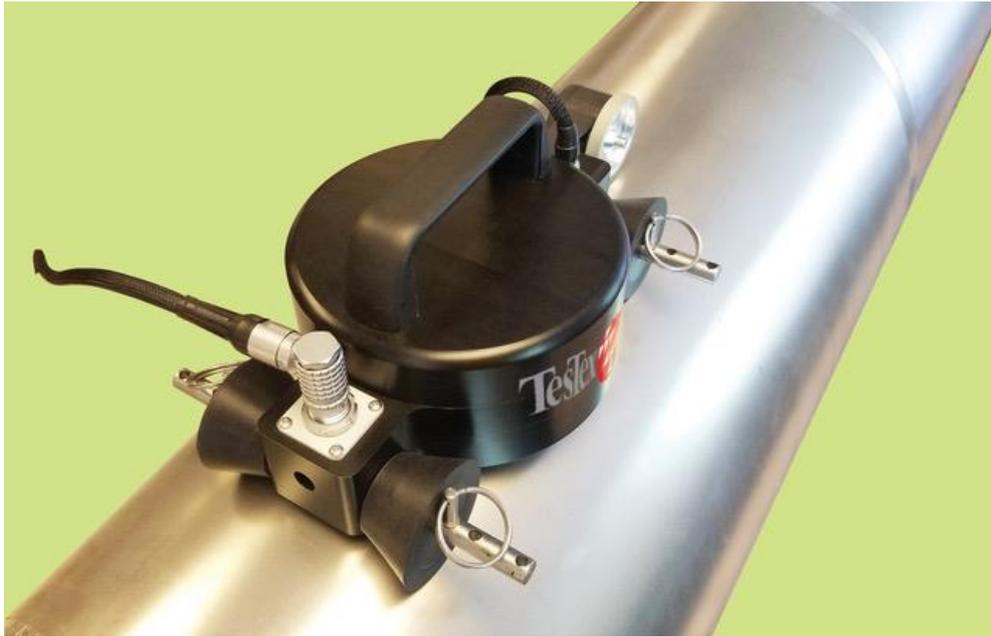
Figure A3-19 TestEx OSET Scout scanner for CUI inspection (courtesy TestEx)

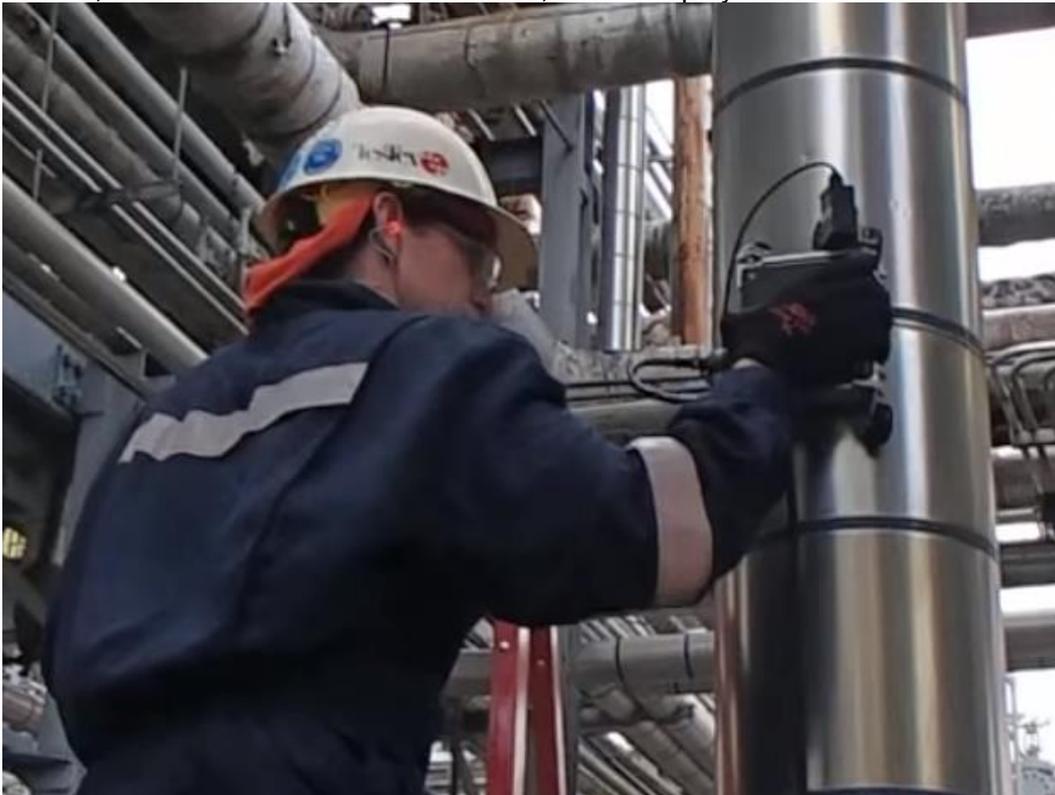
Figure A3-20 TestEx OSET Scout scanner deployed on-site (courtesy TestEx)
