HOIS/NZTC Guidance on inspection of uninsulated external corrosion scabs

HOIS-G-028

Issue 2

28th February 2022

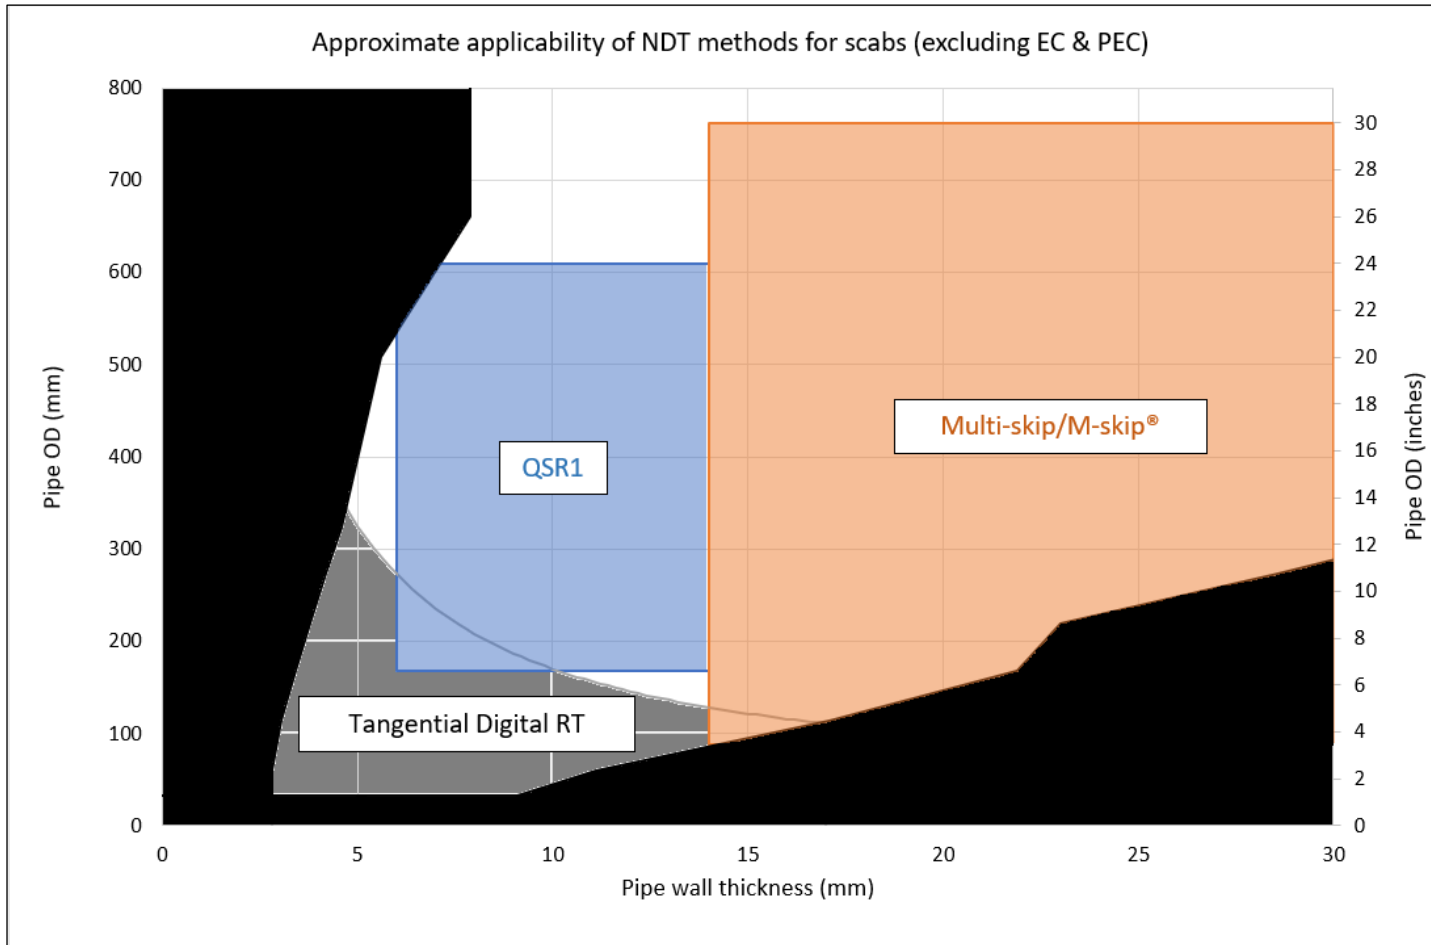
Figure 8-1: Approximate representation of the applicability of different NDT methods for scab sizing, excluding dual frequency EC & PEC, for different pipe diameters and wall thicknesses. The black areas represent pipes that are thinner walled or thicker walled than those normally manufactured (sch 10 used as lower limit and sch XXS or sch 160 as upper limit).

In considering the most effective method for quantitative sizing of scabs to use for a particular scab, the information given in Table 8-1 and Appendix 2 should be considered carefully in addition to the applicability data for OD and wall thickness given in Figure 8-1.

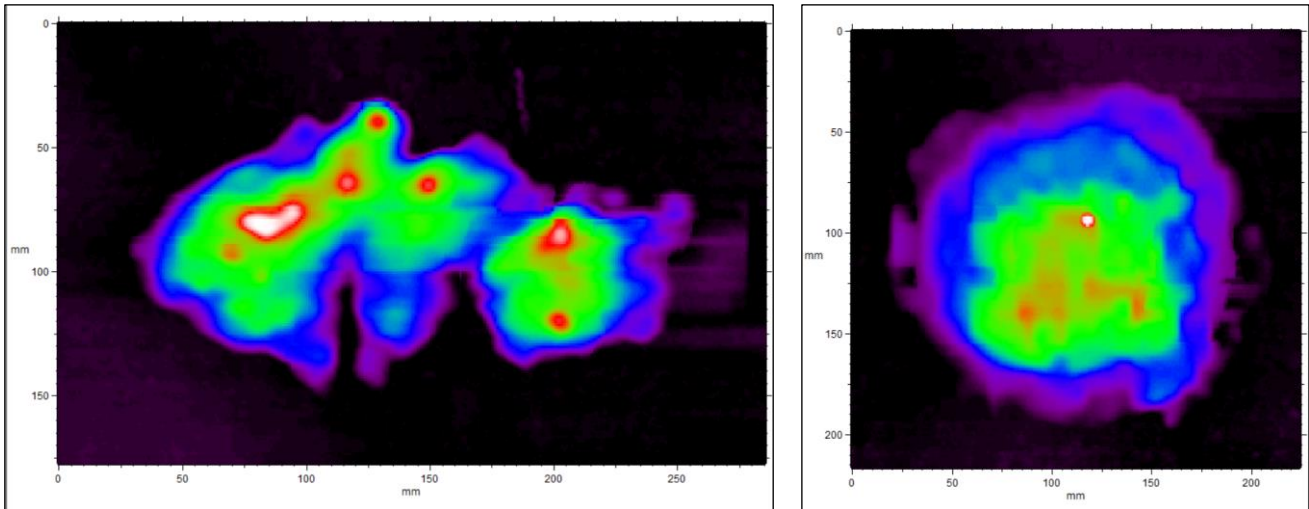
Figure 8-2: Examples of morphologies of the CNC areas of wall loss introduced into the test pipes. Left – multiple localised pits superimposed on a larger scale area of wall loss. Right – area with larger scale wall loss, with a single localised pit introduced.

For both pipes, to simulate the presence of natural corrosion product, the areas of wall loss were covered with synthetic scab material that consisted of magnetite granules (which is ferrimagnetic) embedded in modelling clay.

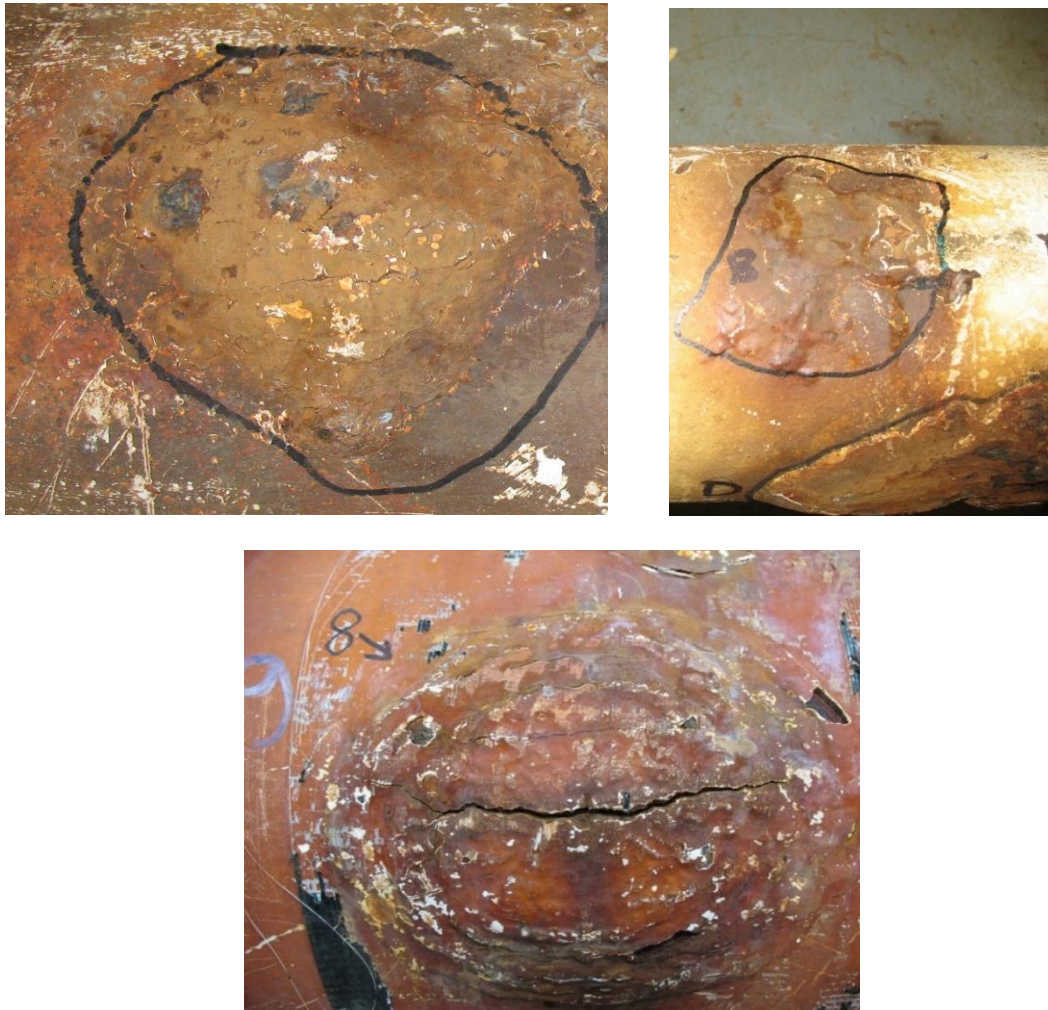
Figure A1-1: Examples of early stage external corrosion which has formed blisters underneath the coating. Note the cracks in the coating in the upper left and lower examples.

In the early stages of corrosion, a blister will form underneath the coating consisting of the corrosion product which forms over the corroded substrate. Examples of blisters with intact coatings are given in Figure A1-1.

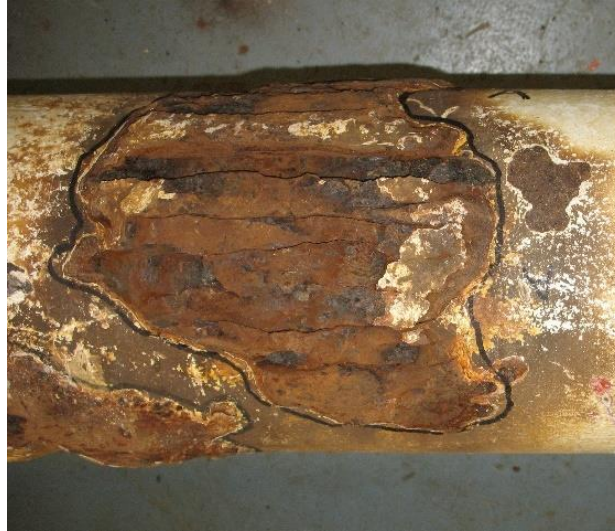
Figure A1-2: Example showing more extensive cracks in the coating and partial loss of the coating

More extensive cracking in the coating and partial loss of the coating may then occur, as illustrated in Figure A1-2.

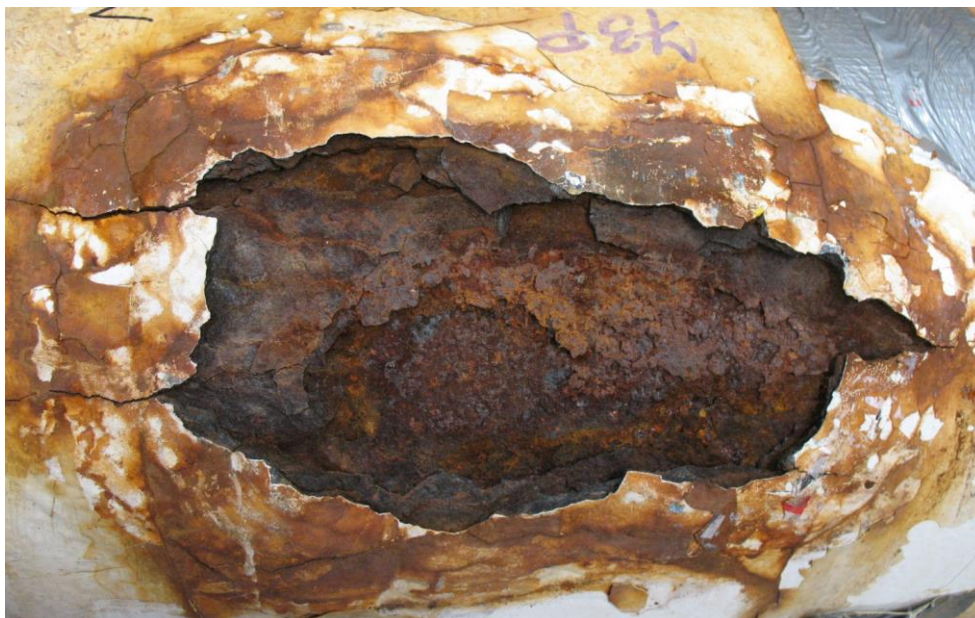
Figure A1-3: Example of external corrosion showing loss of coating

At some point, the height of the external corrosion scab is sufficient to displace the coating which may then be lost, revealing the corrosion product itself, as illustrated in Figure A1-3. Once the corrosion product has been exposed it may then start to be lost (or spalled); it cannot be guaranteed that all the product remains in-situ.

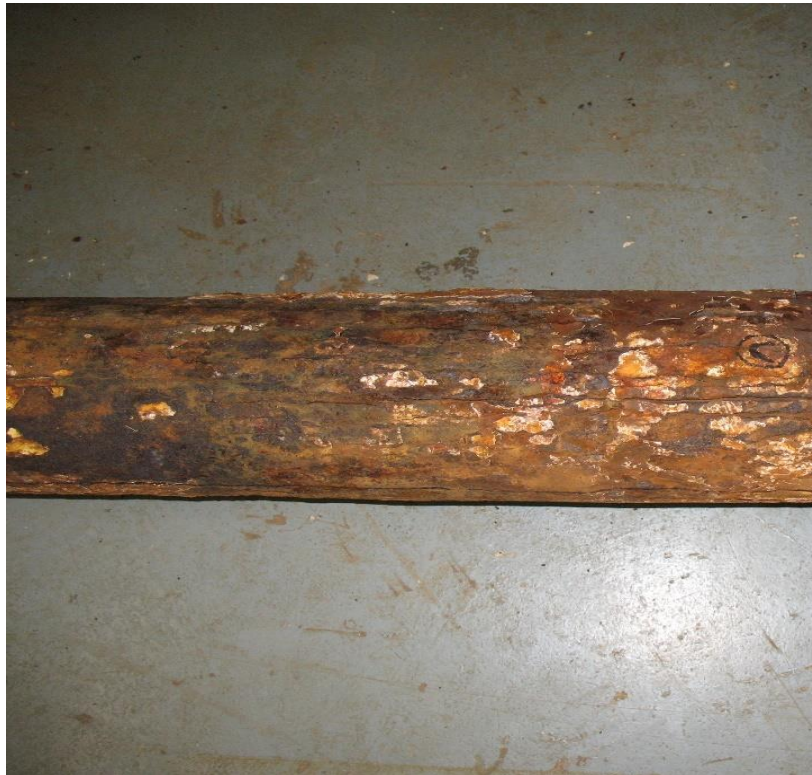
Figure A1-4: Example of widely distributed external corrosion with partial loss of coating

Hence, as illustrated in Figure A1-4, in advanced cases of corrosion, the area affected can be generalised, and extended over a considerable area.

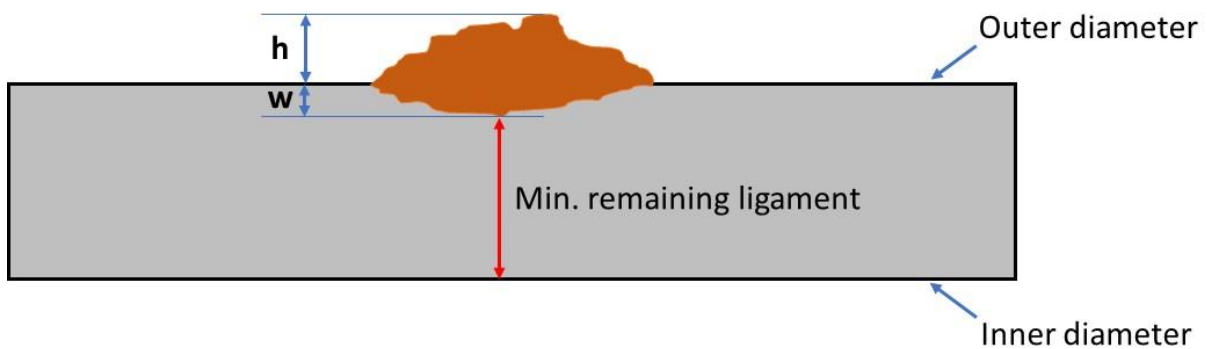
Figure A1-5: Diagram showing definition of scab height (h) and wall loss (w) values

The available scab height and wall loss data does however suggest that a conservative “rule of thumb” value to use would be to assume that the wall loss, w , is equal to the scab height, h (see Figure A1-5 for definition of these values), but only provided there is good evidence that the corrosion product has not been lost (e.g. the coating is still mainly intact).

Note that in this definition, both the wall loss, w , and the scab height, h , are measured relative to the uncorroded surface (see Figure A1-5). Hence the maximum thickness of scab is given by the sum of h and w .

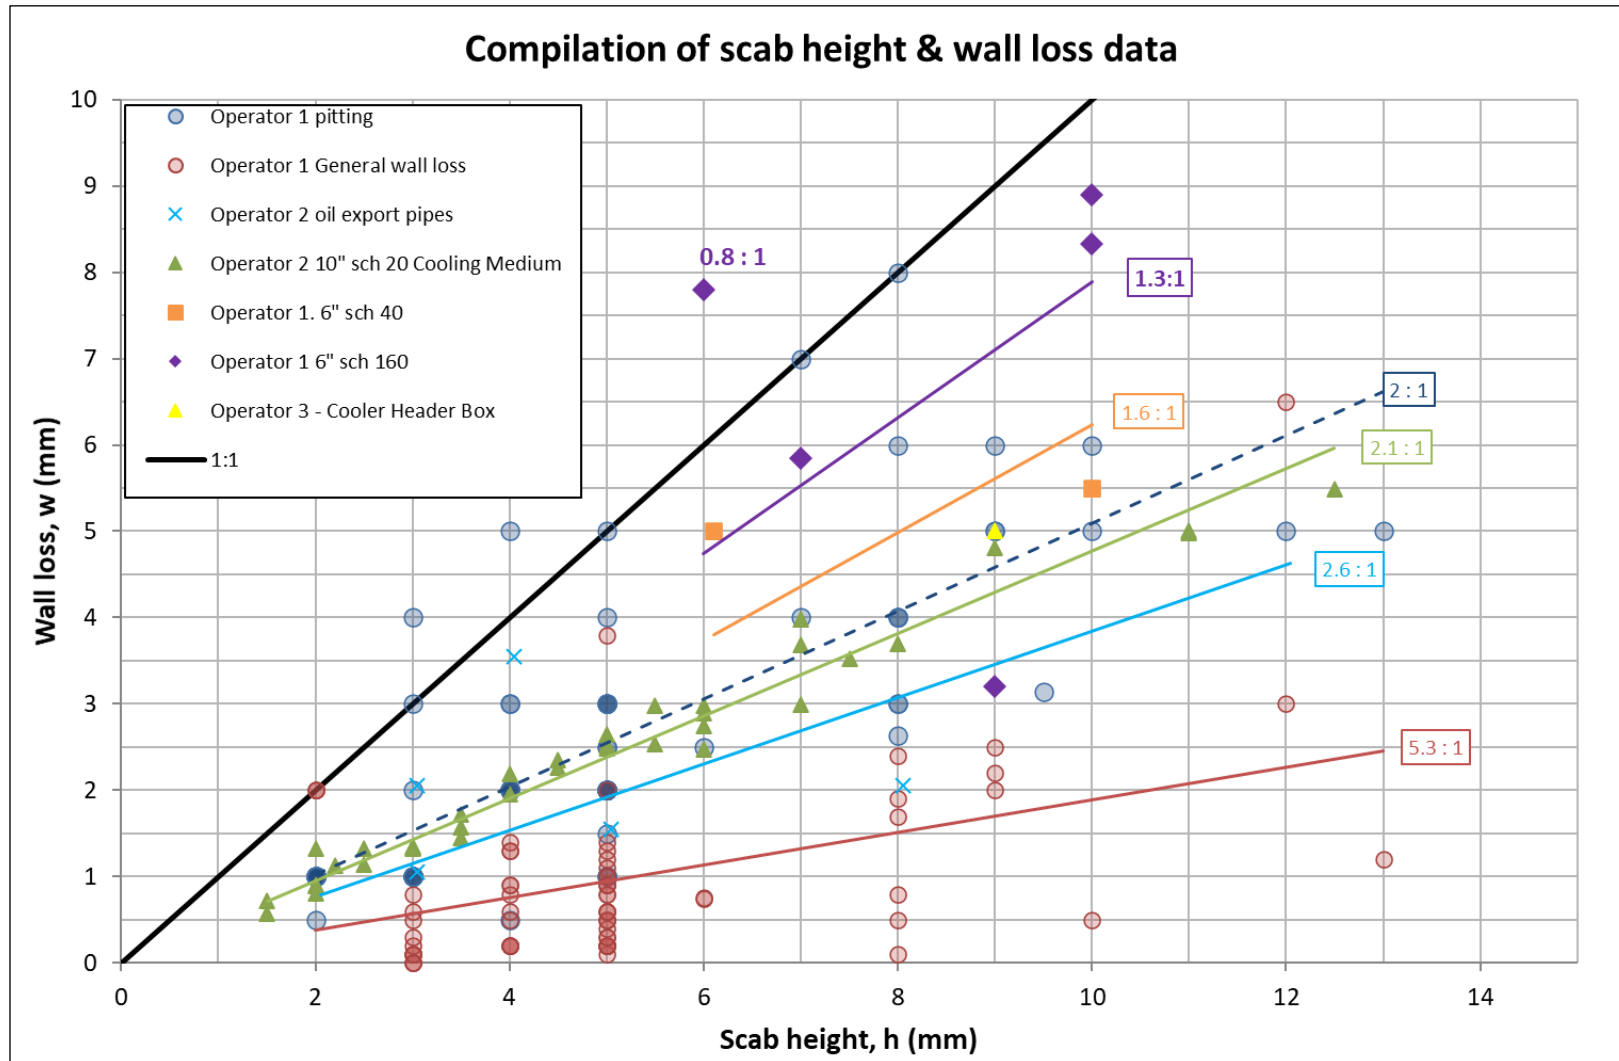
Figure A1-6: Graph showing scab height and wall loss data from all available sources

The correlation coefficient is one for perfect correlation and zero for no correlation. Hence an R^2 coefficient near to one would be indicative of a reliable method for estimating wall loss from a straightforward measurement of scab height. The available data shows substantial scatter in most, but not all, cases.

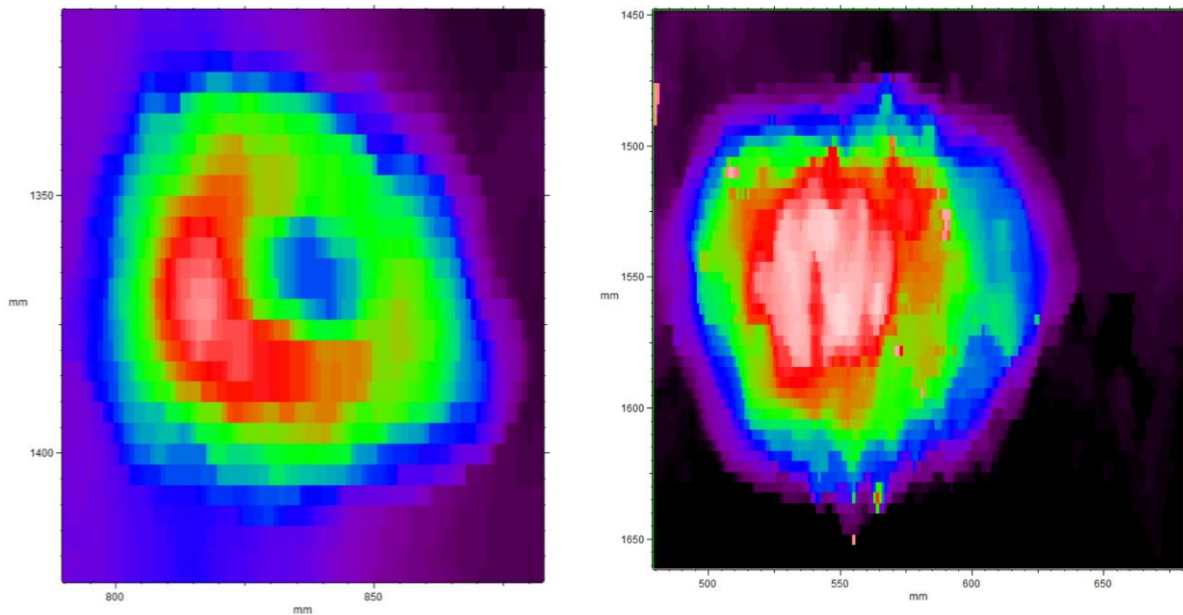
Figure A1-8: Examples of ultrasonic C-scans showing remaining thickness of two scabs on the 10" sch 20 pipes (as a function of circumferential and axial directions) with the axial direction being shown vertically

Examples of the ultrasonic thickness maps obtained from these pipes using an internal UT scanner are given in Figure A1-8, Figure A1-9 and Figure A1-10.

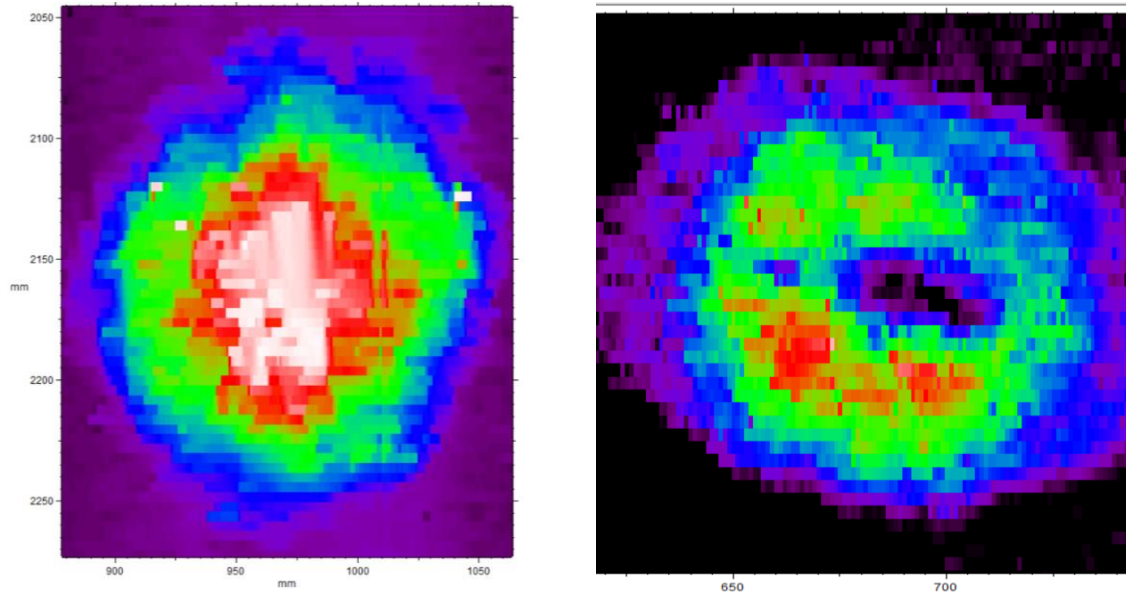
Figure A1-9: Further examples of ultrasonic C-scans showing remaining thickness of two scabs on the 10" sch 20 pipes (as a function of circumferential and axial directions) with the axial direction being shown vertically

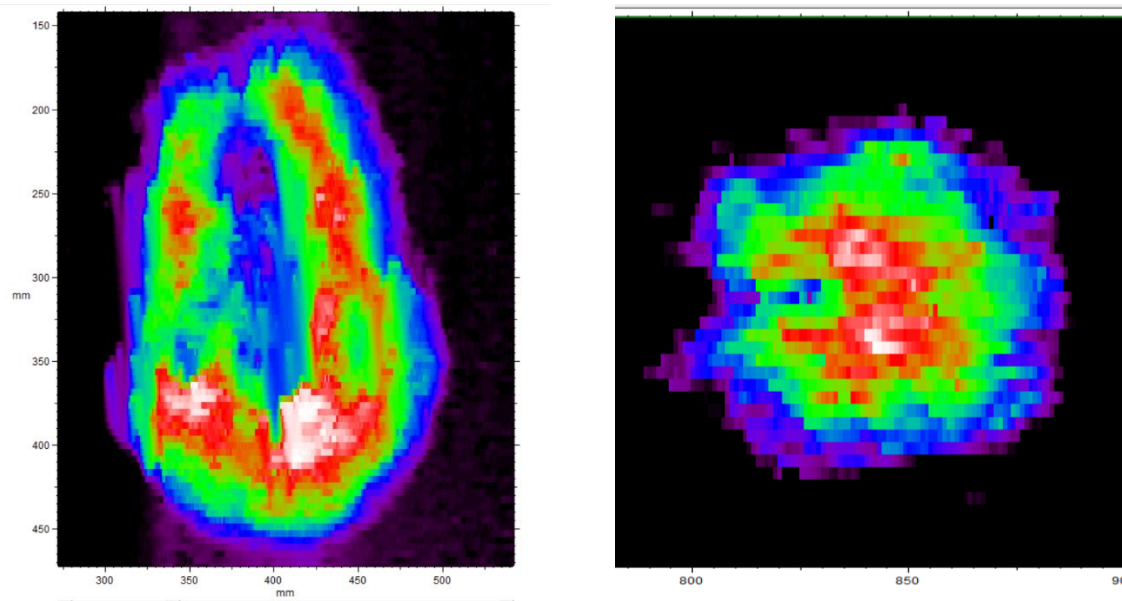
Figure A1-10: Further examples of ultrasonic C-scans showing remaining thickness of two scabs on the 10" sch 20 pipes (as a function of circumferential and axial directions) with the axial direction being shown vertically

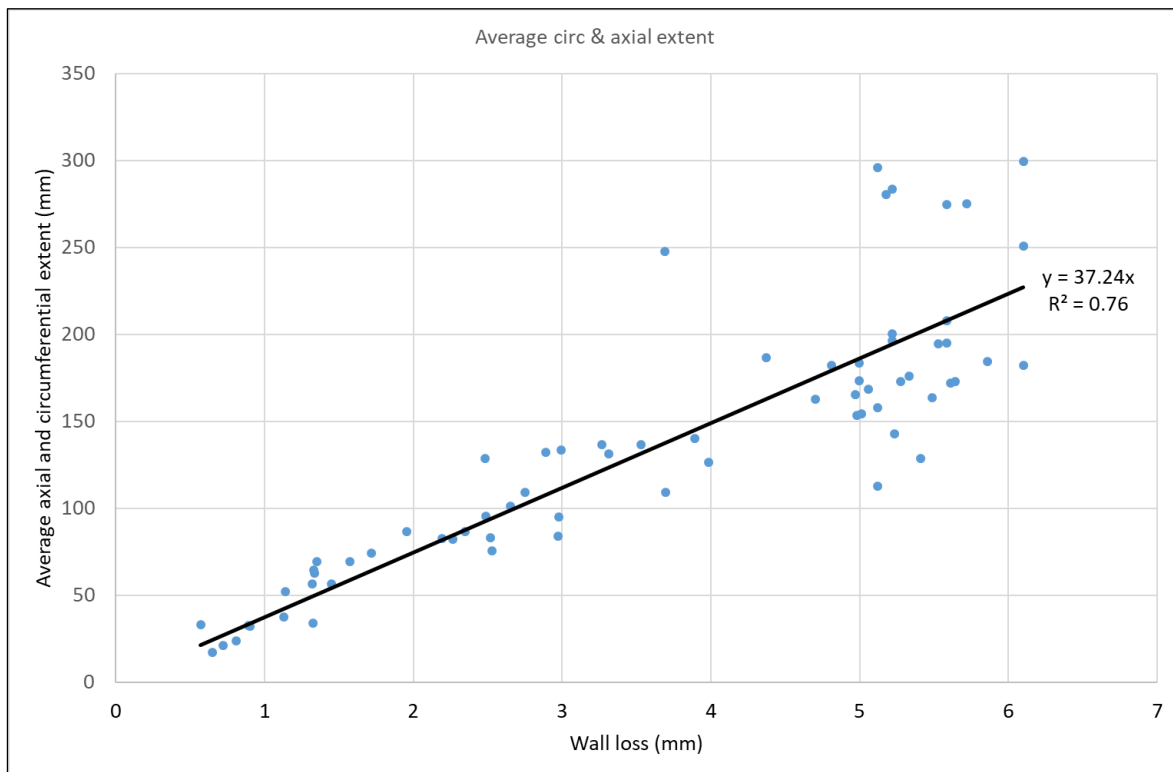
Figure A1-11: Maximum wall losses of the ex-service corroded areas as a function of their average circumferential and axial extents

The average aspect ratio of the areas was ~40. The aspect ratios of individual areas however varied substantially, with a minimum of ~20 and a maximum of ~70.

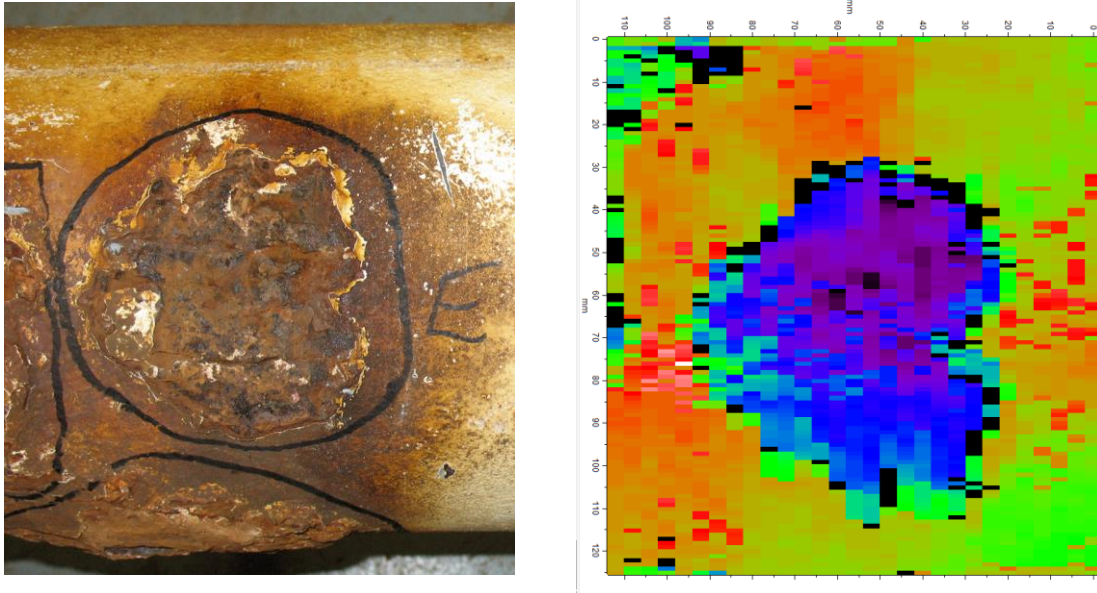
Figure A1-12: Photo of moderate ex-service scab (left) and corresponding UT remaining thickness map/C-scan (right) obtained with the ESR 'piglet' internal scanner

Figure A1-12 shows one of the corrosion scabs on these ex-service pipes and the corresponding UT C-scan. Note the close correspondence between the visual extent/shape of the scab and the UT C-scan.

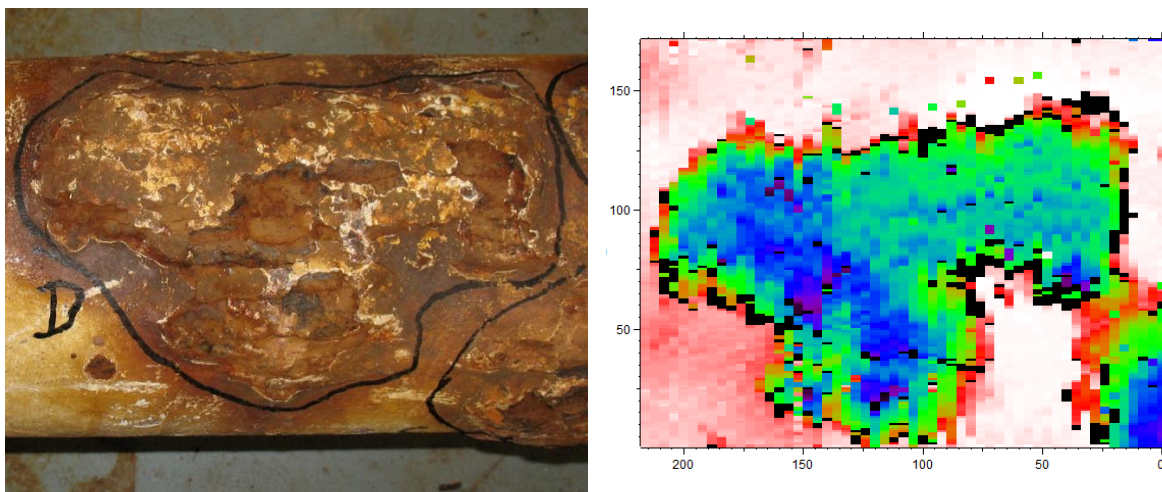
Figure A1-13: Photo of a larger ex-service scab (left) and the corresponding UT remaining thickness map/C-scan (right) obtained with the ESR 'piglet' internal scanner

A larger scab and the UT C-scan obtained from it is shown in Figure A1-13. Note that on the C-scan, some of the areas of wall loss appear to be quite localised.

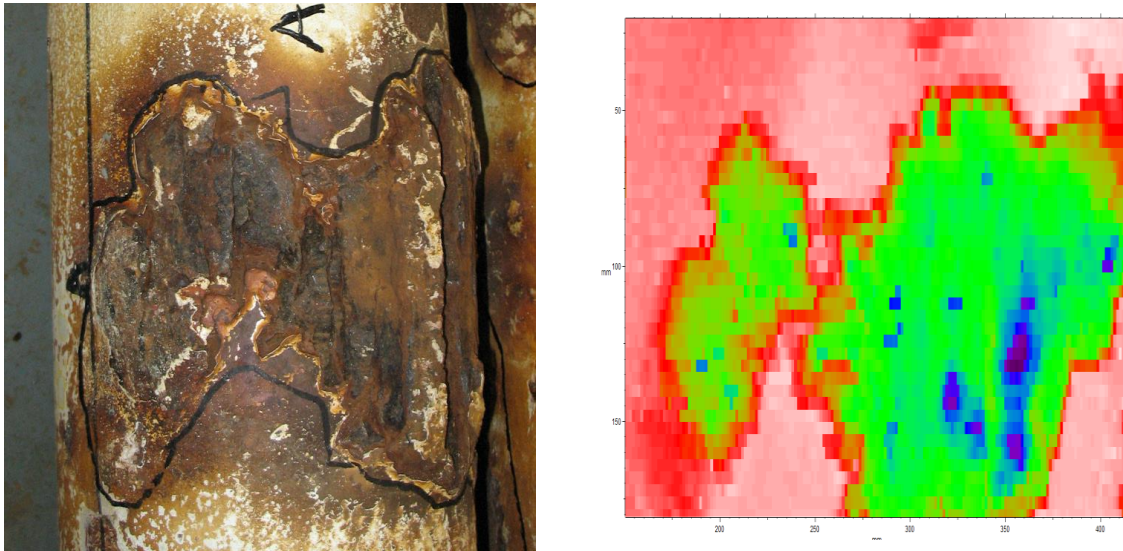
Figure A1-14: Photo of a larger ex-service scab (left) and the corresponding UT remaining thickness map/C-scan (right) obtained with the ESR 'piglet' internal scanner, showing pronounced localised features.

A further example of another larger scab and the UT C-scan obtained from it is shown in Figure A1-14. In this case, there are several localised features, or pits, superimposed on large areas of near uniform wall loss.

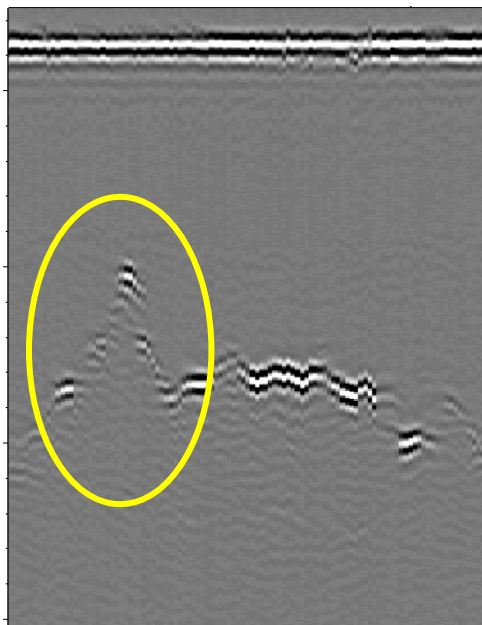
Figure A1-15: B-scan of data showing pronounced localised pitting along one circumferential scan line

One of the ultrasonic B-scans from the above scan (Figure A1-15) shows the pronounced nature of the localised pitting in this scab which in this case corresponds to an additional wall loss of ~ 5mm over a total circumferential extent of ~ 15mm.

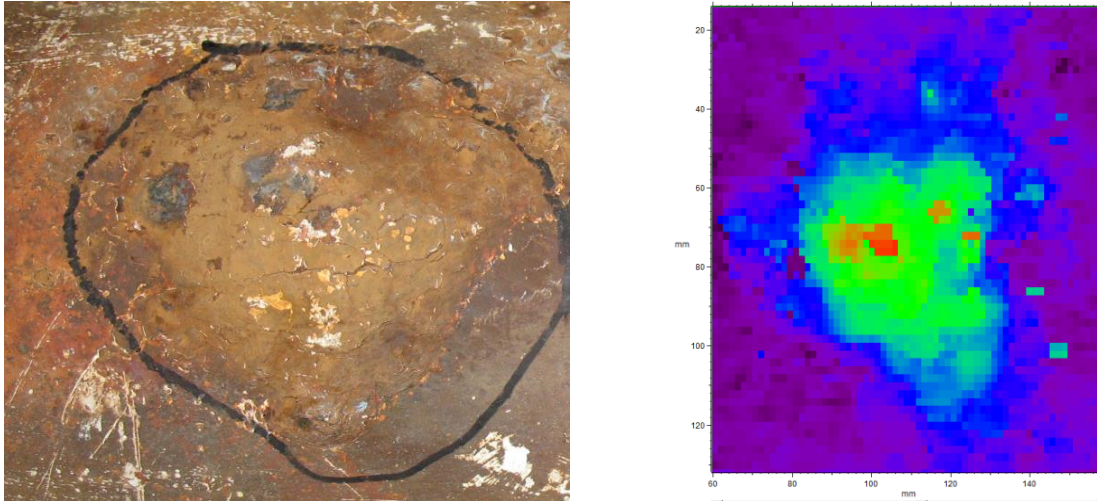
Figure A1-16: Photo of a smaller ex-service scab still covered by coating (left) and the corresponding UT remaining thickness map/C-scan (right) obtained with the ESR 'piglet' internal scanner showing pronounced localised features

A further example is provided by the smaller scab shown in Figure A1-16 which is still covered by coating. The C-scan shows an area of large-scale loss of wall coincident with overall extents of the scab, again superimposed on this there are some highly localised areas of additional wall loss. These are up to ~3 mm deeper than the surrounding surface and only about 5mm x 5mm in axial/circumferential extent.

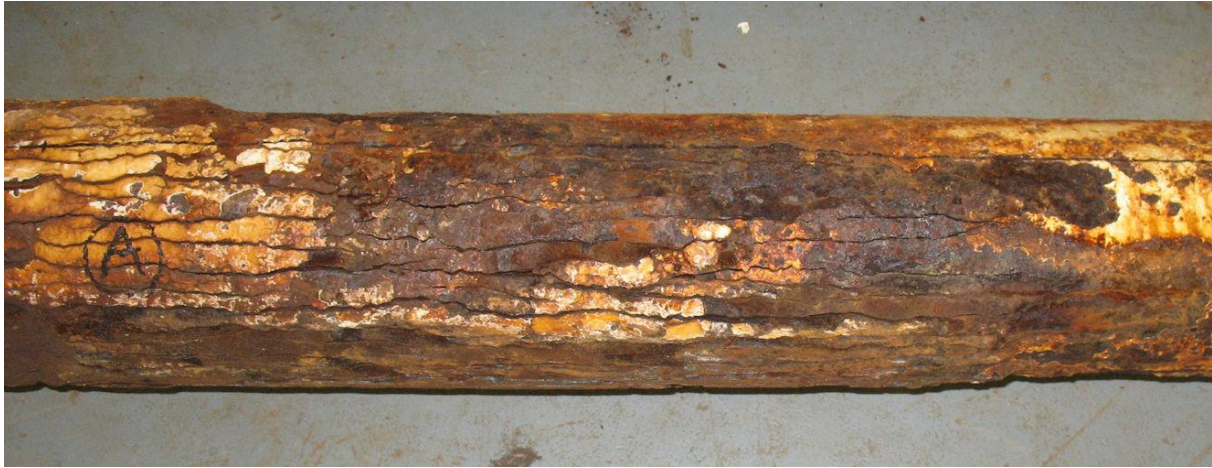
Figure A1-17: Photo of an extensive area of corrosion (top) and the corresponding UT C-scan (below). Two detailed C-scans of individual pits are also shown.

Figure A1-18 shows an extensive corrosion scab affecting the full pipe circumference with an axial length > 1m. The corresponding C-scan shows an extensive area of near uniform wall loss, with two highly localised pits superimposed in different, apparently random locations. C-scans are also shown from two detailed scans, made at full resolution. These show that the deeper pit has an additional wall loss of ~4mm over an area of about 8mm (axial) x 6mm (circ.).

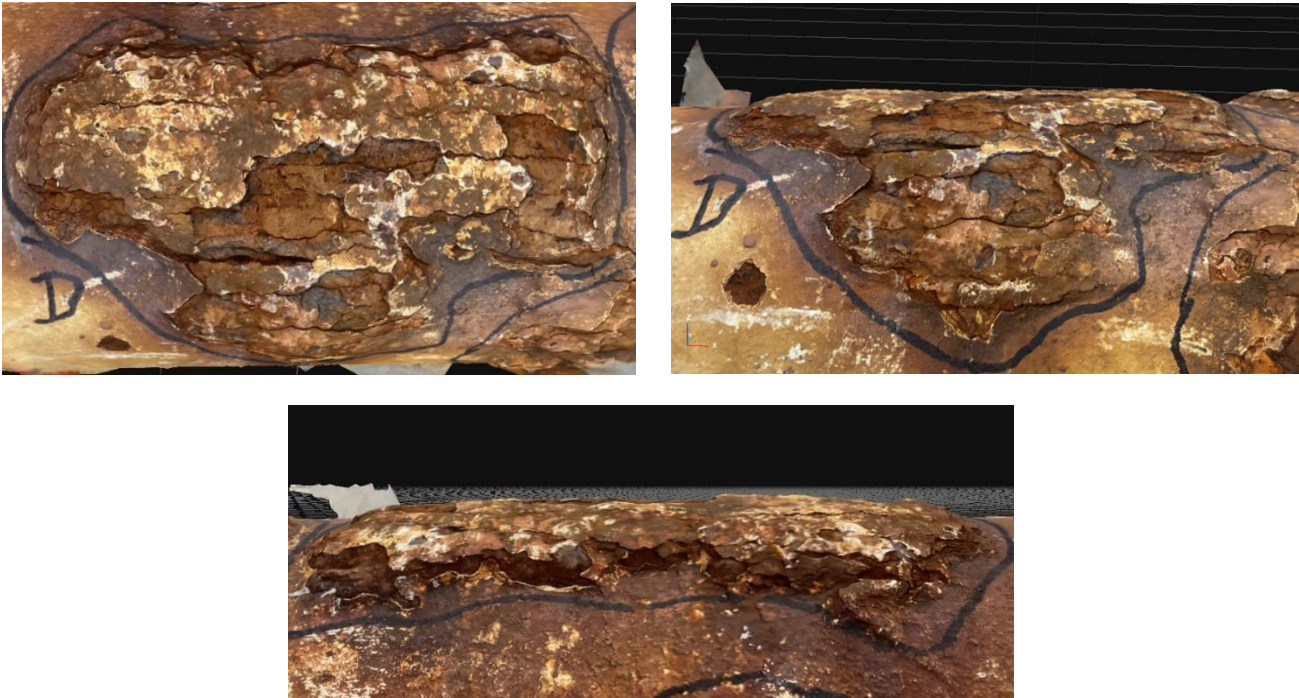
Figure A1-18: Images of a 3-D model of an external corrosion scab using photogrammetry

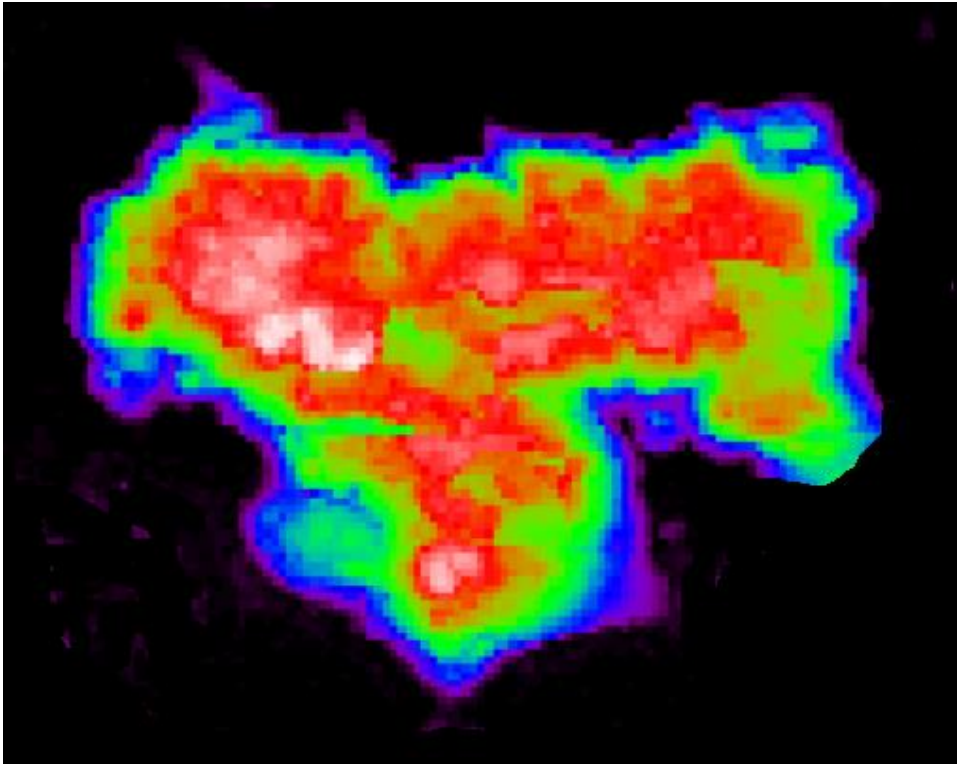
Figure A1-19: 2-D height map of scab shown in Figure A1-18

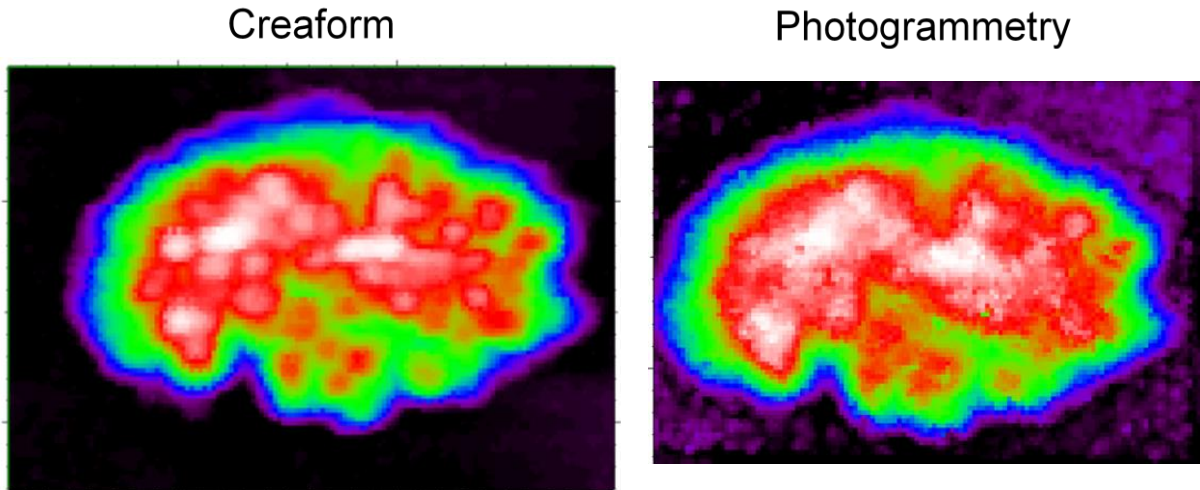
Figure A1-20: Comparison of 2-D depth maps produced by Creaform and photogrammetry

To determine the accuracy of measurements derived from photogrammetry, pipe samples containing CNC-machined areas of wall loss that had been fully benchmarked, were assessed using both photogrammetry and Creaform laser scan data, and the results compared. The deepest points on a limited number of samples showed reasonable correlation with a maximum difference of 0.3 mm between the two techniques. An example of the 2-D depth maps created using both techniques is shown in Figure A1-20. Whilst the map obtained from photogrammetry displayed a lower spatial resolution, the general features were consistent with the Creaform scan.

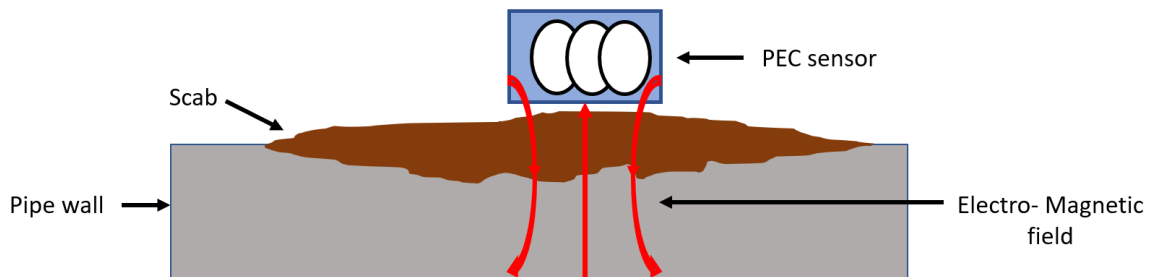
Figure A2-1: Principle of the pulsed eddy current method for measurement of the remaining wall thickness under a scab

For NDT of scabs, the pulsed eddy current (PEC) sensor is positioned above the scab, with the aim of measuring the remaining wall thickness within the sensor footprint, directly beneath the sensor, as illustrated in Figure A2-1.

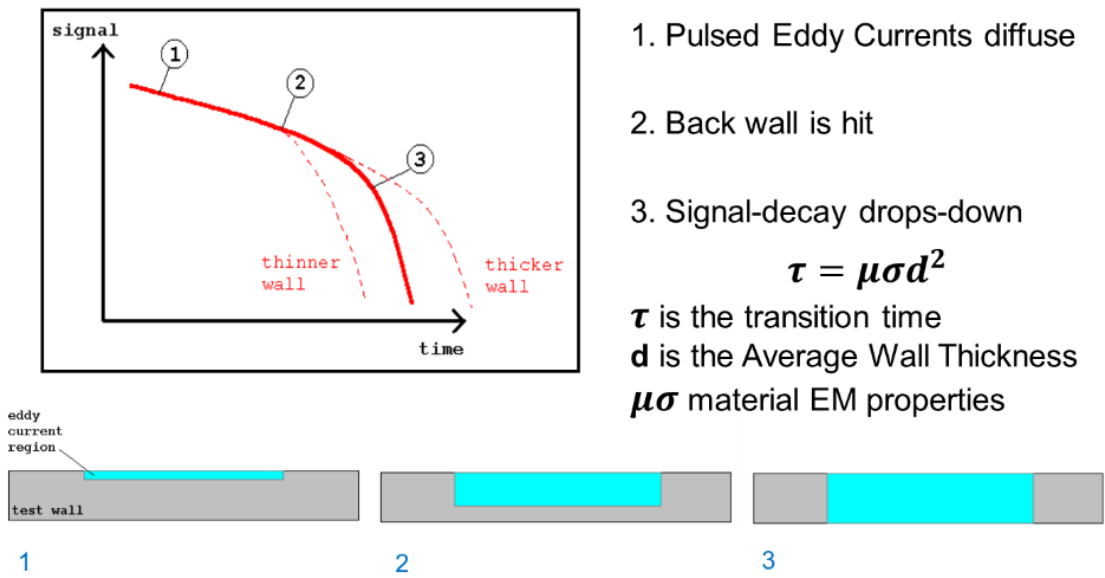
Figure A2-2: Pulsed eddy current signal plotted as a function of time for different remaining wall thicknesses (courtesy TUV Sonovation)

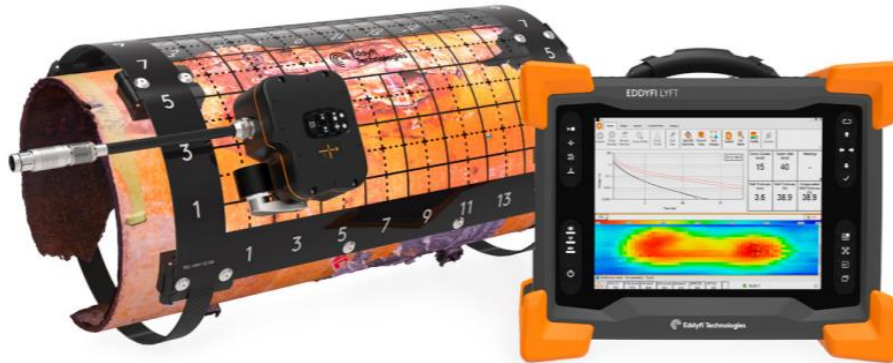
Figure A2-3: Eddyfi Lyft equipment for pulsed-eddy current inspection of an external corrosion scab (courtesy of Eddyfi)

An example of equipment for pulsed eddy current inspection of scab is shown in Figure A2-3.

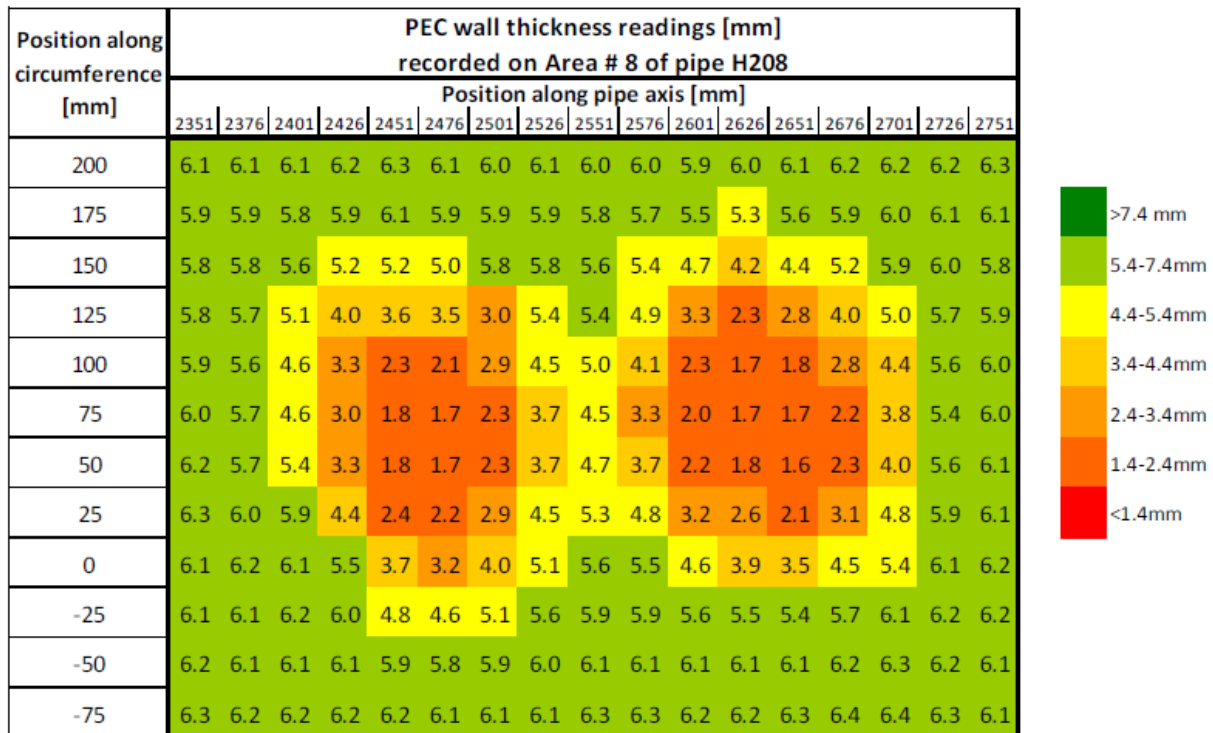
Figure A2-4: An example of a thickness map (C-scan) of an external corrosion scab (courtesy of Bilfinger and Shell Global Solutions International)

An example of a PEC C-scan map of an externally corroded area, without insulation, on a 10” Sch. 20 (6.4mm nominal wall thickness) pipe is given below in Figure A2-4.

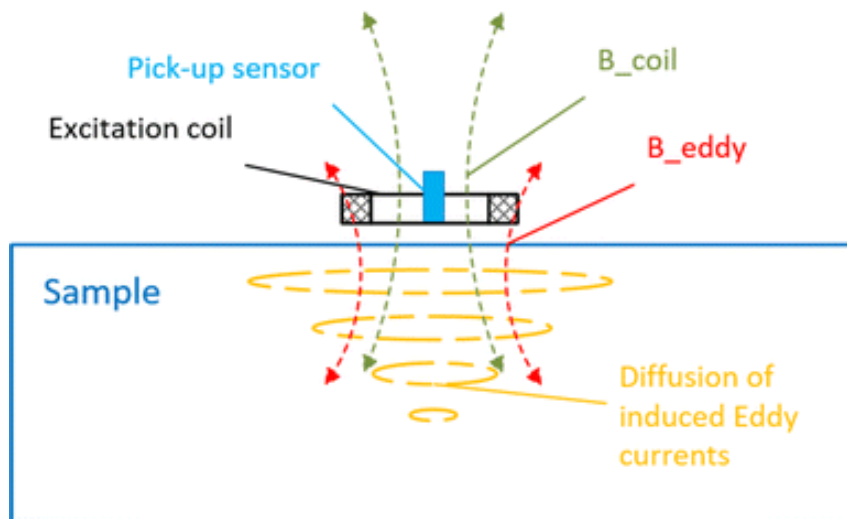
Figure A2-5: Principle of the eddy current method for NDT

Eddy current testing is based on the phenomenon of electromagnetic induction. In an eddy current probe, an alternating current flows through a wire coil and generates an oscillating magnetic field. If the probe and its magnetic field are brought close to a conductive material like a metal test piece, a circular flow of eddy currents will begin to move through the metal. The eddy currents flowing through the metal will in turn generate a magnetic field, which will interact with the coil and its field through mutual inductance (see Figure A2-5).

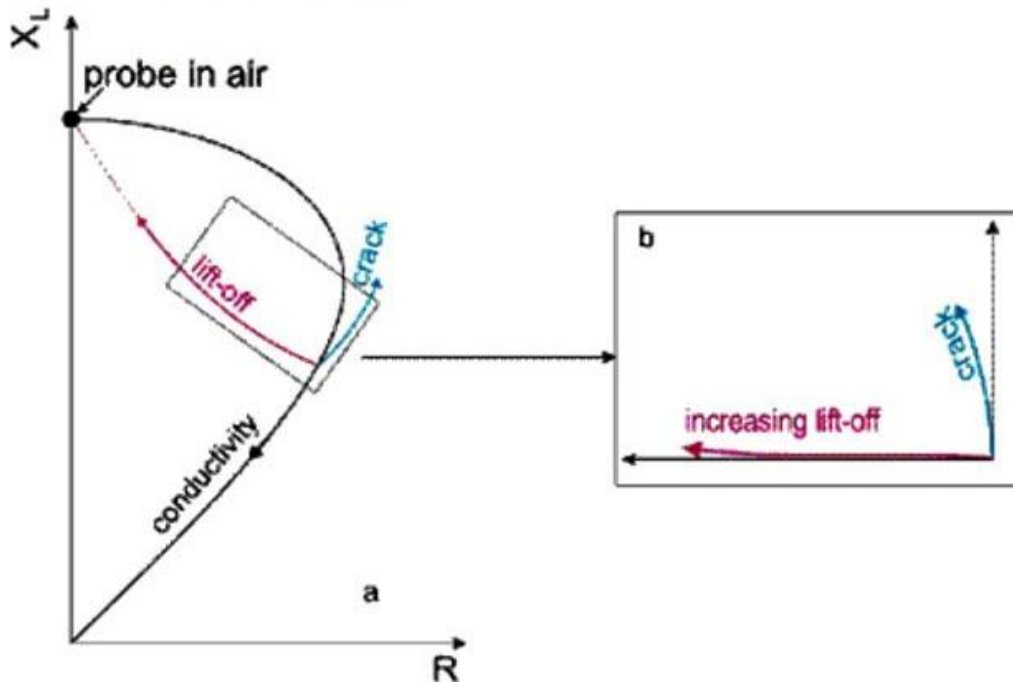
Figure A2-6: Impedance plane plot of eddy current signals showing the characteristics of lift-off and crack signals

Lift-off effects can be distinguished from those due to surface defects such as cracks by the characteristics of the response obtained in the sensor coil impedance plane (see Figure A2-6).

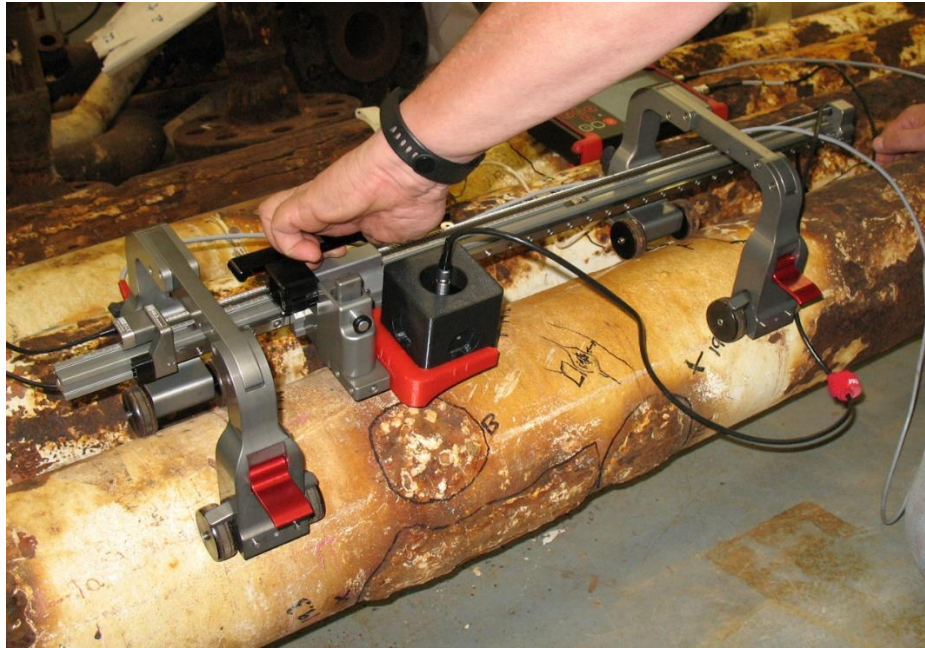
Figure A2-7: 2-D scanner being used to apply the dual frequency eddy current method to an externally corroded pipe during previous HOIS trials

To maintain a constant distance above the uncorroded pipe surface, a manually operated 2-D scanner (see Figure A2-7) is used, located on the parent material around the corroded area.
