HOIS/NZTC Guidance on inspection of uninsulated external corrosion scabs

HOIS-G-028

Issue 2

28th February 2022

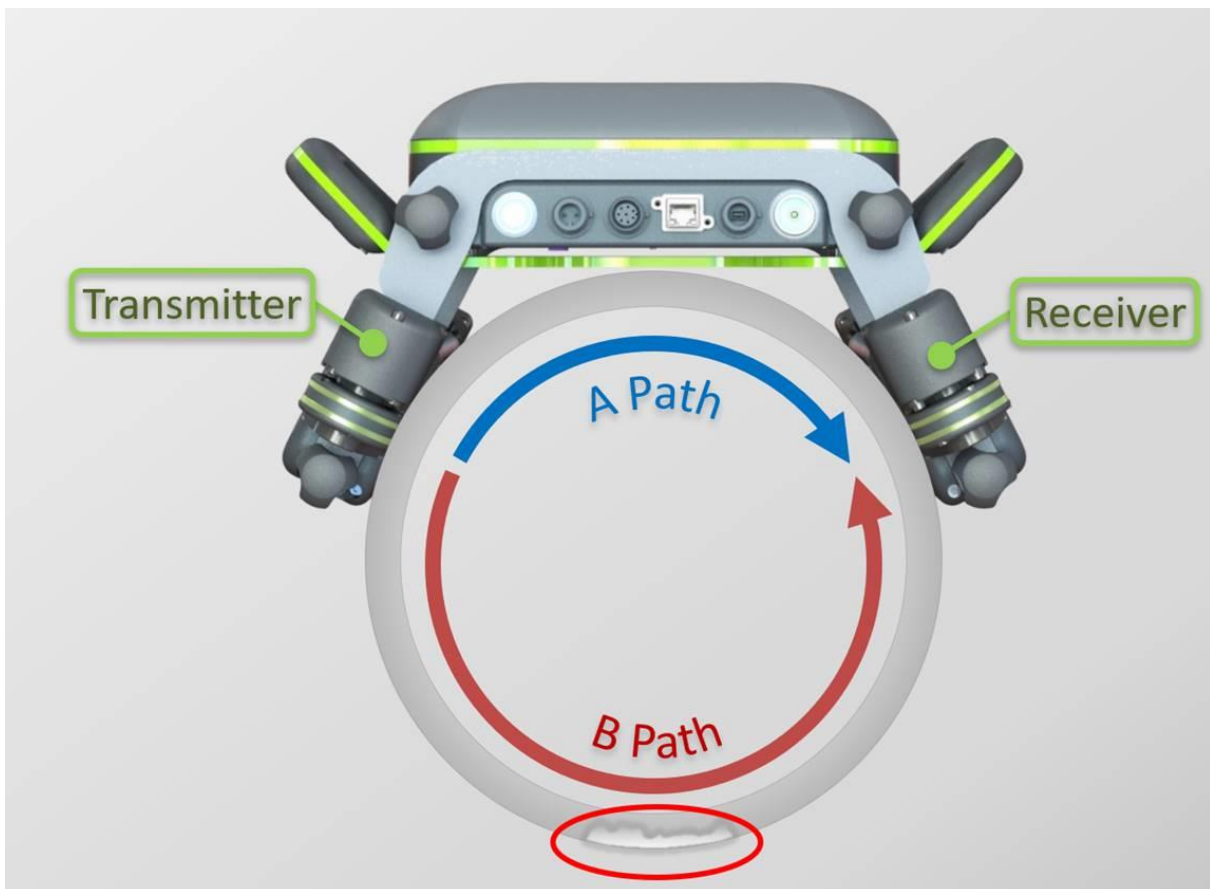
Figure A2-9: Schematic of the configuration of QSR1 (courtesy GUL)

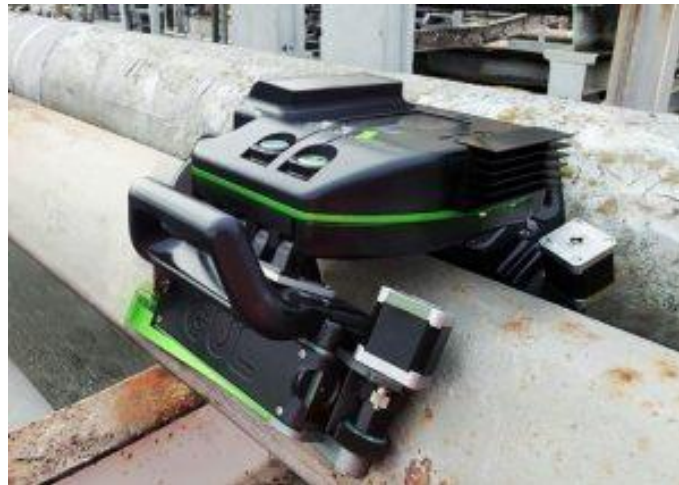
Figure A2-10: QSR1 scanner on a pipe (courtesy GUL)

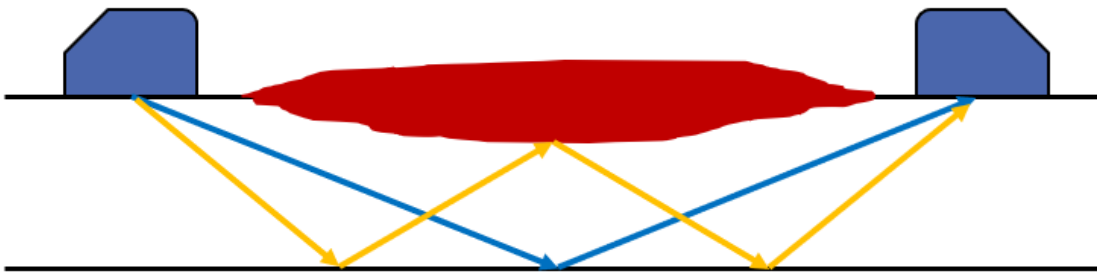
Figure A2-11 Concept of the Multi-skip/M-skip® method showing the ray paths for the first two signals between the transmitter (Tx) and the receiver (Rx) for external corrosion

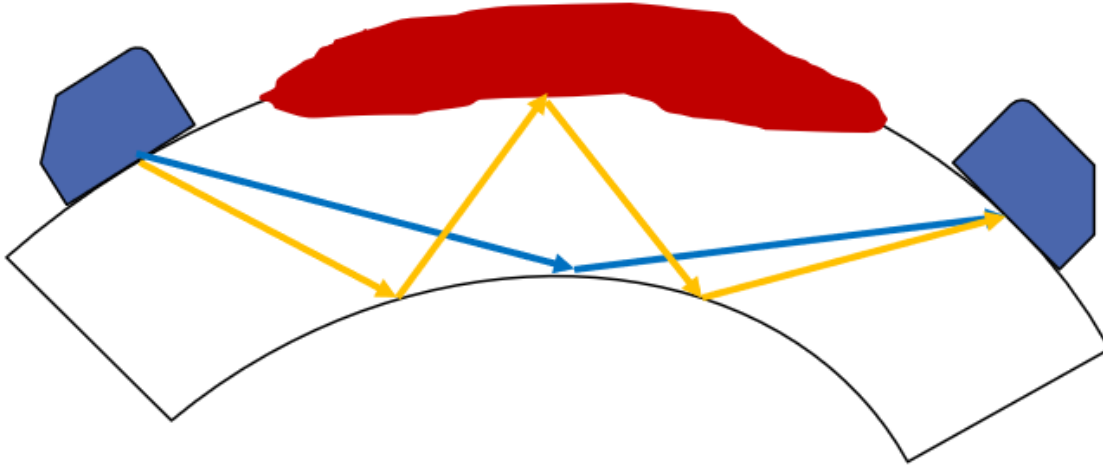
Figure A2-12: Schematic of circumferential beam Multi-skip/M-skip® showing the first two skip signals (1 and 2). Where possible, sizing should be based on skip 2 (orange propagation path).

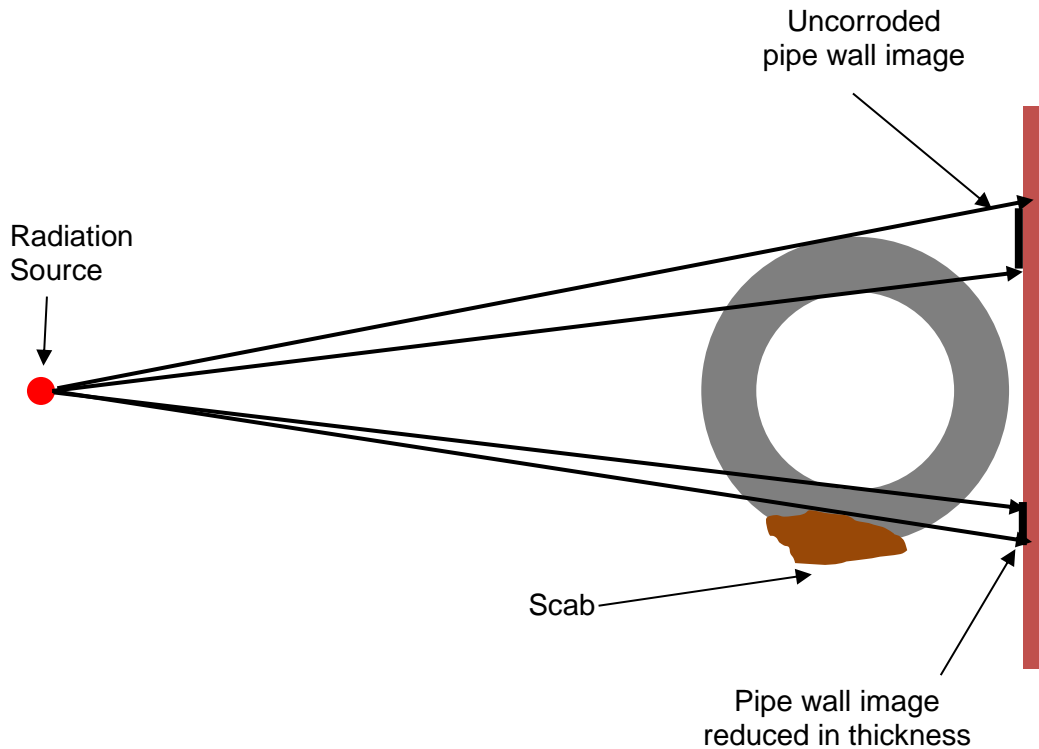
Figure A2-13: Schematic of tangential radiography for scab inspection with the source aligned with the pipe axis

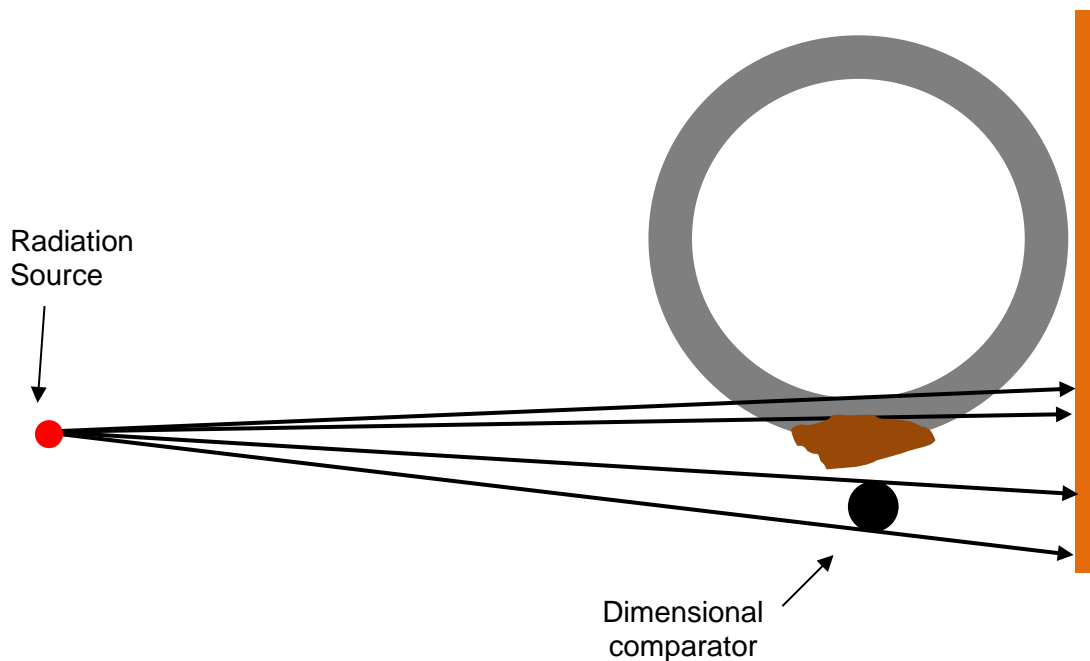
Figure A2-14: Schematic of tangential radiography for scab inspection with the source offset from the pipe axis

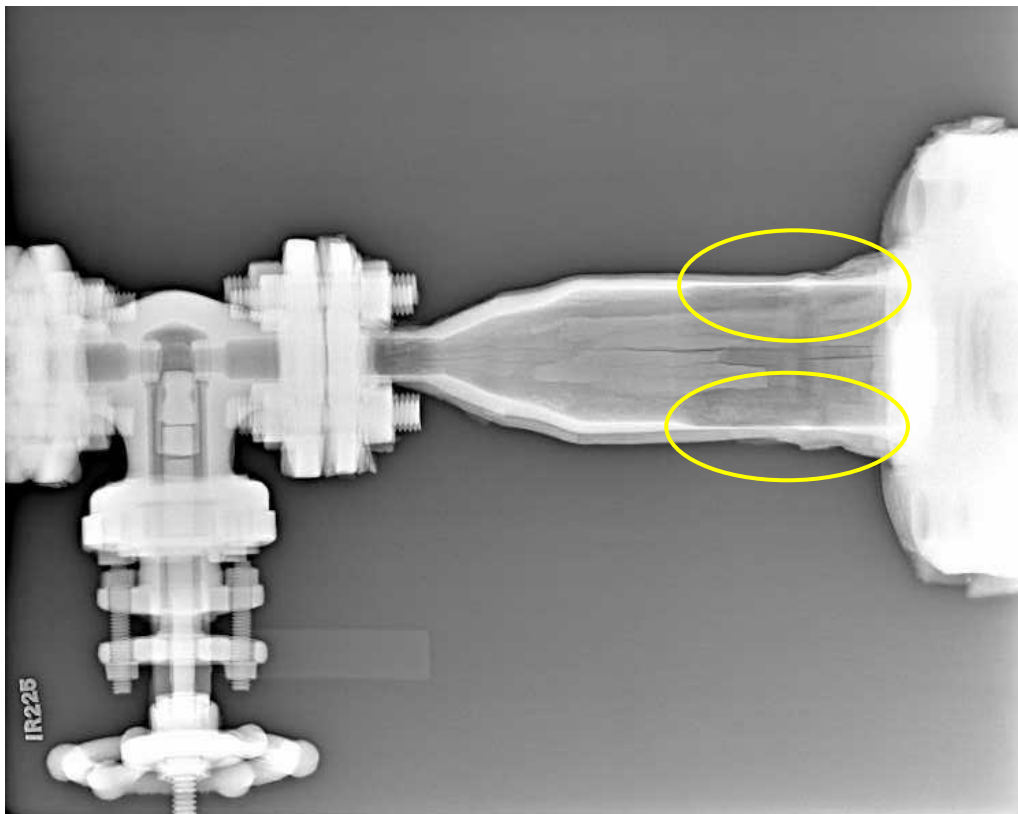
Figure A2-15: CR image of a pipe assembly including a valve, reducer section and a short length of 2" pipe. The reducer pipe section has heavy external corrosion and the radiograph clearly shows very little remaining wall thickness in the areas highlighted.

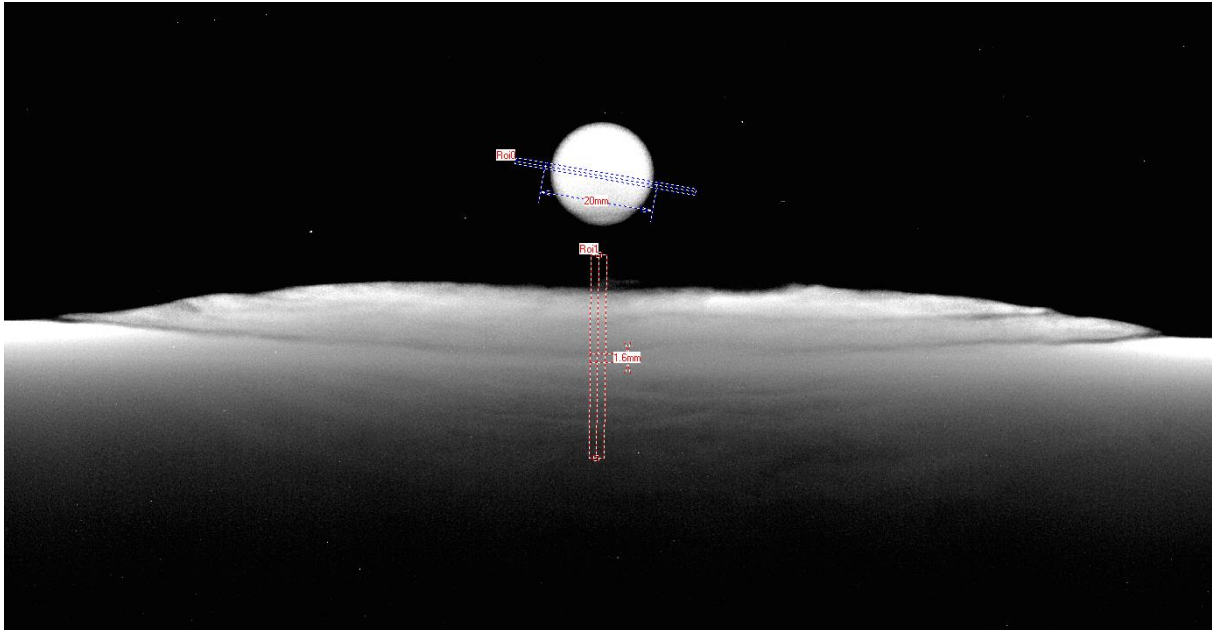
Figure A2-16: CR image of a scab on a 10" sch 20 pipe showing ball bearing comparator used for dimensional calibration and determination of the minimum remaining wall thickness (c. 1.6mm)

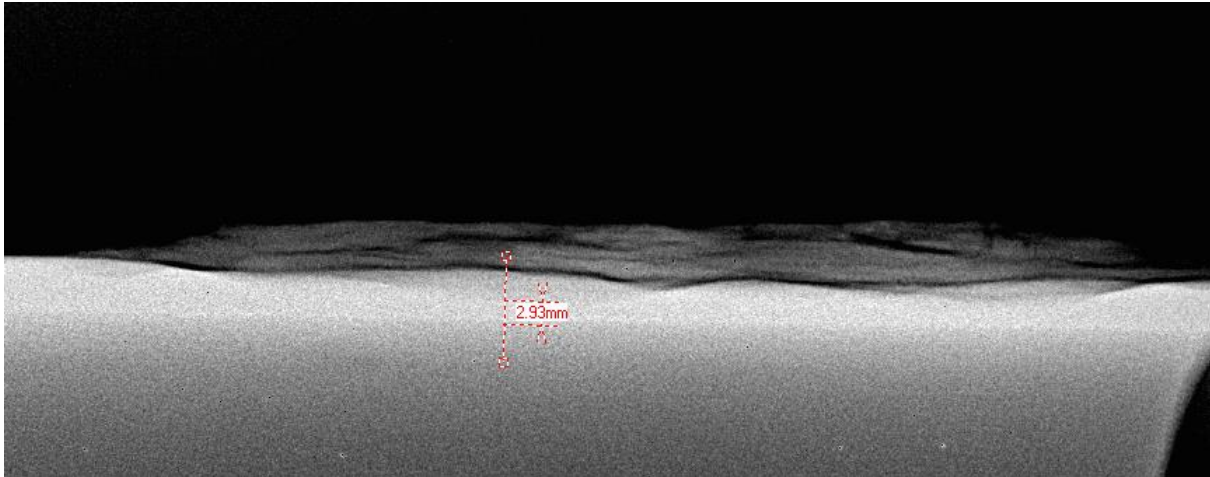
Figure A2-17: Magnified and enhanced DR image of the scab section of specimen H129 showing an alternative interpretation using internal pipe wall features which give a smaller remaining wall thickness

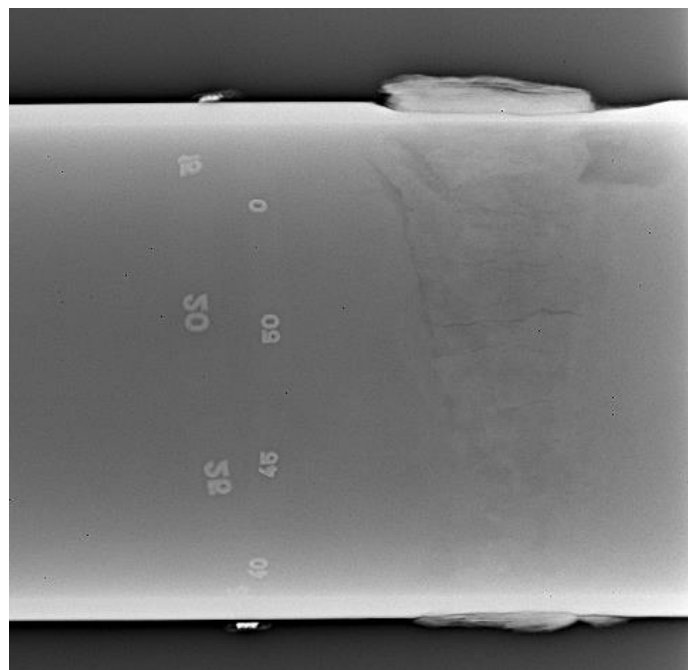
Figure A2-18: DR image of the scab section of specimen H168, close to the angle showing the greatest wall loss/minimum remaining wall thickness. Note the lack of structure in the images of the pipe walls.

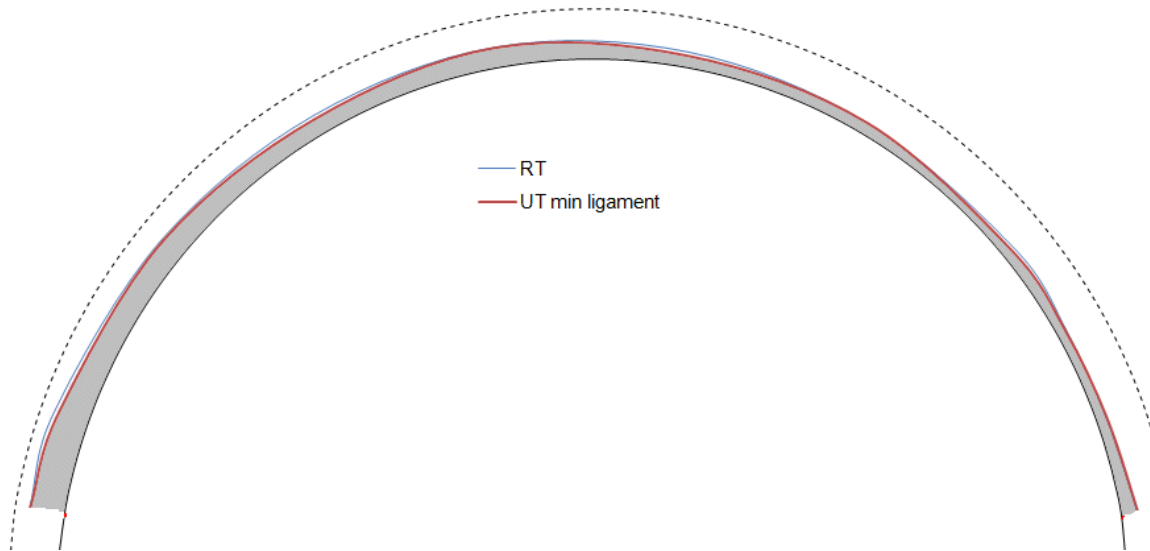
Figure A2-19: The shape of remaining metal under the scab in pipe H168 derived from the UT benchmark data and the DR measurements

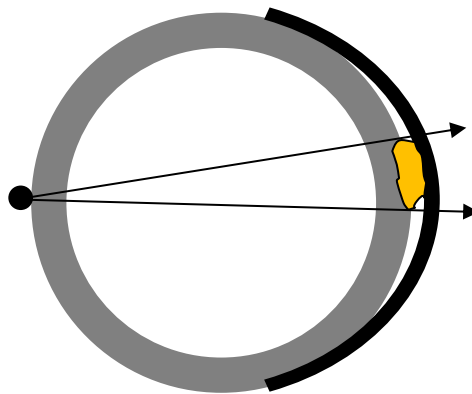
Figure A2-20: Schematic of double-wall single image radiography for scab inspection

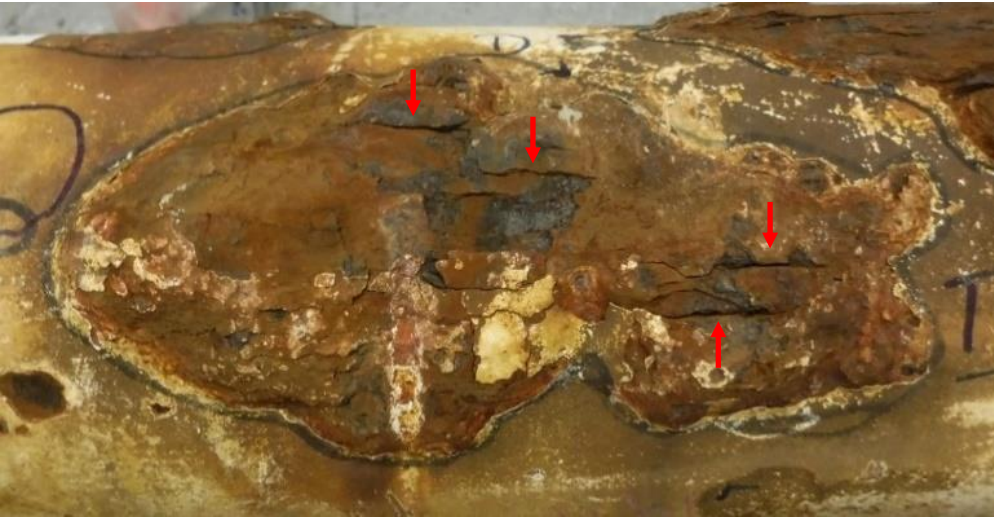
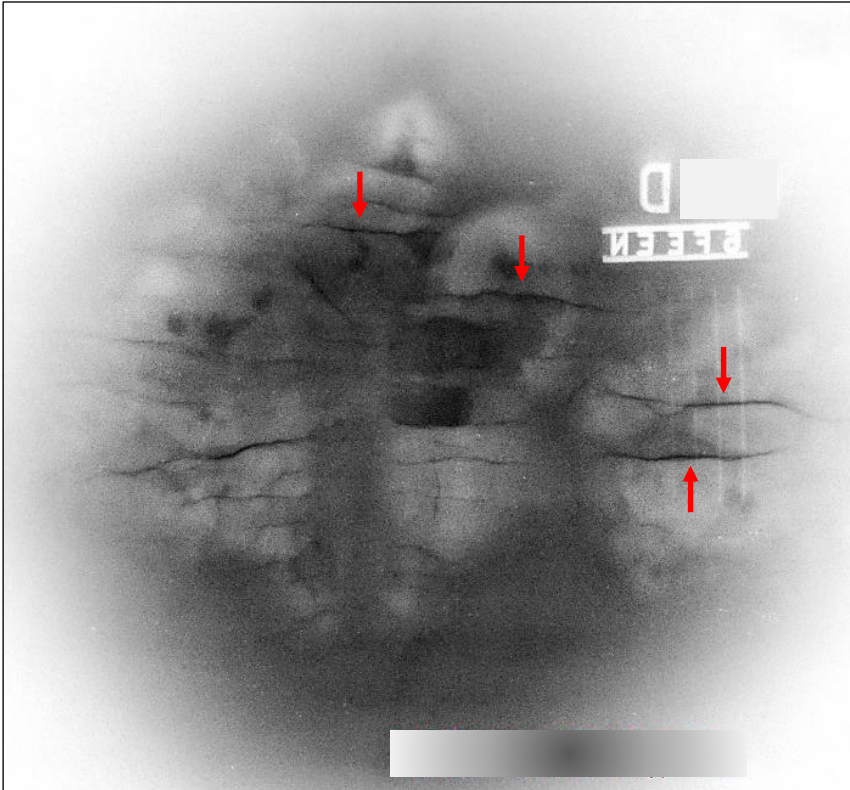
Figure A2-21: Example of an ex-service external corrosion scab and associated radiograph from the recent HOIS study

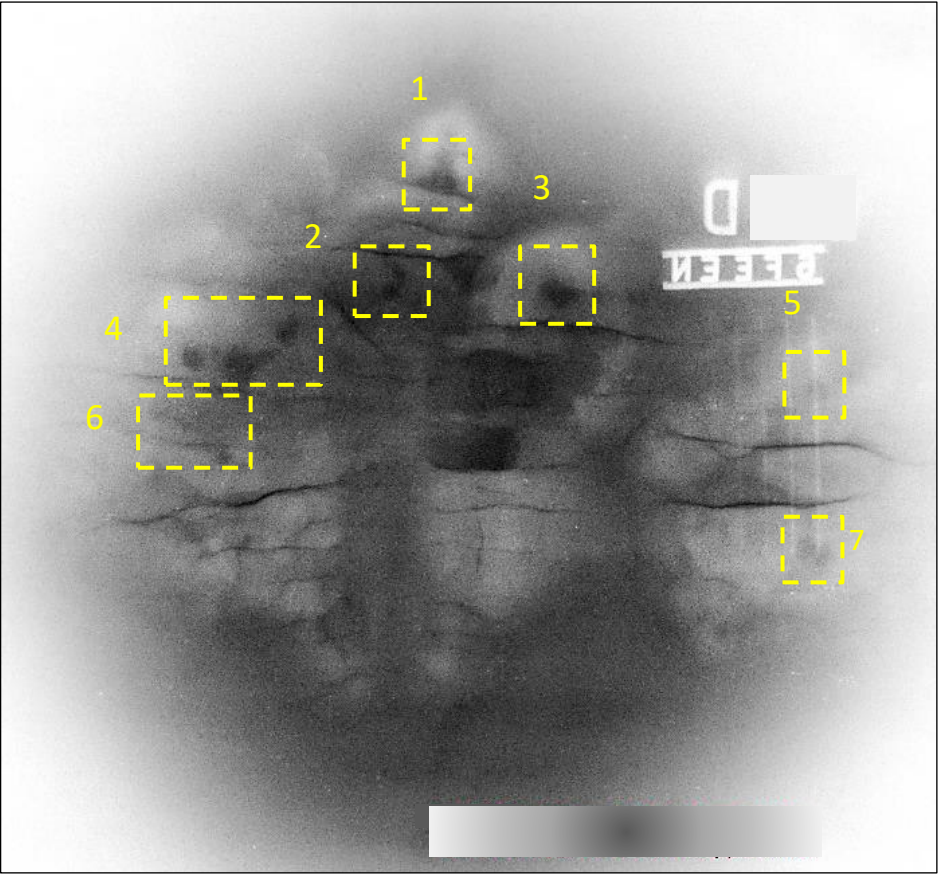
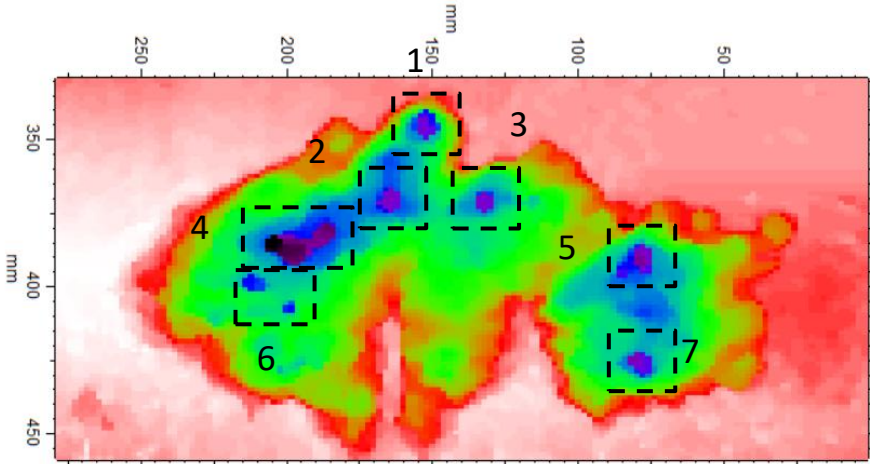
Figure A2-22: Comparison between a radiograph and a UT scan of a scab assessed in the recent HOIS study

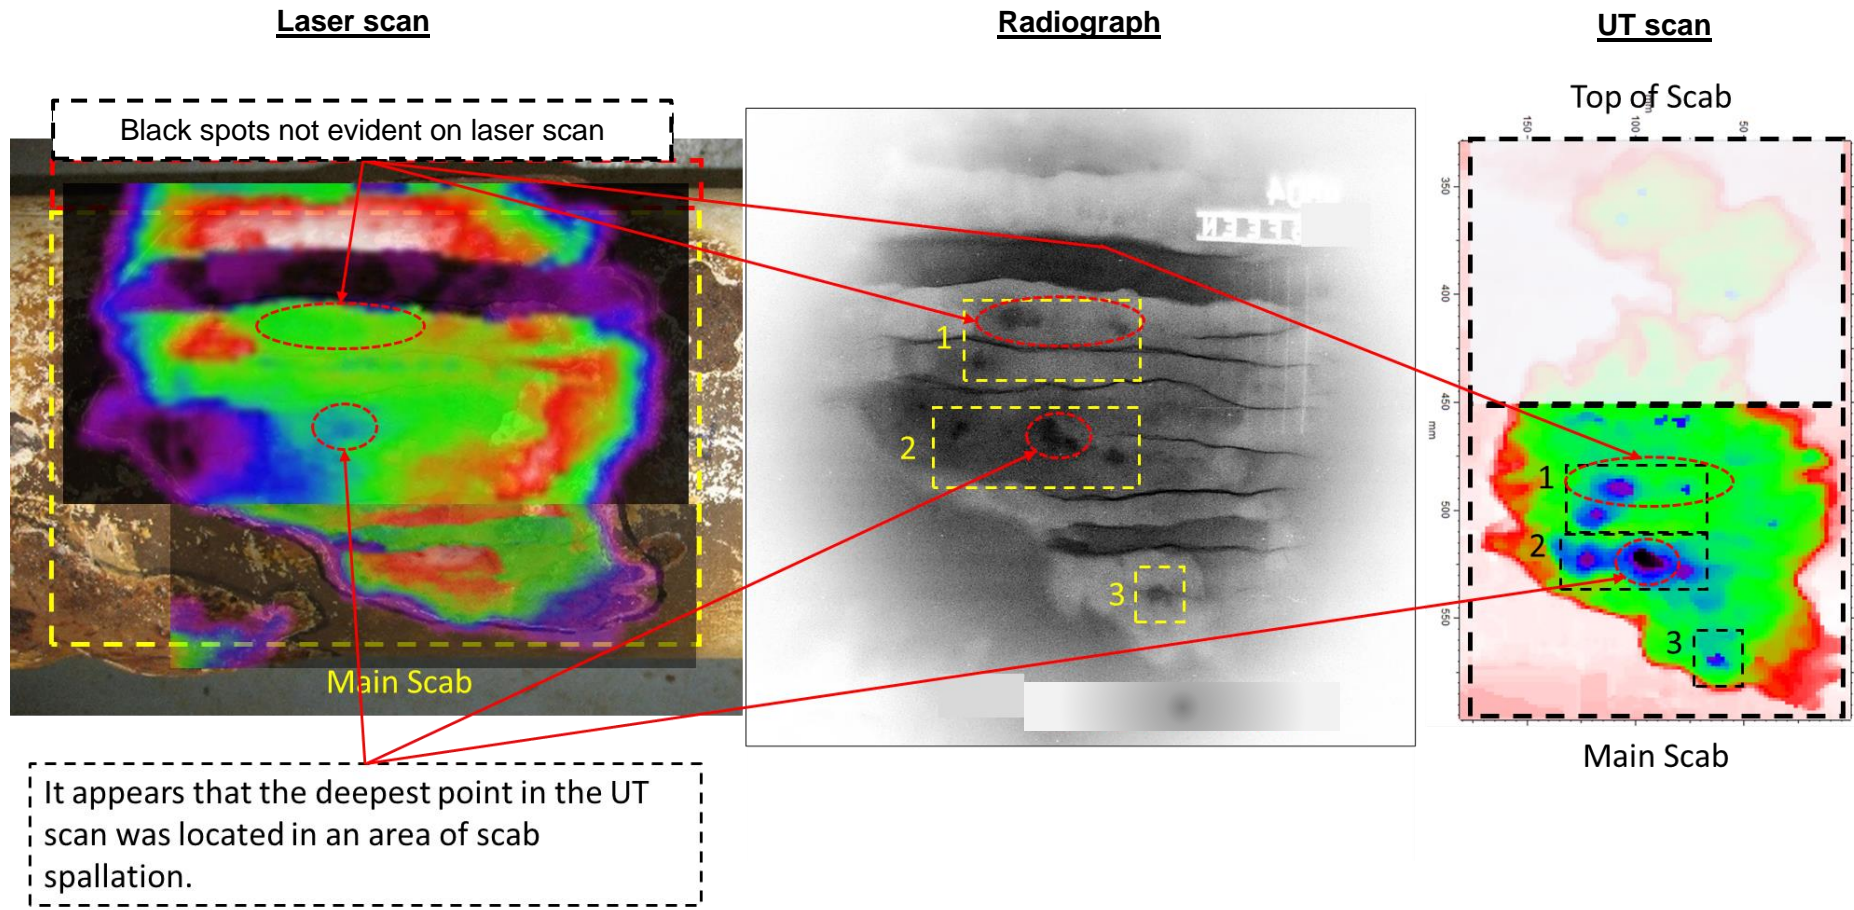
Figure A2-24: Comparison between radiograph, UT, and laser scan of a scab assessed in the recent HOIS study
