# BALL BEARING TESTING IN SUPPORT OF MTG IRS INSTRUMENT

ESTL carried out a ball bearing life test programme in support of the development of the Metosat Third Generation Infrared Sounder (MTG IRS) instrument [1]. Two ball bearing pairs were tested simultaneously in the same vacuum chamber. One pair was solid lubricated (sputtered MoS<sub>2</sub> applied to the balls and raceways) and the second fluid lubricated using Fomblin Z60 oil.

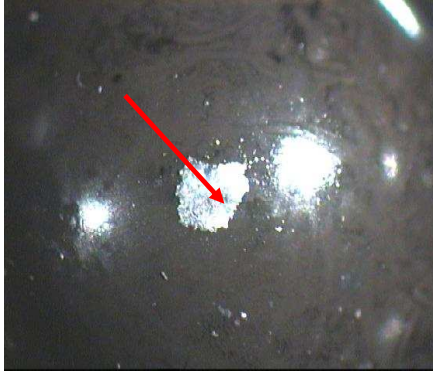
Figure 13: Compressed flake on ball surface indicated by red arrow. Note that the two other highlights are reflections from the microscope lighting

**Balls** – The balls appeared to be in good condition and were wetted by the discoloured oil. However, of some concern were some small compressed shiny flakes present upon the surfaces of a few balls. These features are consistent with a compressed metallic particle and an example is shown in Figure 13.

The origin and nature of this flake were not clear from visual inspection. It seems feasible that these particles gave rise to the high transient peaks which were observed at some stages of the oil test. The transient peaks then reduced as the particle was compressed during operation.
