# Testing of Advanced Generic Scan Mechanisms (AGSM)

M J Anderson<sup>(1)</sup>, T Forshaw<sup>(1)</sup> and G Parzianello<sup>(2)</sup>

AGSM was envisaged as a generic scan drive mechanism for large across track scanners (e.g. EGPM mission). The two Breadboard Models (BBM's) tested in this programme were foreseen as technology demonstrators and incorporated some novel features, i.e:

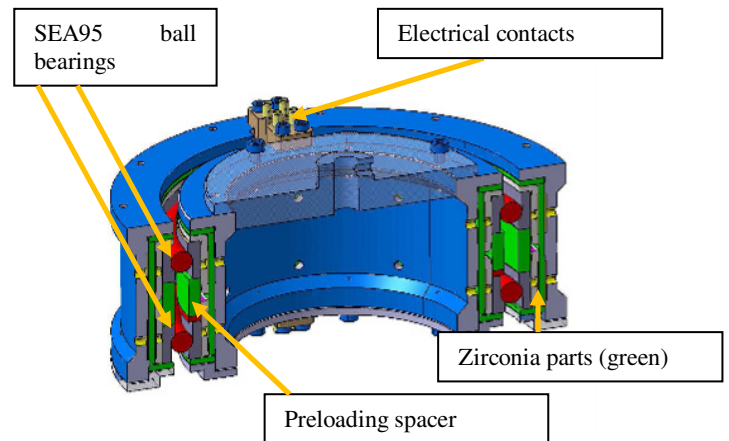
Figure 1: AGSM BBM2 – 3-D cross-section

ESTEC supported development of the AGSM by funding the design, building and testing of the BBM's. ESTL supported the development of the AGSM by procuring bearings, designing and manufacturing cages and by, lubricating the ball bearings. BBM2 began its life and thermal vacuum test at RUAG, Switzerland. It is illustrated in the Fig.1 and the following features are evident.

- The support bearings were SEA95 ball bearings manufactured by SKF and they were mounted back-to-back as illustrated. A spacer (red) was used to set the hard preload and it was installed between the inner rings.
- Zirconia inserts (green) were used to electrically isolate the ball bearings from the Ti-alloy housings and shafts and also from each other.
- Electrical contact to the inner and outer rings was made through sprung contacts as shown in Fig 1.

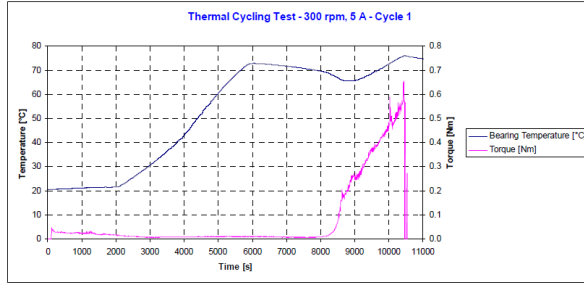
Figure 2: Torque increase above 50 deg C during testing at RUAG

During thermal vacuum testing of BBM2 at RUAG, the

torque of BBM2 increased rapidly with rising temperatures above 50 deg C (Fig.2).

As the main function under testing (i.e. the current flow through the bearing) was not compromised by this behaviour at nominal temperature, it was proposed to carry out the accelerated life-test at ambient temperature at ESTL and then complete the work by carrying out a thermal investigation of the torque behaviour.

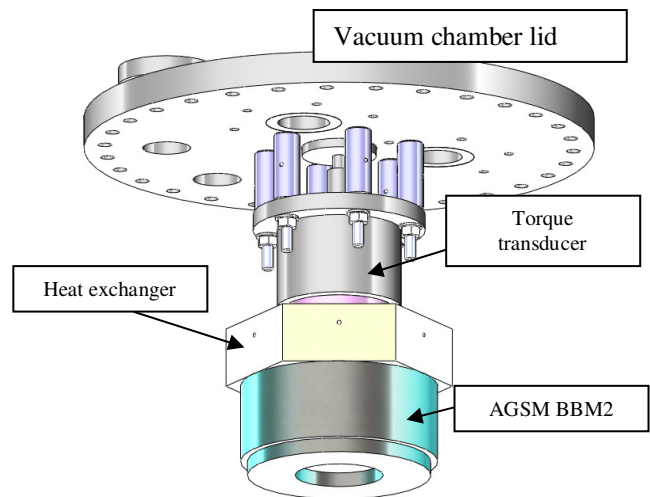
Figure 4: Test set-up

The AGSM BBM2 was installed in a vacuum chamber and mounted upon a Kistler piezoelectric torque transducer, whose output is converted to a voltage proportional to torque by a charge amplifier. These instruments have a tendency towards signal drift with time and it was therefore necessary to reverse the rotation direction of the AGSM at regular intervals to determine the torque zero position when taking a slow-speed torque measurement at 30rpm. Signal drift over the measurement period (5 to 10 minutes) is normally negligible.

Rotation of the central shaft was accomplished by a drive motor located externally to the vacuum chamber and at a rotation rate of 30 to 300 rpm. The test set-up is illustrated in the following Figure.

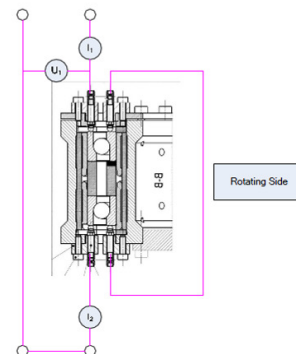
Figure 5: Electrical connections to ball bearing.

A current of 5A was passed through the outer ring of the upper bearing and the bearing inner rings were connected within the vacuum chamber as illustrated in Fig 5. The current exited the vacuum chamber via the outer ring of lower bearing.

linked to the inner ring. The inner rings of both bearings were electrically connected within the vacuum chamber. The current exited the vacuum chamber via the outer ring of bearing 2.

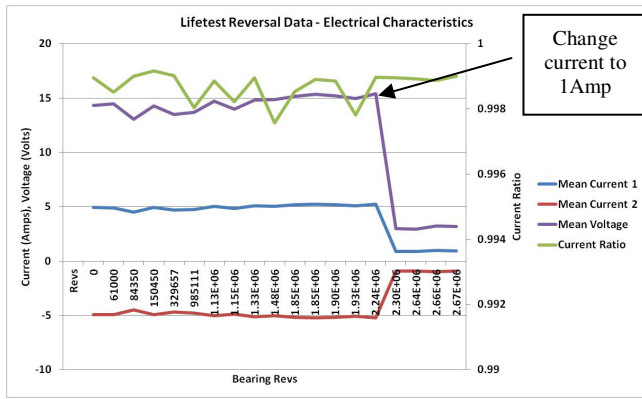
Figure 6: Summary of electrical data from torque reversals

The current and voltage drop as indicated in Fig 5 were measured throughout the test and the results are summarised in Fig.6.

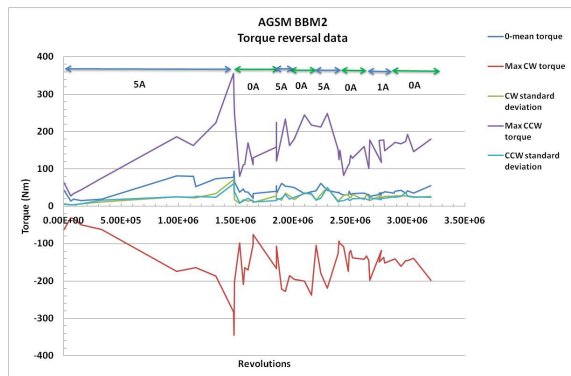
Figure 7: Summary of torques measured during reversals

The ball bearing torque was measured at intervals during testing and the results are provided in the Fig 7. Note that the torque progressively increased when 5A was passed through the bearings and the power was stopped at 1.5 million revs. The torque then decreased and subsequent testing with and without current indicated that there was a correlation between passing current and torque increases.

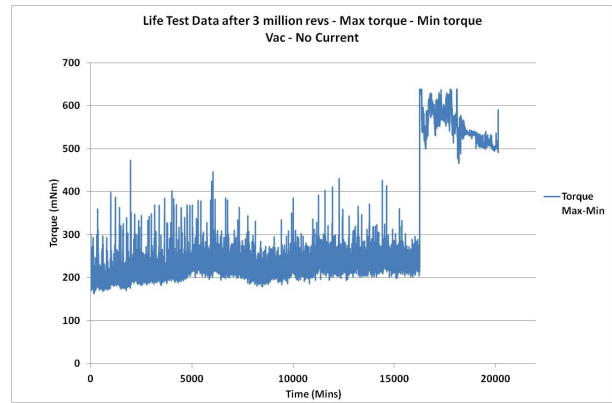
Figure 8: Torque increase at 3.2 million revs

At approximately 3.2 million revs, anomalously high torques suddenly occurred in vacuum at room temperature as illustrated in the following Figure.

The test was suspended and BBM2 removed from the vacuum chamber for further investigations. A number of observations were apparent:

- The bearings could not be rotated by applying a torque to the drive shaft by hand
- Flakes of lead-bronze were present at the bottom of the vacuum chamber
- Heavy lead bronze transfer to balls had occurred
- “Burs” or flakes of lead bronze were present at the edges of lead-bronze inserts
- A solvent rinse of the bearings was carried out and the bearings could then be rotated
- It was agreed with ESTEC to abort the life test and proceed with torque vs temperature measurements (thermal testing) to prevent any further degradation of the bearings.

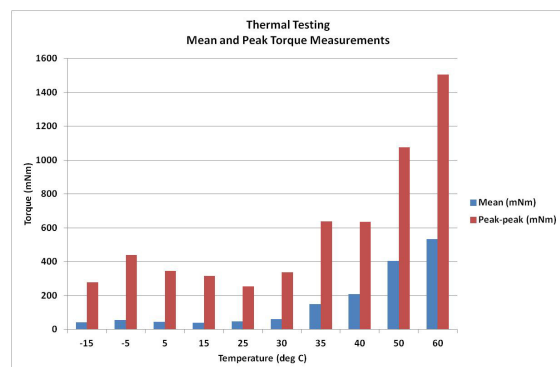
Figure 9: Results from thermal testing

The thermal test comprised heating and cooling the bearings and measuring the torque at stable temperatures. The results are provided in Fig 9.

From the thermal tests, it was apparent that the torque increased as temperature increased. Upon completion of thermal testing, the bearings were removed from the

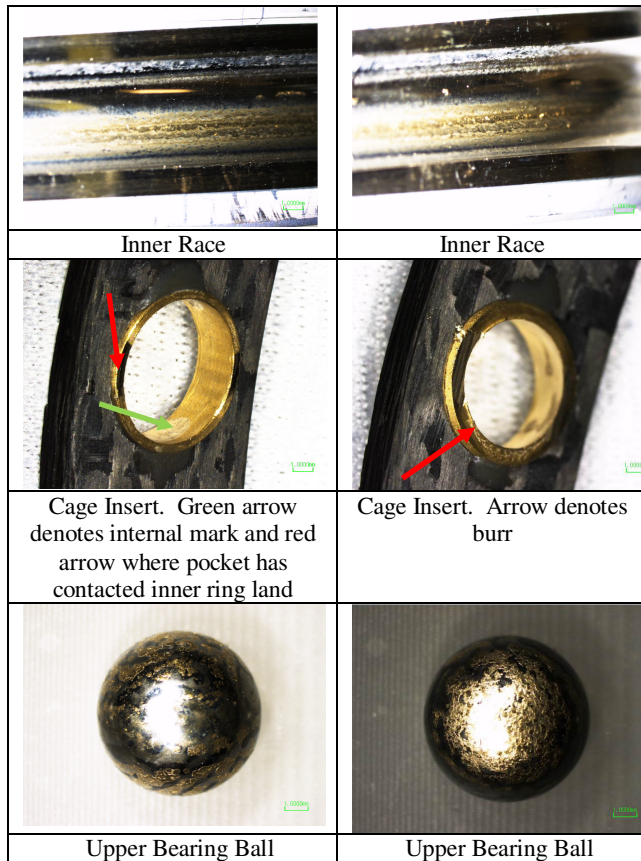
*Figure 10: Upper Bearing Inspection*

The bearings were disassembled and the raceways, balls and cages examined using a low-power optical microscope. The findings are illustrated in Fig 10.

From the visual examination, a number of observations were apparent:

1. **Lead-Bronze Debris:** Loose debris flakes were observed during disassembly of bearings. Debris was also compressed onto the inner and outer raceways.
2. **Cage Condition:** inserts displayed evidence of wear due to contact with the inner ring land – the cage was no longer ball riding. (it was designed to be inner race riding if the nibbed restraints wore out). All inserts displayed evidence of wear to the pockets, nibs and I.D. The nibbed inserts exhibited evidence of wear and “burrs” have formed on their internal diameters.
3. **Ball Condition:** Large, irregular patches of lead bronze material were compressed onto 12 of the 24 balls in upper bearing. These balls exhibited a clearly defined track where the ball had been in

contact with the inner and outer race.

It was concluded that the high torques measured in these tests was attributable to abnormal quantities of lead-bronze debris compressed onto the balls of the upper bearing. The hot plate tests revealed that the upper bearing was exhibiting high torques at +60 deg C and this behaviour was consistent with the compressed lead-bronze debris present upon the balls resisting rotation of the bearing as the balls move onto a different part of the raceway due to thermally induced dimensional changes in the rings. During continuous operation, lead-bronze debris is normally flattened at the ball to raceway contacts and rougher regions are formed at the edges of the ball tracks as debris is pushed aside. It is therefore proposed that the presence of abnormal quantities of compressed lead-bronze debris upon the balls and at the edges of the raceways contribute to the high torques measured at +60 deg C.

- There was less wear in the lower bearing to which the drop of Z25 oil had been added before testing at RUAG.
- Wear was observed in the cage ball pockets and this wear in the restraining inserts resulted in the cage being able to contact the inner ring land. It is proposed that for future designs of this cage type that alternate pockets are machined as slots to accommodate more ball movement, thus reducing ball to cage contact and wear (refer to Fig 11 for an example illustrating the concept).
