# CRYOGENIC MOTOR ENHANCEMENT FOR THE NIRISS INSTRUMENT ON THE JAMES WEBB SPACE TELESCOPE

Initial testing of the JWST NIRISS Dual Wheel Mechanism showed unsatisfactory life from the motors used to drive the individual wheel components. An investigation<sup>1</sup> uncovered that the internal friction had increased due to wear at the lubricated interface between the motor gearhead planetary gears and the planet gear retaining pins, reducing output torque. Work was undertaken to improve the life of this interface. Several design options were selected for development. A successful redesign was qualified with a larger gearhead, modified to use ball-bearings for planetary gear support. To further enhance life, all internal lubrication was changed to sputtered MoS<sub>2</sub>. PGM-HT cages were also employed for planetary and motor rotor bearings.

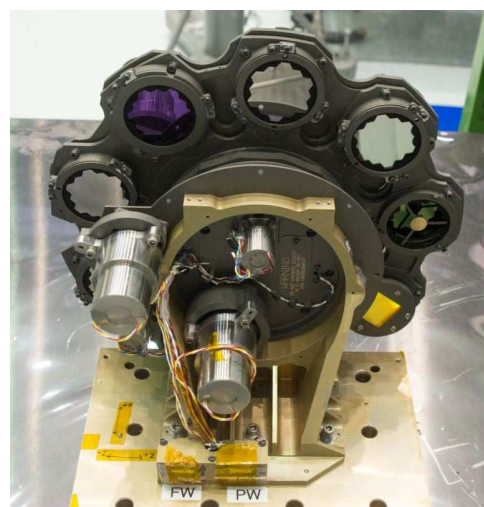
Figure 1: NIRISS Dual Wheel

The Dual Wheel (DW) consists of two wheels, the Filter wheel and Pupil Wheel both of which are driven by independent Geared Motors with planetary reduction gearheads mated to a common structure.

The NIRISS Dual Wheel is depicted in Figure 1. The bottom image of Figure 2 represents the motor design reviewed at the Failure Review Board (FRB)<sup>1</sup>. The top image of Figure 2 depicts the motor design ultimately selected for flight.

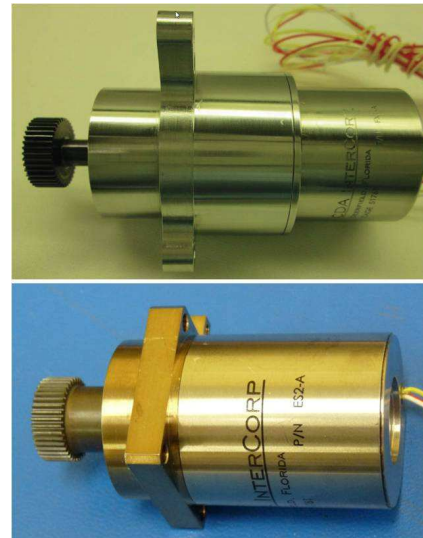
Figure 2: Pupil Wheel Motors – Enhanced Design (Top) and Original Design (Bottom)

Increasing the gear head size from 1.25" to 1.5" was calculated to decrease the contact stresses inside the motor bearings and at planet gear interfaces by 40% over the heritage design.

This increase in gear head size needed to be accommodated with the existing motor interfaces on the Dual Wheel. An interface spacer was designed to transition between the larger gear head and DW interface. A longer pinion shaft length was required.

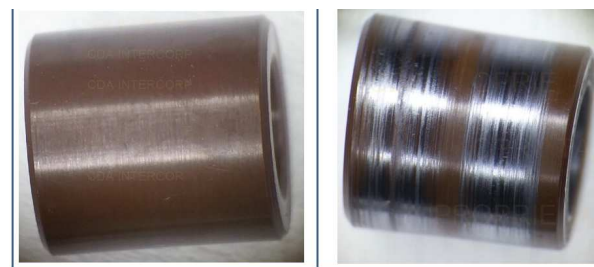
Figure 4: Pre / Post Wear Test Bushing Condition

Post test disassembly and inspection showed distinct wear of the bushing on both the outer and inner bearing surfaces, indicating the bushing rotated within the planet gear bore as well as in the planetary gear pin. Metallic particulate was observed in the bushing bores (likely from end-face wear of planet gears). MoS<sub>2</sub> transfer to the bushing at the planet gear interface was evident. An image of a bushing, pre and post test, is given in Figure 4.

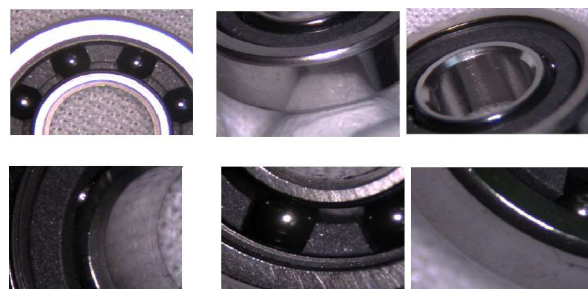
Figure 13: Motor Bearing Condition

The motor bearings were found in excellent condition after disassembly. Both bearings were clean and free of visible debris. The balls, ring raceways and PGM-HT retainers showed even lubrication wear and transfer. Both the bearing bore and OD were in the as-assembled condition and showed no scuff marks or scoring. There was no relative motion evident between the bearings and their respective journals. Refer to Figure 13 for images of the motor bearings.
