## SOME RECENT EXPERIENCES OF MECHANISM PERFORMANCE AND COMPONENT ASSESSMENT IN THERMAL VACUUM TESTS AT ESTL

J. A. Duvall & K. Parker

*ESTL, UKAEA Risley, Warrington, Cheshire, UK*

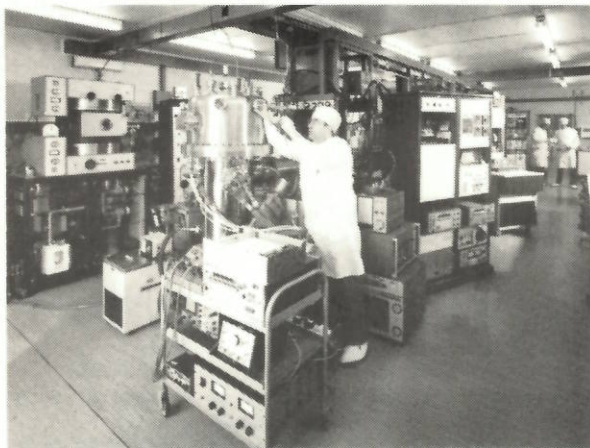
Figure 1. Part of the ESTL test facilities.

Several types of ultra-high-vacuum test chambers are used for mechanism testing. Certified clean room conditions have proved to be essential in the success of thermal vacuum testing, particularly with regard to the handling and inspection of mechanisms. Part of ESTL is shown in Figure 1.

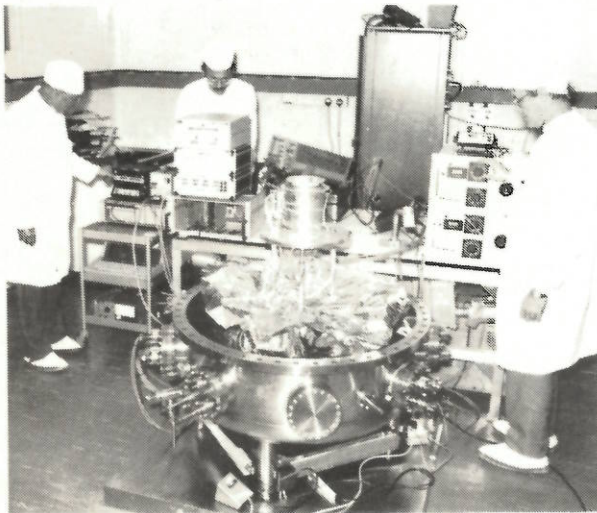
Figure 5. Giotto despin mechanism being installed in the ESTL 1-metre diameter test facility.

It was essential to do this in vacuum so as to exclude the effect on the system of the damping factor in air. Figure 5 shows this mechanism in the ESTL test facility.

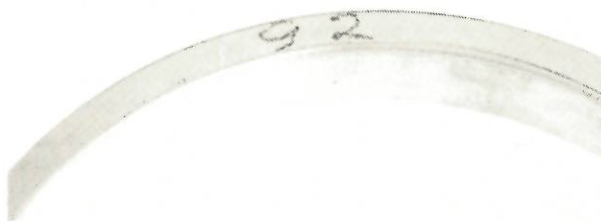
The practice of etching identification symbols on bearings, as in Figure 11, is undesirable. Several problems have been encountered where this type of engraving has caused misalignment and unacceptable preload variations, particularly in duplex bearings under hard preload.

Figure 11. Engraved symbols on bearing

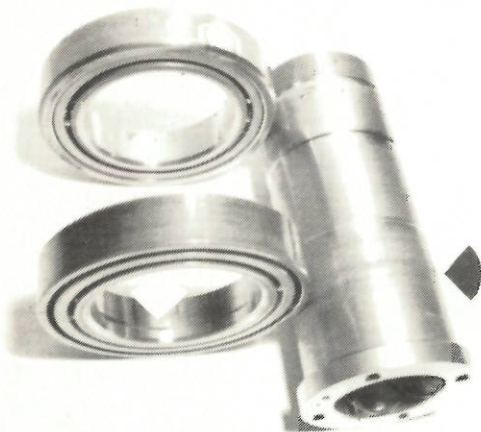
A consequence of the failure of some tooth tips was that one or more particles had entered an adjacent bearing. Pitting damage was found on the balls and races and as seen in Figure 14 the shaft had seized within the inner ring.

Figure 14. Shaft/inner race seizure.

It was deduced that the high torque generated by the presence of tooth particles had resulted in the shaft rotating within the inner ring until galling seizure had occurred.

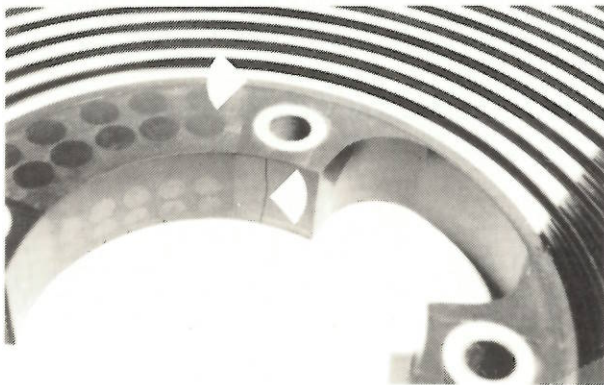
Insulating materials must be carefully selected for strength and rigidity, particularly in coaxial disc type units. Although surface cracks have been found in ceramic discs, presumably formed during vibration testing, more serious structural cracks have been found in polymeric discs. The example shown in Figure 16 has cracked near a

metallic insert sleeve. In one instance we found that the electro deposited silver had cracked across the ring.

Figure 16. Cracked slip ring disc

Surprisingly these defects had not caused any noticeable departure from the specified performance but obviously they suggest that a failure could eventually occur.

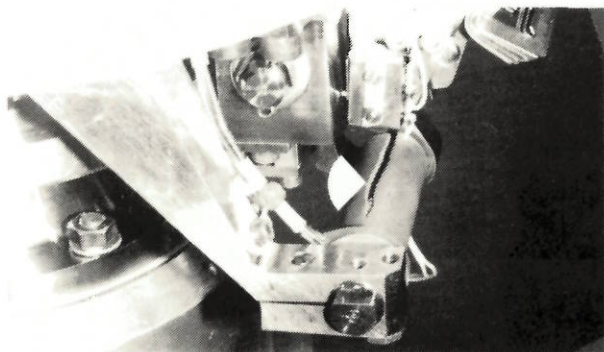
Figure 17. Ruptured MAE heater sheath

One type of release mechanism employing memory alloy elements had been tested satisfactorily in ambient air conditions, but when the heater was energised in vacuum at  $-60^{\circ}\text{C}$ , with what was assumed to be the correct power input, the difference in thermal transfer resulted in localised over-heating and rupture of the outer sheath, as shown in Figure 17. Silicone compounds were released which contaminated the mechanism and the vacuum testing facility.

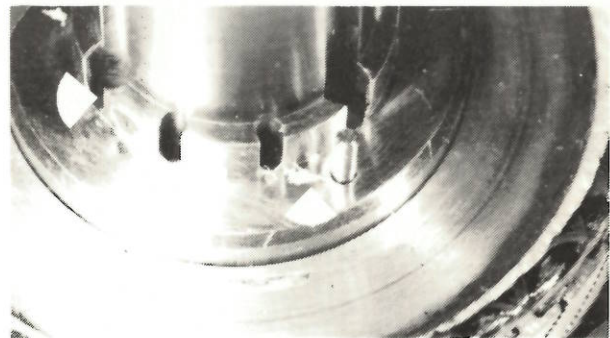
One disturbing feature found during dismantling that sharp edges on components have resulted in abrasion of cable insulation. The holes shown in Figure 18 are used as guides for power slip ring cables but the sharp edges had cut through the insulation and the particles removed had been trapped between two radial surfaces causing slight misalignment.

Figure 18. Sharp edges and insulation debris
