Thermal Vacuum Performance of Cycloid and Harmonic Gearboxes  
with Solid ( $\text{MoS}_2$ ) and Liquid (Braycote 601) Lubrication

S.Gill, D.J.Forster, and R.A.Rowntree

European Space Tribology Laboratory (ESTL),  
AEA Technology, Risley, Warrington, UK

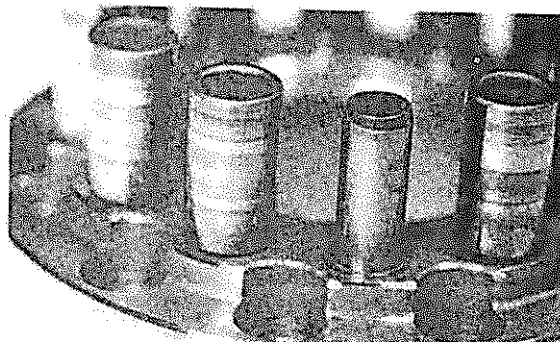
Figure 7: Output Hub post MoS<sub>2</sub> Lubricated Tests.  
Figure 9: Cycloidal Plate post MoS<sub>2</sub> Testing.

The cycloid plates had lubricant remaining in all regions. Although the loaded portion of the tooth was highlighted by two lines of discoloured lubricant, on removal there were no obvious wear scars at this juncture, Figure 7. These components were typical of the component condition throughout this gearbox.

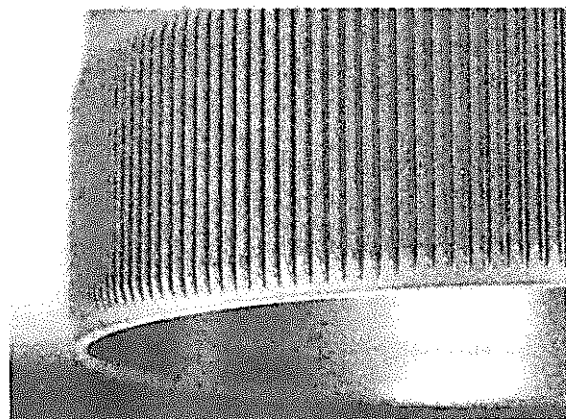
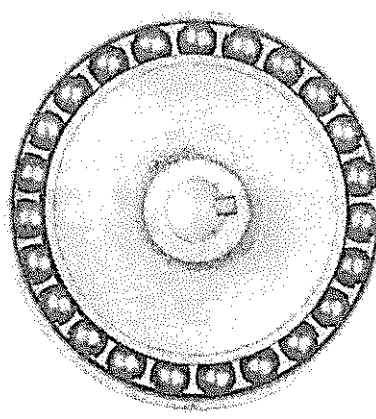
Figure 15: Circular Spline post MoS<sub>2</sub> Testing.  
Figure 17: Wave Generator post MoS<sub>2</sub> Testing.

Figures 16 & 17 highlight features of the Harmonic Drive following the tests whilst dry-lubricated with MoS<sub>2</sub>. A view of the circular spline in Figure 16 clearly shows the tooth profile of the leading edge and the degree of engagement of the mating wave generator by the transfer of bonded lubricant. Visual inspection showed that the same regular wear and deformation pattern exists at the point where contact with the flexspline is first made. A similar mark was also evident on the flexspline. The wave generator showed no signs of distress, and the balls have a healthy transferred film, Figure 17. Visual inspection of the interface between the wave generator and the flexspline showed the wave generator to have a thin sheen of MoS<sub>2</sub> all around, whilst the inner bore of the flexspline showed a zone of densely compacted MoS<sub>2</sub>, which was well bonded to the surface.
