HOIS/OGTC guidance for trunnion pipe support management and inspection

HOIS-G-033, Issue 1

October 2020

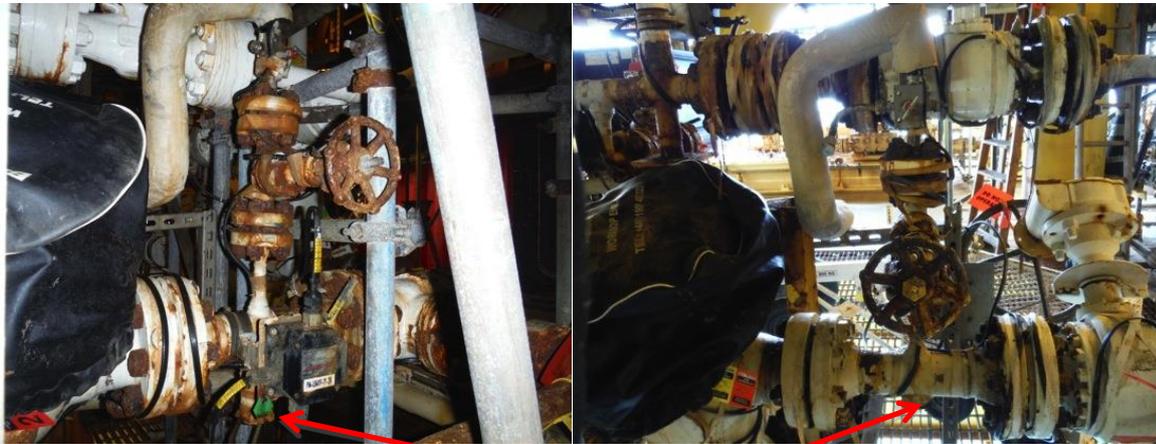
Figure 7-9: Side view of vertical trunnion supports.

As with case study 2, this case study is taken from a redacted inspection findings follow-up report. No information was provided on how these trunnions were originally assessed. The two vertical trunnions of concern are on 3" carbon steel piping with a nominal wall thickness of 11.1mm (Sch.

160) which had been in service for ~ 20 years. Note the challenging access requirements in Figure 7-9.

The trunnion endcaps were removed, and external delaminating corrosion was located on the external and internal surfaces of the trunnion pipe supports. The depth of the scale on the inside of both trunnions was estimated to be between 5 and 6mm. The scale was removed, and UT spot readings were performed where possible. Blasting revealed pitting corrosion over the whole trunnion footprints with more severe pits, as shown in Figure 7-10 and Figure 7-11.

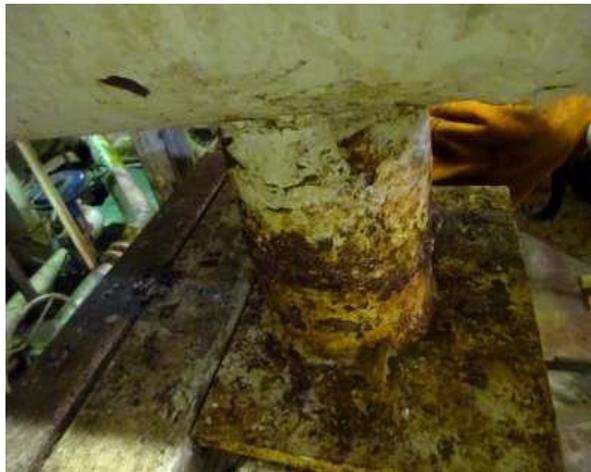
Figure 7-12: Vertical trunnion on process fluid containing 10" Sch 40 line.

The trunnion in Figure 7-12 was on an offshore asset and identified for investigation because there was evidence of external corrosion to the receiving pipework, trunnion body and end plate. The pipework was isolated, and the trunnion inspected using a borescope. Some example images are shown in Figure 7-13 and Figure 7-14 which were of concern because of the presence of a watery fluid at the base of the trunnion and a black sticky fluid which had some characteristics of crude. The fluid was subsequently sampled and analysed by an offshore chemist who ruled out the presence of hydrocarbons and identified iron sulphide and iron oxide corrosion product as a result of the stagnant water inside the trunnion (thought to be deluge water).

The trunnion was then removed (cold cut) to further assess the condition of the process pipe. Light surface corrosion was identified with no excessive pits as shown in Figure 7-15. The area was cleaned, and wall thickness measurements taken using a button probe and found to be within nominal. A new clamp type support was fitted Figure 7-16.

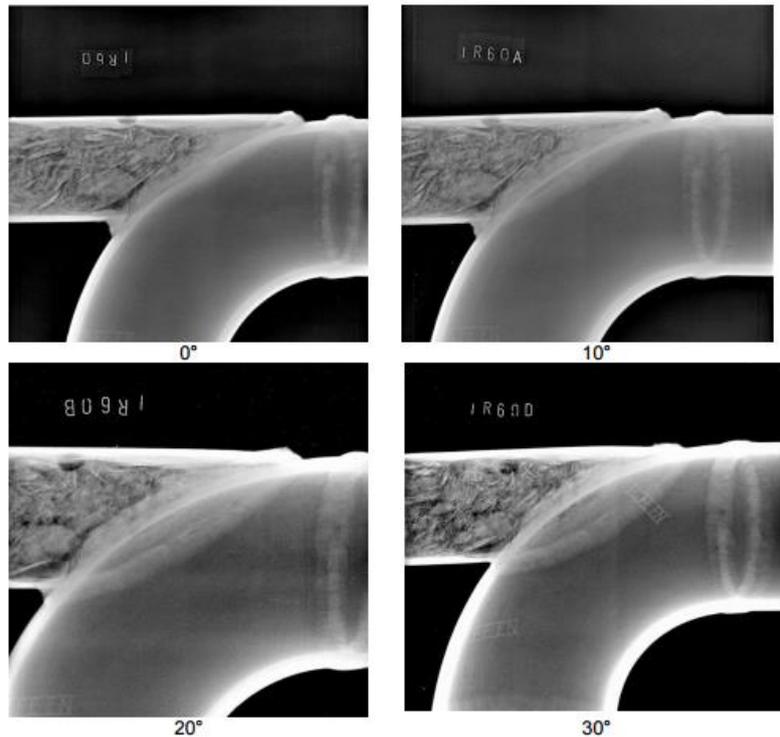
Figure A 1-9: Computed radiography images at different angles.

This example demonstrates that for tangential radiography of trunnions located on elbows, the source and detector should, if possible, be aligned so that the tangent point on the elbow coincides with the extrados, as this corresponds to the centre of the trunnion which is where the greatest wall loss is likely to be present.
