# INVESTIGATION OF AN ANOMALOUS FAILURE OF BEARING ON A FAN WITHIN THE COLUMBUS MODULE OF THE ISS

## ABSTRACT

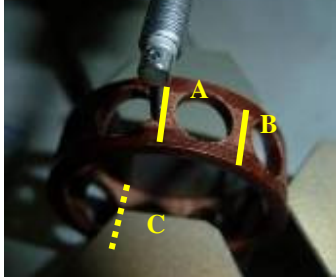
Figure 18: Profile measurements on the cage. A: profile next to the oval pocket. B: max wear step. C: min wear step

The profile was measured in three sections as indicated in Figure 18. It can be observed (Figure 19) that the wear is not equal on the two sides of the cage and appears bigger on the left hand side (140-150  $\mu\text{m}$ ) when compared to the right hand side (110-120  $\mu\text{m}$ ). The smallest wear is about 10-15  $\mu\text{m}$ .

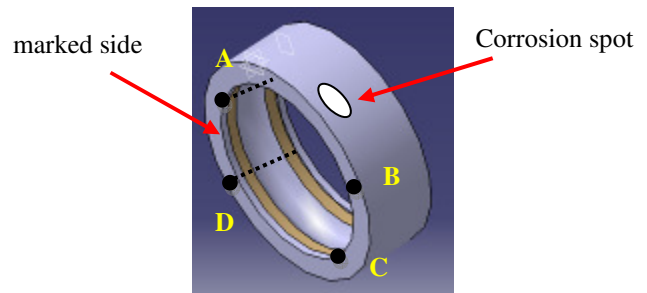
Figure 21: position of profile measurements on the outer ring

The worn lands of the two parts of the outer ring have been measured with the profilometer in the four locations indicated in Figure 21.
